Bureau of
Safety and
Environmental
Enforcement

QC-FIT EVALUATION OF CONNECTOR AND BOLT FAILURES SUMMARY OF FINDINGS

EXECUTIVE SUMMARY

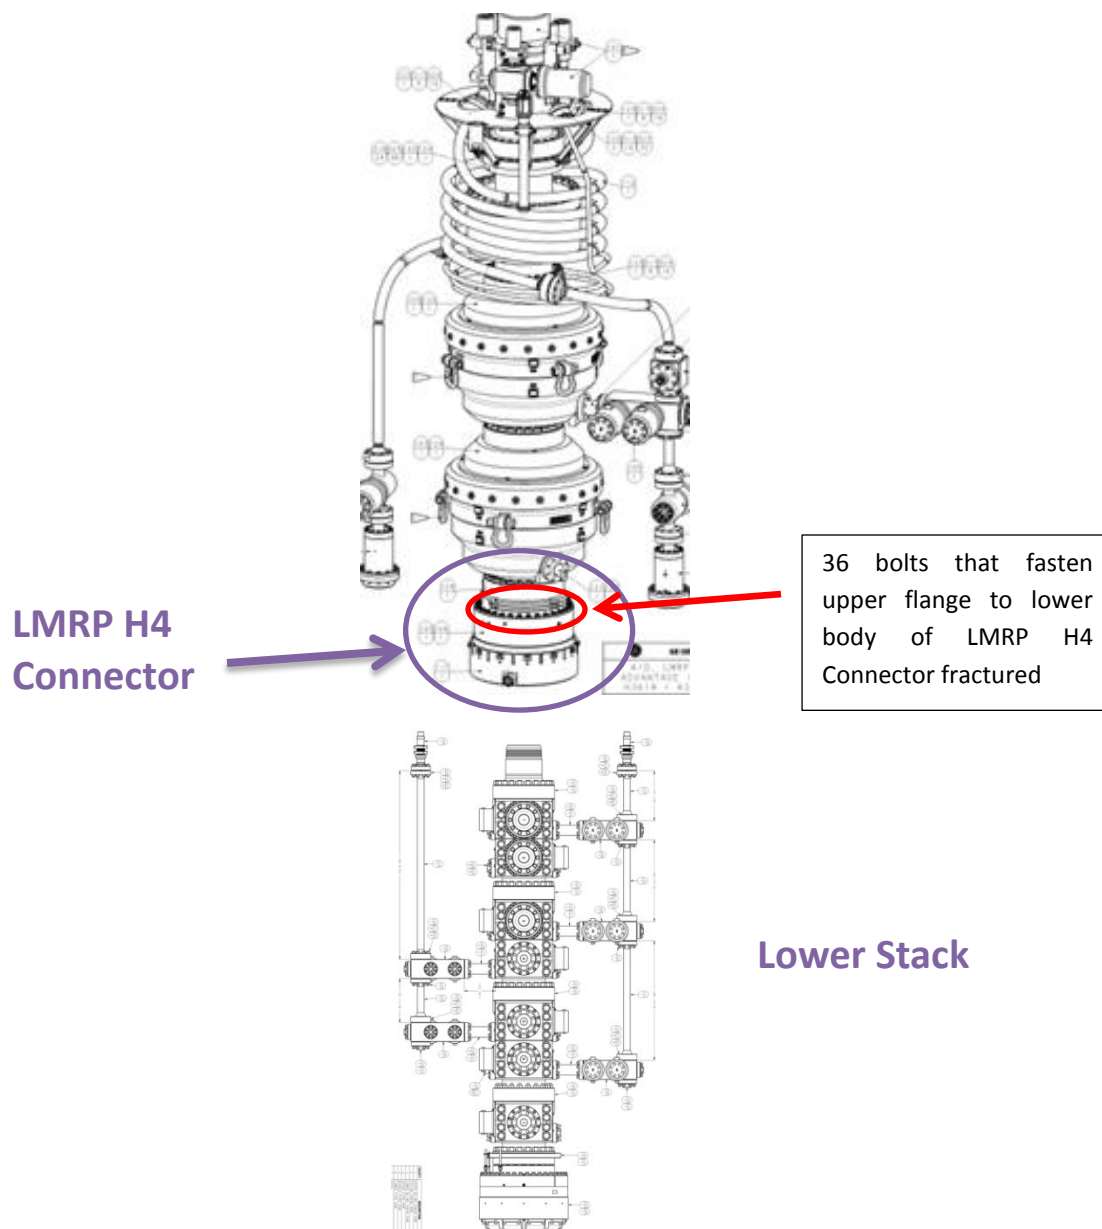
FIGURE 2 - SCHEMATIC OF LMRP H4 CONNECTOR AND MANDREL INDICATING LOCATION OF 36 CONNECTION BOLTS, DEPICTING SEPARATION (REF. 2013 GE PRESENTATION TO BSEE) GE COPYRIGHT, NON FOIA

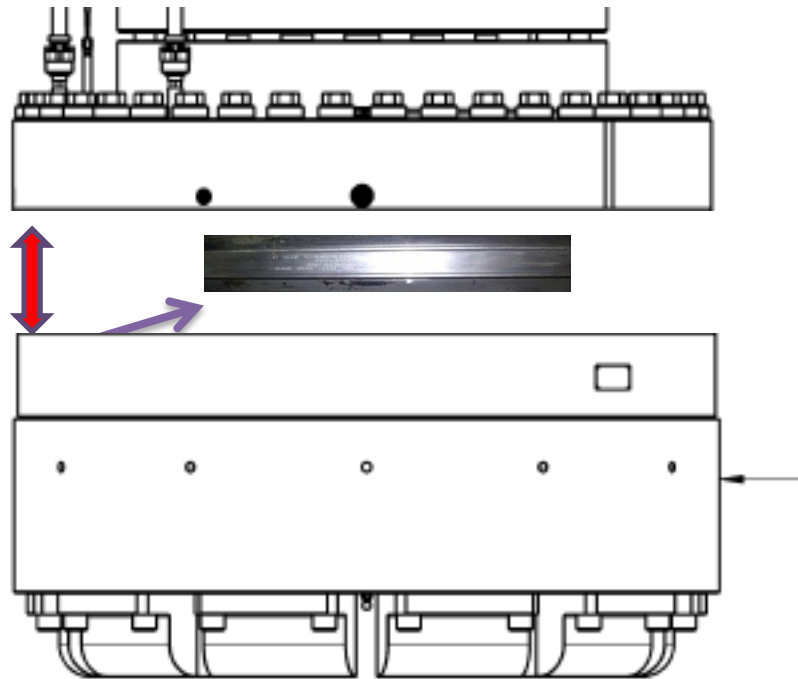
FIGURE 3 - SCHEMATIC DEPICTION OF LMRP H4 CONNECTOR SEPARATION. ALL 36 BOLTS THAT FASTEN THE CONNECTOR FAILED (REF. 2013 GE PRESENTATION TO BSEE) (GE COPYRIGHT, NON FOIA

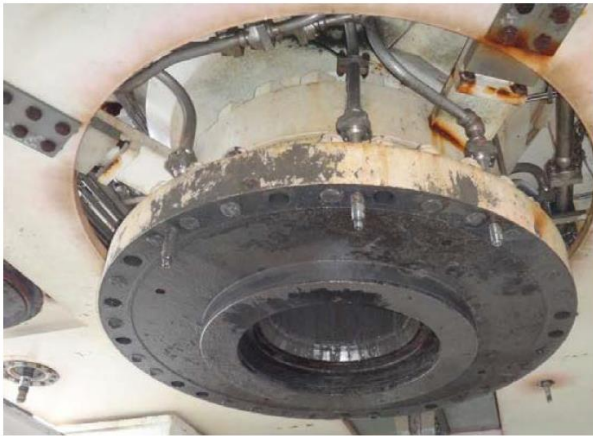
Upper half of failed LMRP Connector

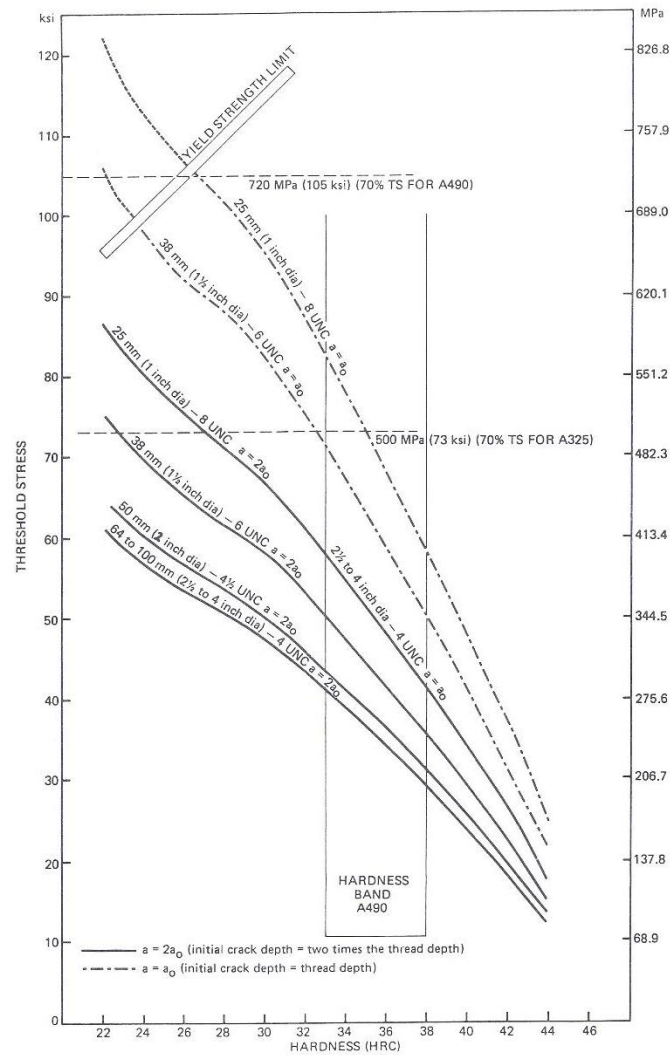
Plot of threshold stresses for stress-corrosion cracking in low-alloy quenched and tempered bolting materials with different hardness levels. Note: UNC denotes unified coarse thread.

Based on curve above, when bolts are subjected to stresses in the range of approximately 28,000 to 35,000 psi with diameters in the range of 2.5-4 inches, and hardness 34-38 HRC, they will likely fracture due to stress corrosion cracking. For example, bolts with a hardness of 34 HRC, will likely fracture due to stress corrosion cracking (SCC) at approximately 35,000 psi. When subjected to an applied stress of approximately 28,000 psi. Bolts with a material hardness value greater than 38 HRC, will likely fracture due to SCC. Therefore, the higher the bolts' material hardness value, the lower threshold stress they can withstand before fracturing due to SCC. The lower the bolts' material hardness (more ductile its material strength properties), the higher the threshold stress they can withstand before fracturing due to SCC.

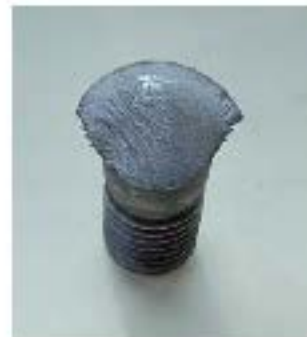
Fig. 3 — Hydrogen embrittlement and failure of a hard chromium-plated chain conveyor bolt.

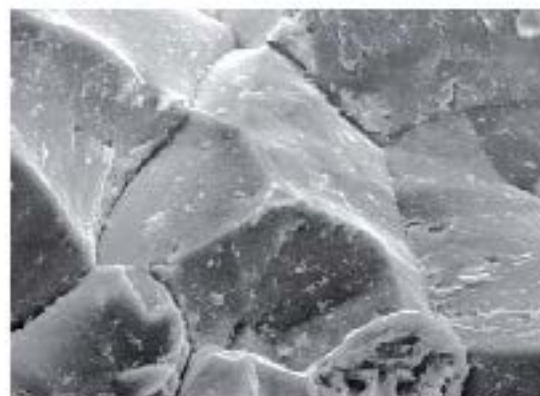
Fig. 4 — Intergranular fracture due to hydrogen embrittlement (photo courtesy of Aston Metallurgical Services Co., Inc.).
