BSEE Panel Report 2021-001

Investigation of May 29, 2019, Fatality

Lease OCS-G02116, Eugene Island
Area Block 331

March 11, 2021

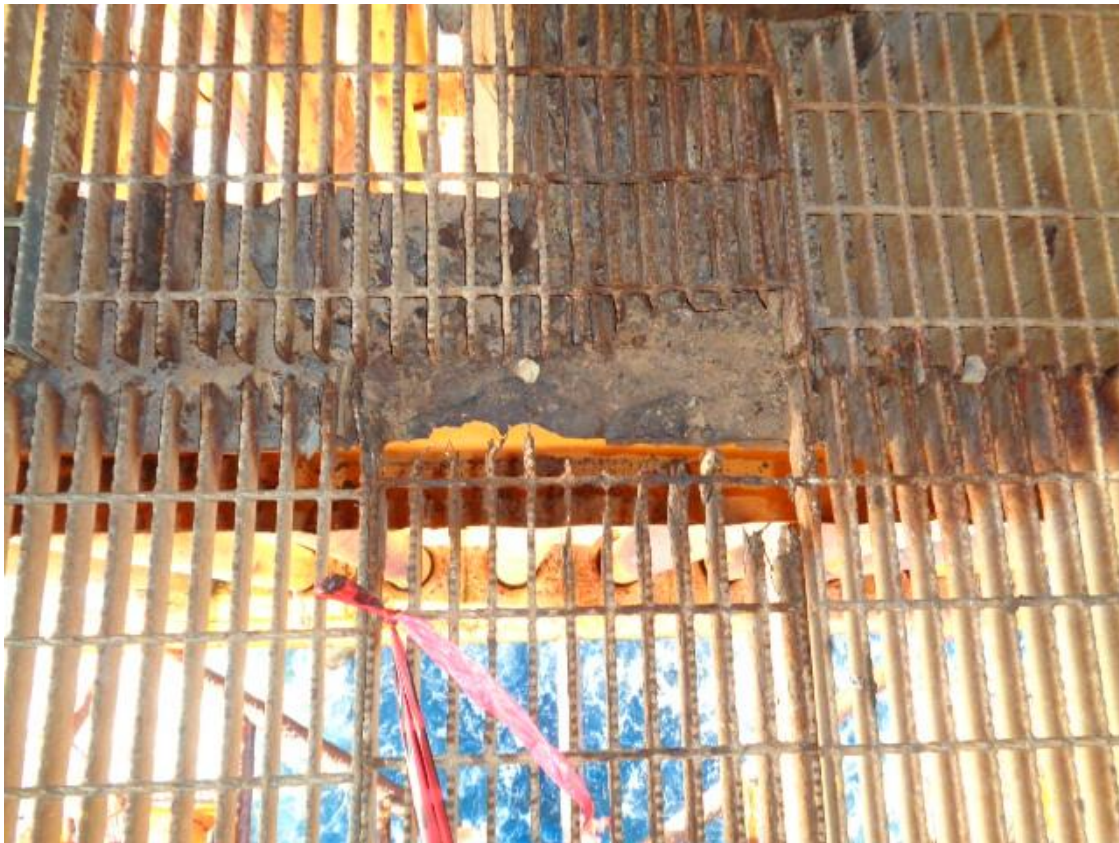
Prior to 0752, according to the *Figure 6* time stamp, the UWA returned to the section of hazardous grating to assess the severity of the corrosion by striking it with a “small sledgehammer.” After assessing the end of the section of hazardous grating with the sledgehammer, the UWA took another photograph of the condition of the grating (*see Figure 6*). The UWA gave the camera used to take the photographs to the lead PO so that an ALMS entry could be created for the hazardous grating section.

Figure 6- Pre-Incident Photograph of Hazardous Grating Section with Red Danger Marking Tape Affixed and After Impact from Sledgehammer Strikes

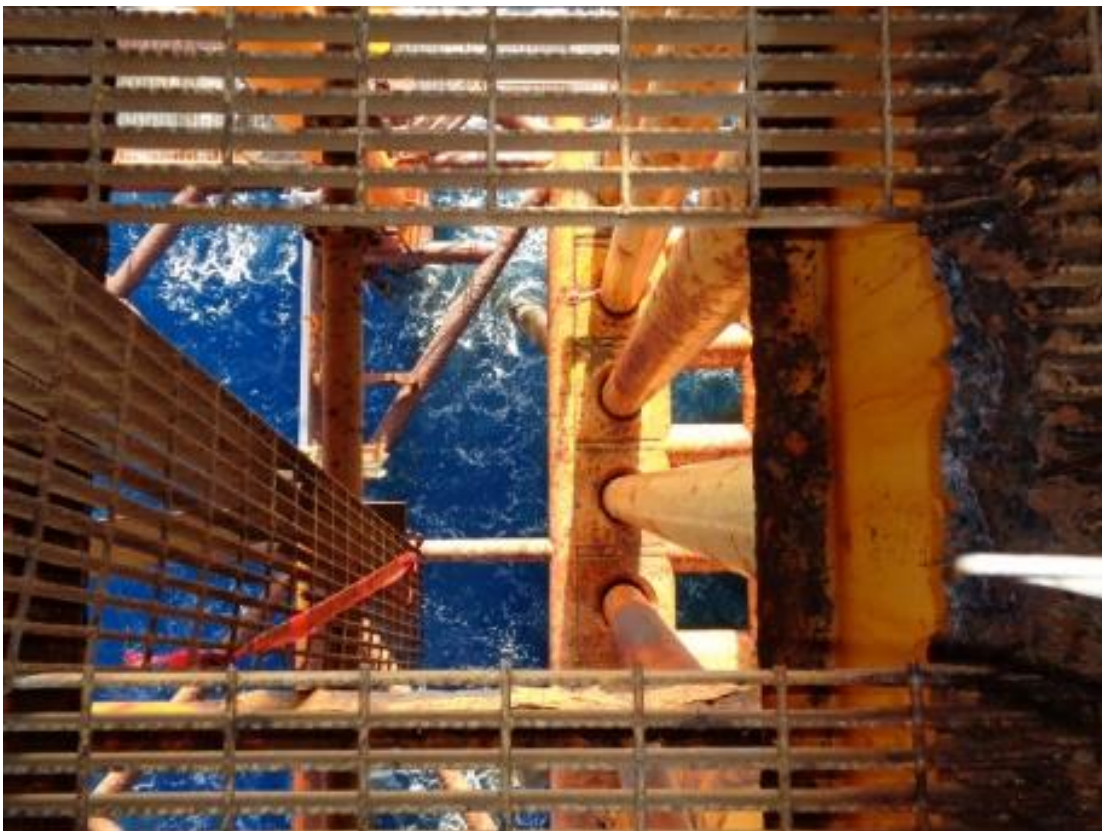
Figure 8- Post-Incident Photograph of Hazardous Grating Section Suspended in Open Hole with Red "DANGER" Marking Tape Affixed

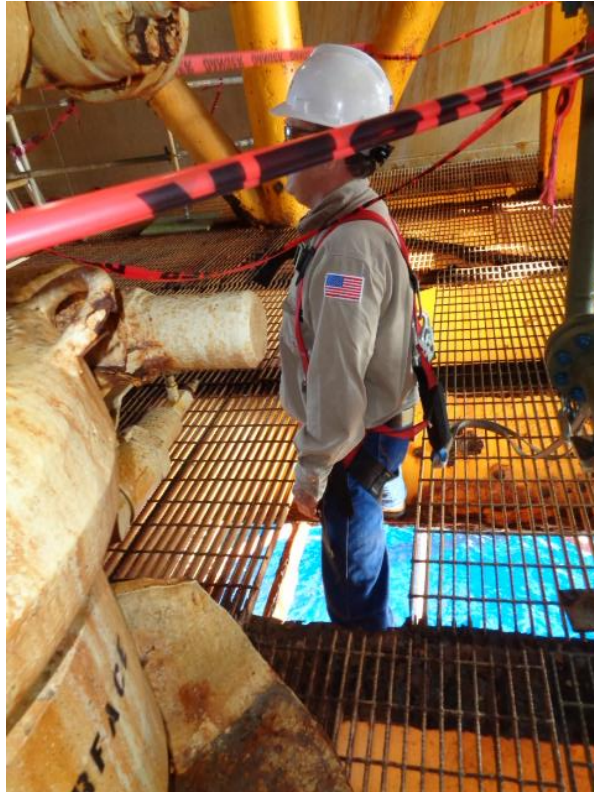
Figure 9- Post-Incident Photograph of the Production Superintendent Wearing Fall Protection Standing in the Open Hole After the Hazardous Grating Section was Removed

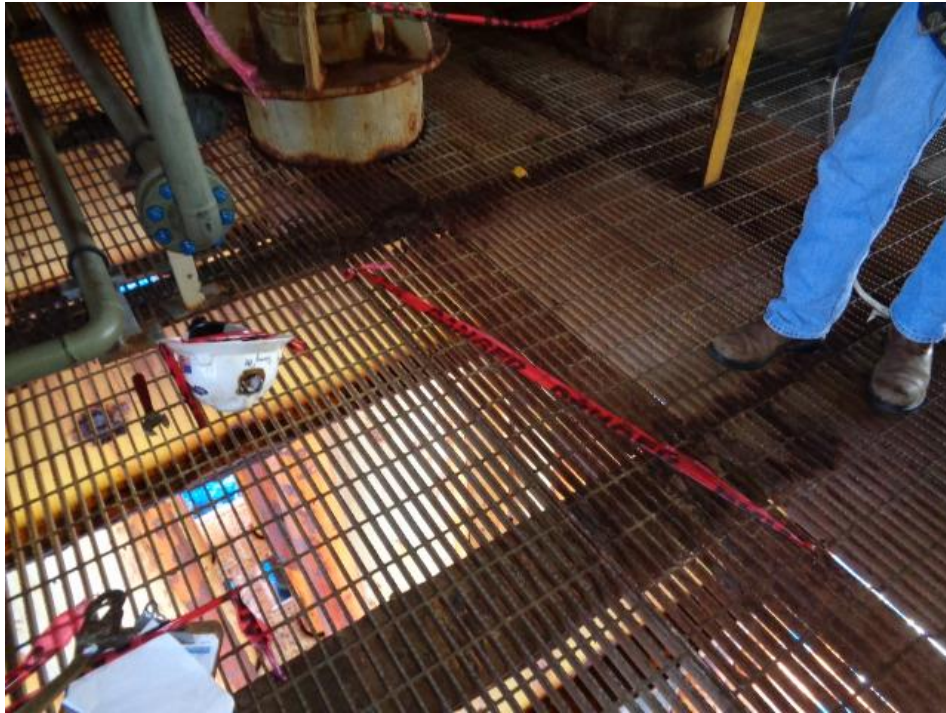
Figure 11- Post-Incident Photograph of Hazardous Grating Section Placed in its Approximate Pre-Incident Position

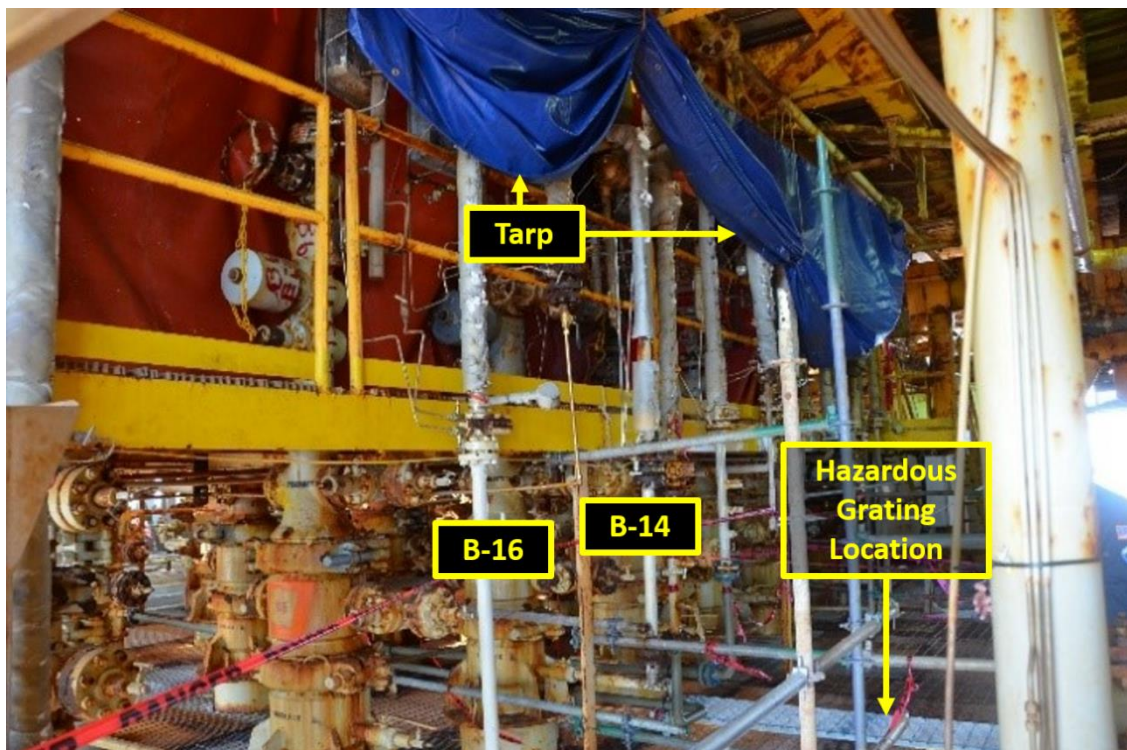
Figure 13- Post-Incident Photograph of the North Side of Wellbay Showing the Locations of Tarp Placement (for Hot Work), Hazardous Grating, and Wells B-14 and B-16

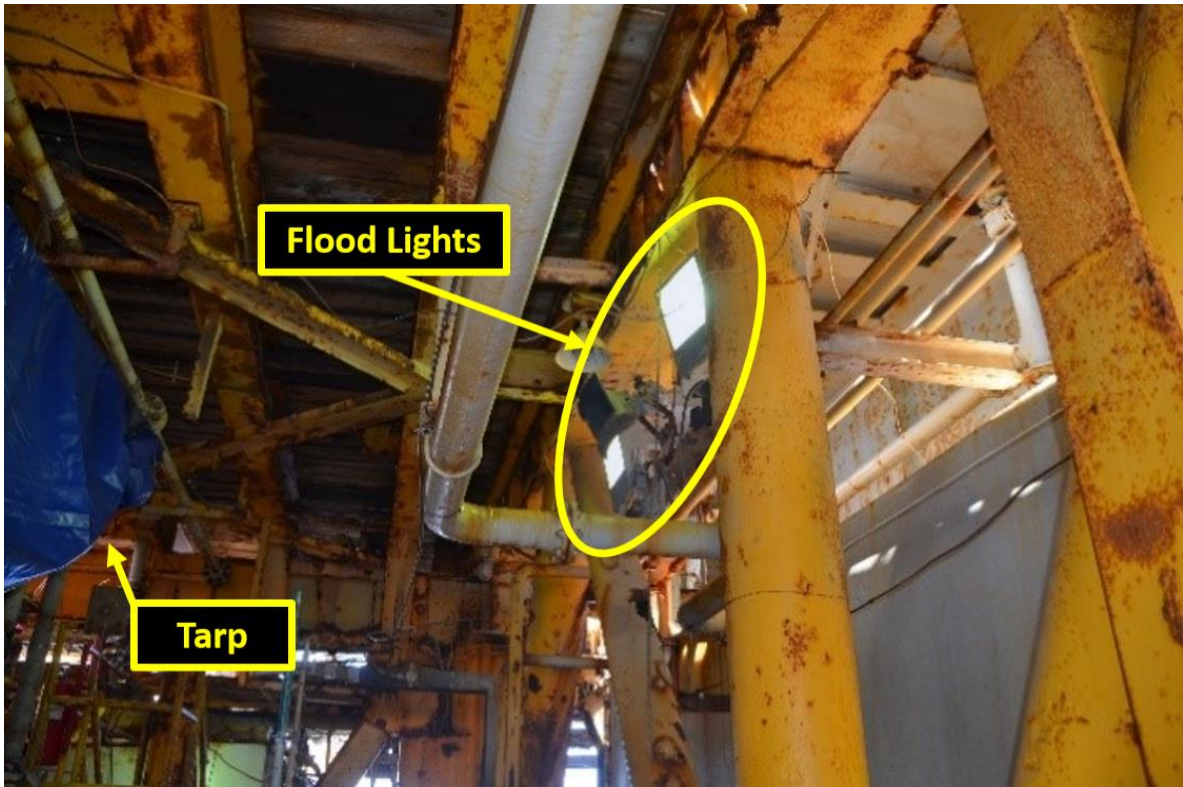
Figure 14- Post-Incident Photograph of Two Flood Lights Located at the North Side of the Wellbay

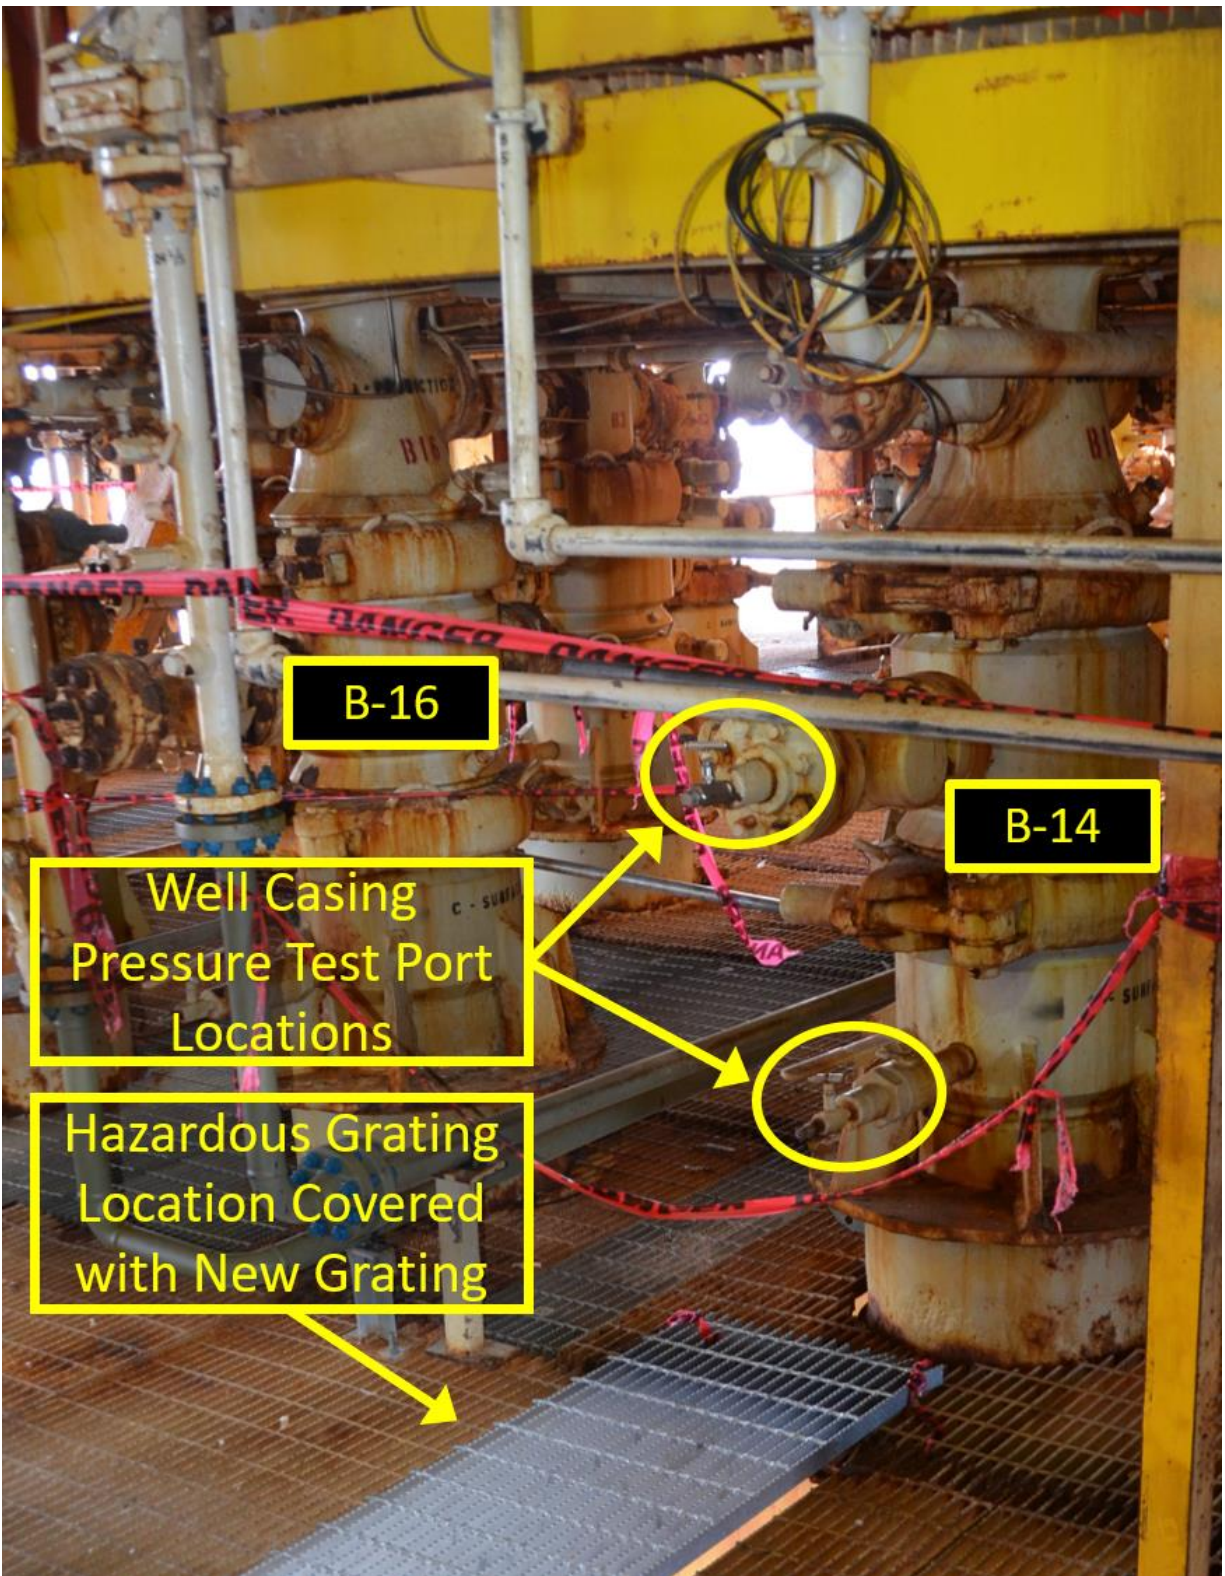
Figure 15- Post-Incident Photograph Showing Well B-14 Casing Pressure Test Port Locations in Relation to the Hazardous Grating Section and Well B-16

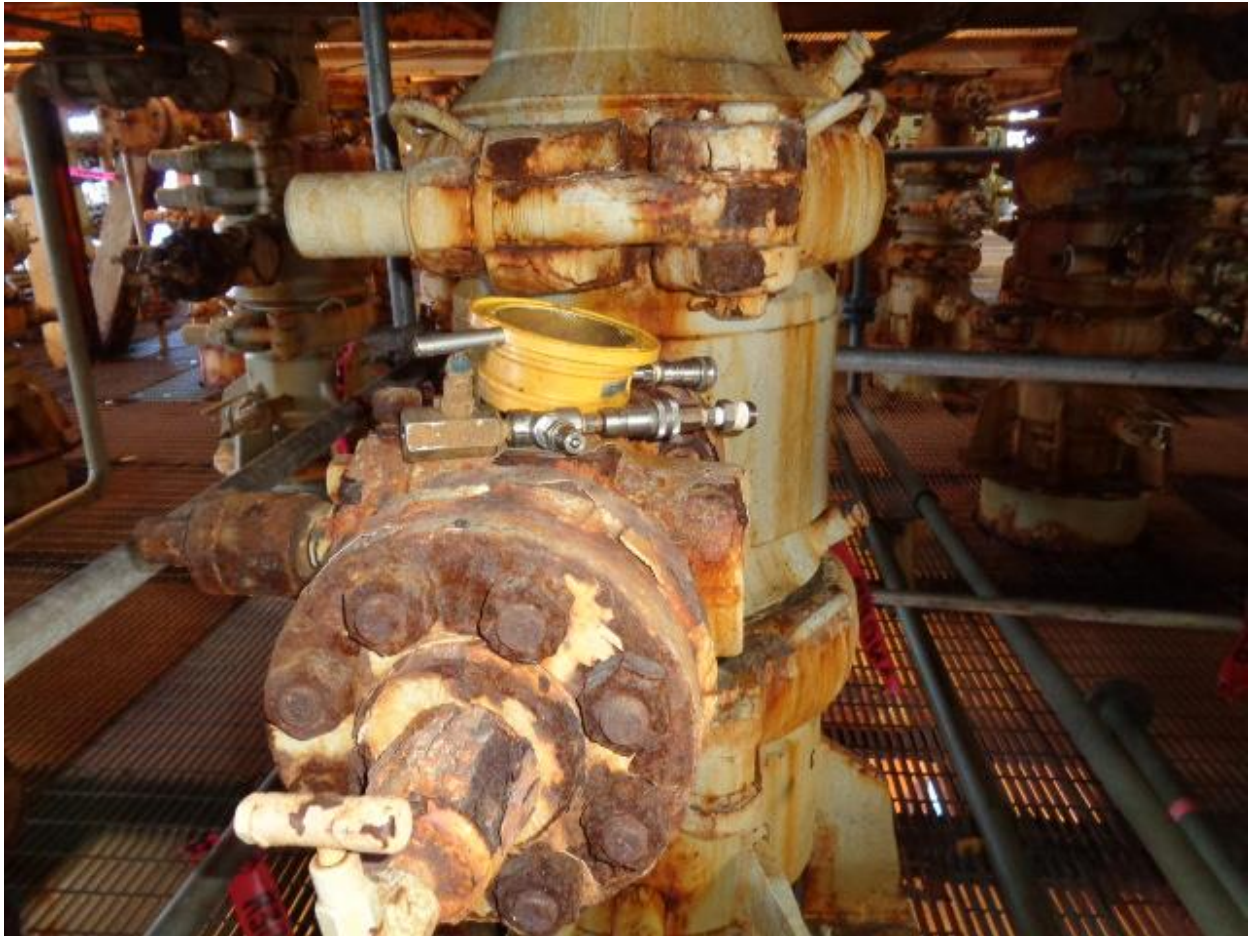
Figure 16- Post-Incident Photograph showing the Location of the Pressure Gauge and Testing Manifold on Well B-16
