BSEE Panel Report 2019-002

# **Investigation of October 11, 2017 Flowline Jumper Failure**

Lease OCS-G 24055  
Mississippi Canyon Block 209  
Gulf of Mexico Region,  
New Orleans District

December 30, 2019

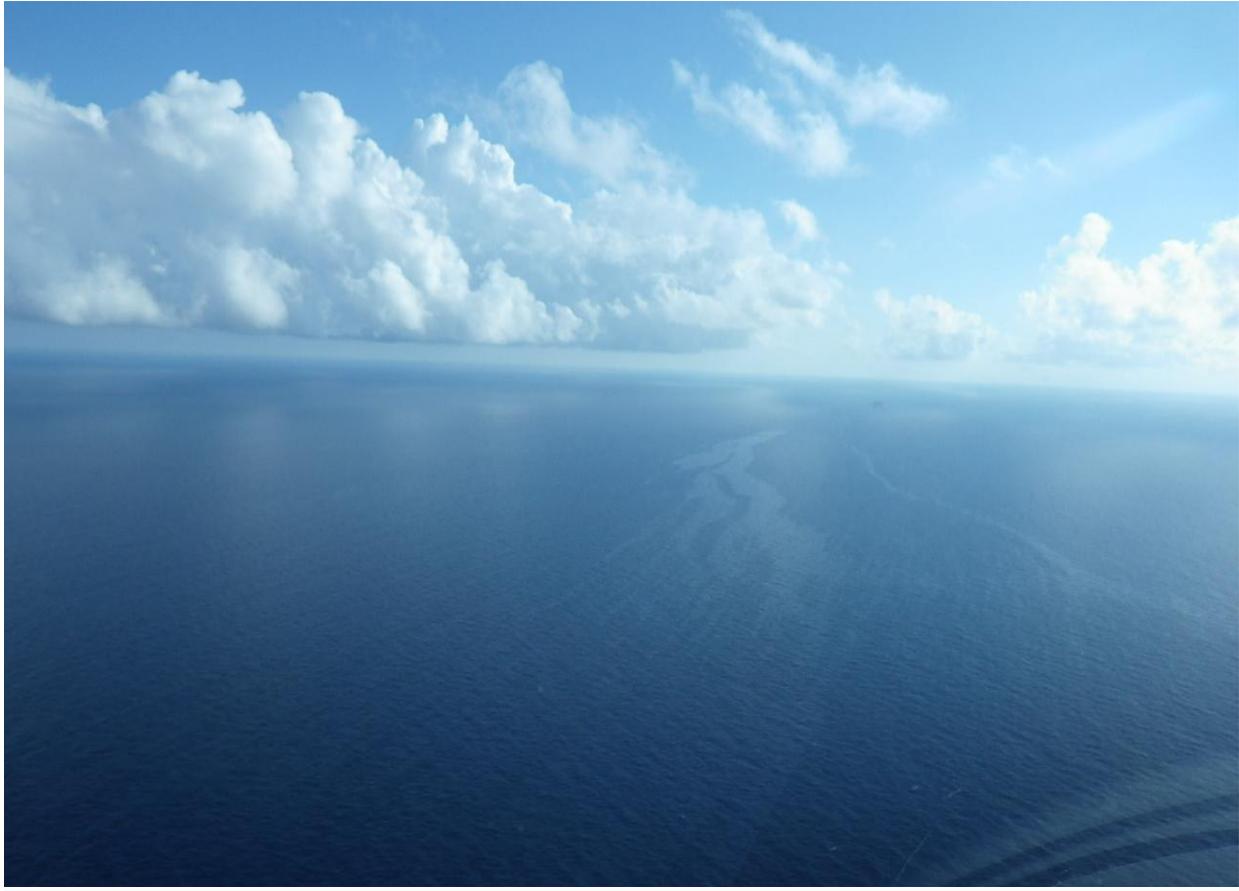
On October 13, BSEE Investigators photographed the sheen during a flyover on the way to initiate an onsite investigation (see Figure 1).

*Figure 1- Sheen observed during flyover.*

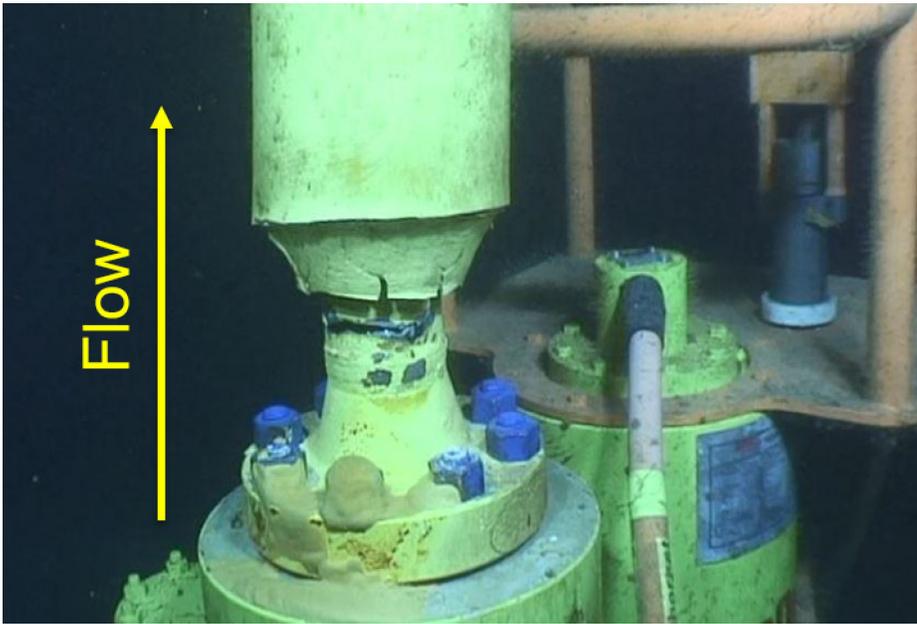
On October 12, LLOG conducted a visual inspection of the MC 209 flowline using a Remotely Operated Vehicle (ROV). The inspection confirmed that the jumper connecting the MC 209 SS001 wellhead to the PLET cracked at the base below the MPFM.

Figure 4- Crack downstream of MPFM flange

Personnel conducting the flyover observed three separate sheens on the water's surface. Subsequently, LLOG conducted an underwater survey using a ROV. LLOG engineers visually confirmed that the MC 209 SS001 jumper connecting the wellhead and the PLET fractured immediately after the downstream MPFM flange (see Figure 4).

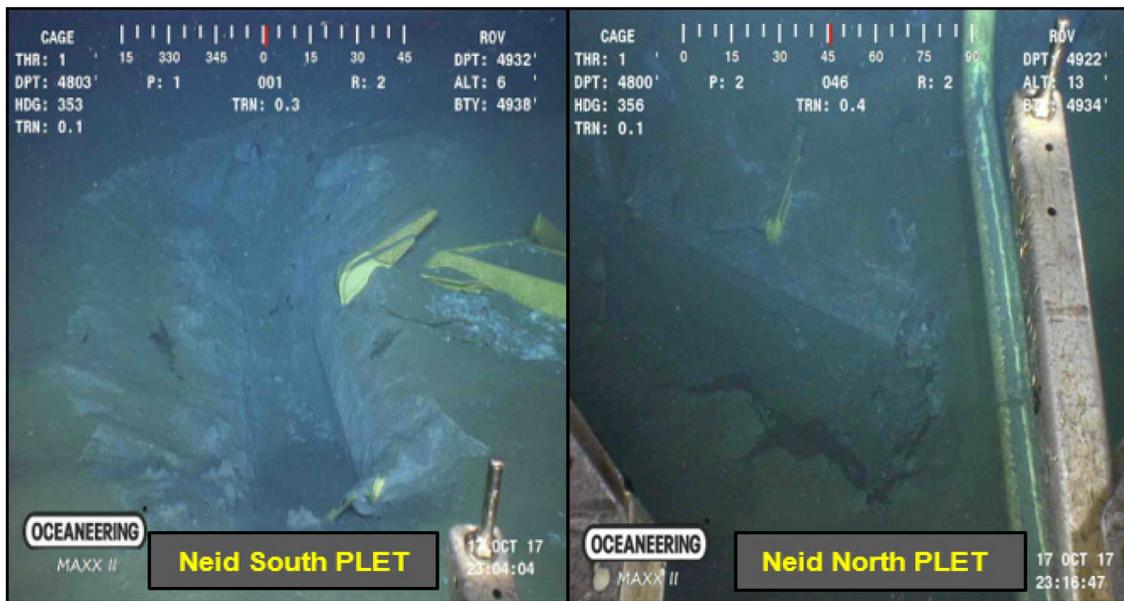
LLOG completed the MC 209 PLETs, jumper, and flowline installation as approved on April 17, 2015. During the ROV inspection conducted on October 12, 2017, it appeared that PLET connected to the wellhead by the fractured jumper moved from its installed position (see Figure 5).

LLOG concluded this movement resulted from thermal walking of the pipeline. Thermal walking occurs when a pipeline heats and expands as oil from the reservoir flows through the pipeline. This expansion placed force on the PLET and caused the PLET to move outside of its design location. This movement exerted excess stress on the well jumper and is a contributing factor to the jumper failure.

Figure 5- ROV footage with seafloor disturbance from PLET movement.

- Evaluate designs of applicable components for their tolerance under increased loads due to thermal expansion or other movement.
- Evaluate the use and placement of sleepers or other components that mitigate the buckling of pipelines.
- Evaluate the construction of flowline components to ensure that materials have adequate corrosion mitigation properties.
- Evaluate the use of different surveying methods such as Light Detection and Ranging (LIDAR) to confirm that pipeline systems remain within their design tolerances throughout their service life.

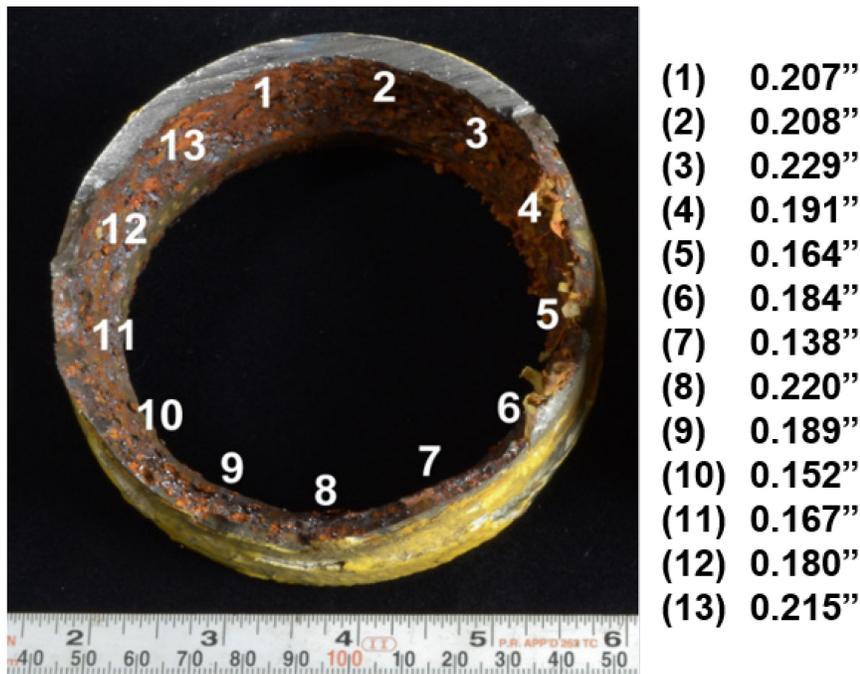
The piping section was constructed of API 5L Grade X65 steel. Visual observations revealed evidence of corrosion on the inside surface of the piping. The pipe suffered a wall thickness loss of nearly 50% relative to what would be nominal thickness of the steel. The fracture area had the highest thickness loss. (Figure 6)

Figure 6- Jumper cross section showing wall thickness loss.

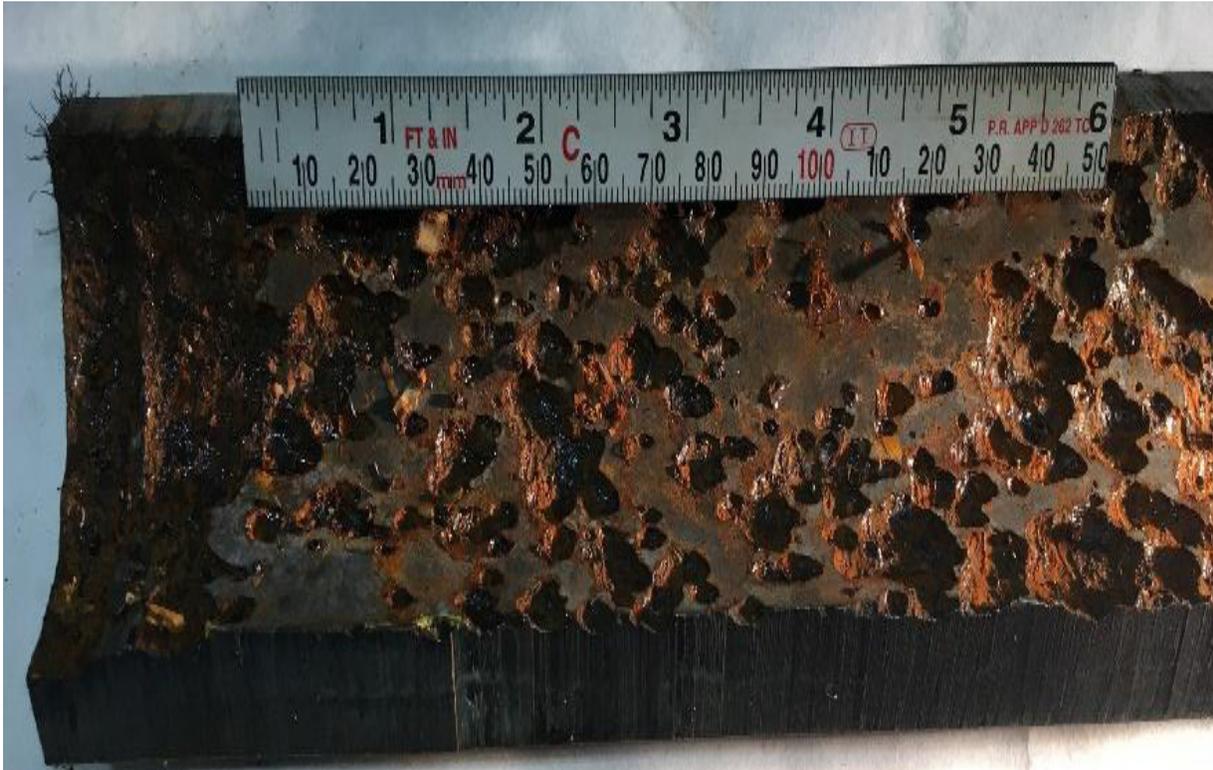
The corrosion pattern had a distinctive plateau and pitting pattern (Figure 7). Analysis concluded that carbonic acid corrosion was the primary mechanism responsible for the metal thickness loss. Carbonic acid occurs when carbon dioxide dissolves in water and is aggressive to steel.

Figure 7- Pitting on inside of jumper

The concentration of corrosion in areas of the piping which were downstream of fittings and 90-degree bends in the jumper was evidence that the corrosion occurred during service. The fittings and 90-degree bends increase turbulence in the fluid flow. This turbulence increases the likelihood of corrosion by shifting the fluid flow from oil wet<sup>3</sup> to water wet<sup>4</sup>, and it can work to remove any corrosion protective layers by erosion.

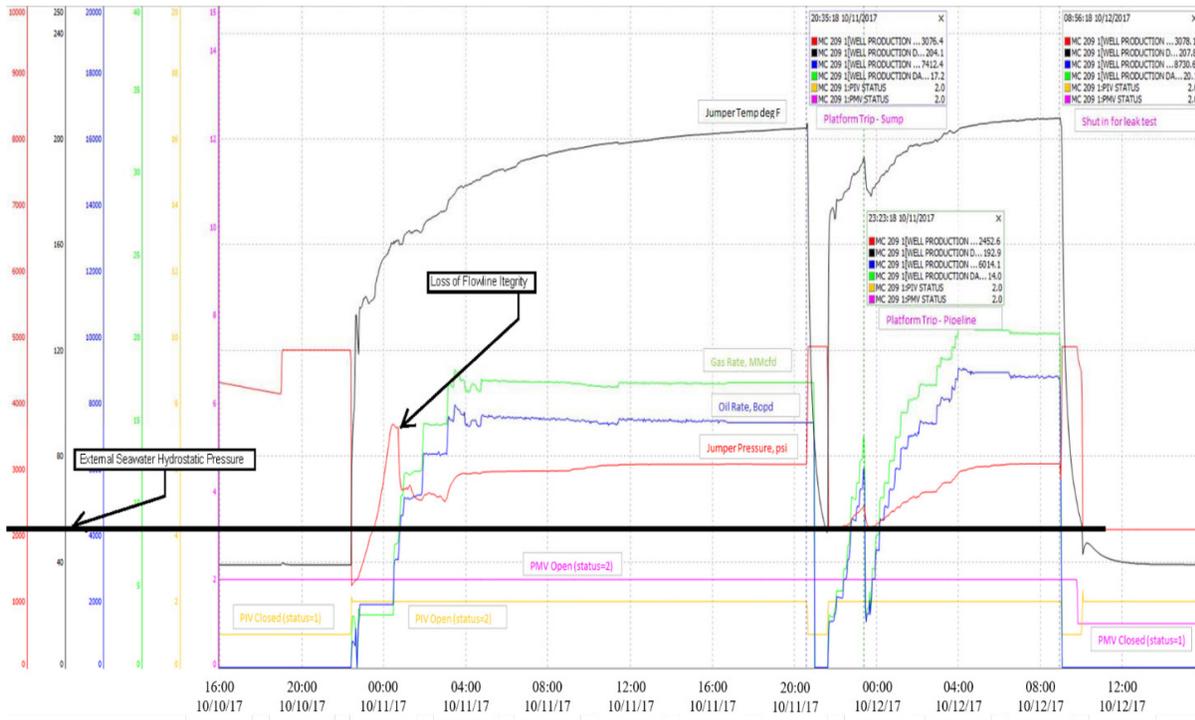
Analysis of this DPT trend (figure 9), shown in red, indicates loss of flowline integrity occurred on October 11, 2017, at 00:42. The loss of flowline integrity is characterized by the jumper

pressure trending toward the hydrostatic pressure. However, the pressure of the well while flowing prevents the jumper pressure from reaching hydrostatic pressure.

At 20:46 on October 11, 2017, the jumper pressure increased to 5000 psi as the PIV (yellow) closed due to a platform shut-in. When the PIV opened again, the jumper pressure immediately dropped to hydrostatic pressure. This is a possible indication of a leak but is inconclusive. It is not abnormal for a flow line's settle-out pressure to equal external seawater hydrostatic pressure when the well's operating pressure is relatively close to hydrostatic pressure.

Figure 9- MC 209 well start up trend for 10/11/18.

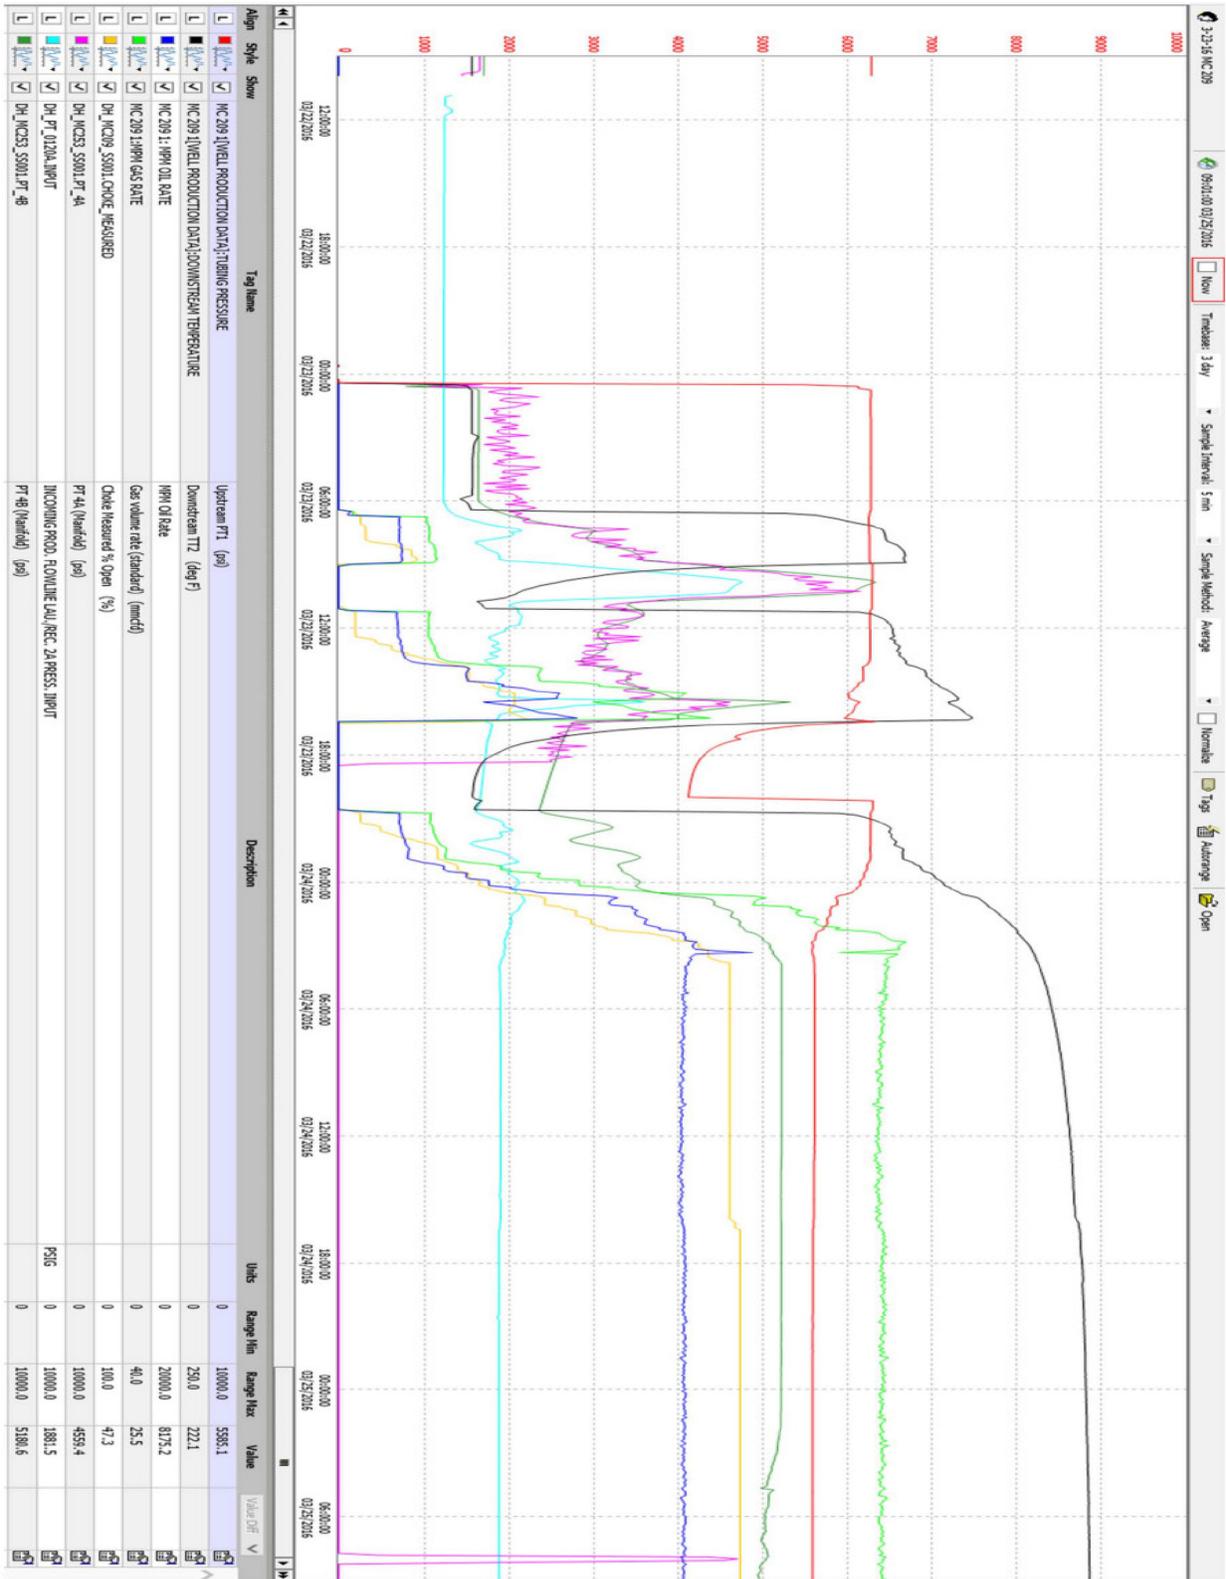
For context, a comparison to the trend seen at the time of the incident Figure 10 is included in Appendix A. The reason for this comparison is to highlight the complexity of well start up. Looking only at the pressure of the flowline does not give a reliable indication of a leak. Other

The MC-209 well start-up trend for March, 2016, shows the behavior of subsea manifold pressure during well start up (Fig. 11). For the first several hours of start up the flowline experiences erratic pressure swings. However, the operation of the subsea choke directly corresponds to the to pressure changes. This comparison trend exemplifies that the choke can cause pressure changes that mimic a leak.

Figure 10- MC 209 comparison startup trend from 3/24/16.
