Addendum to Final Report  
for  
**UNITED STATES DEPARTMENT  
OF THE INTERIOR**  
BUREAU OF OCEAN ENERGY MANAGEMENT,  
REGULATION, AND ENFORCEMENT  
WASHINGTON, DC 20240  
**FORENSIC EXAMINATION OF DEEPWATER  
HORIZON BLOWOUT PREVENTER**  
CONTRACT AWARD No. M10PX00335

Report No. EP030842  
30 April 2011

Forensic Examination of Deepwater Horizon  
Blowout Preventer

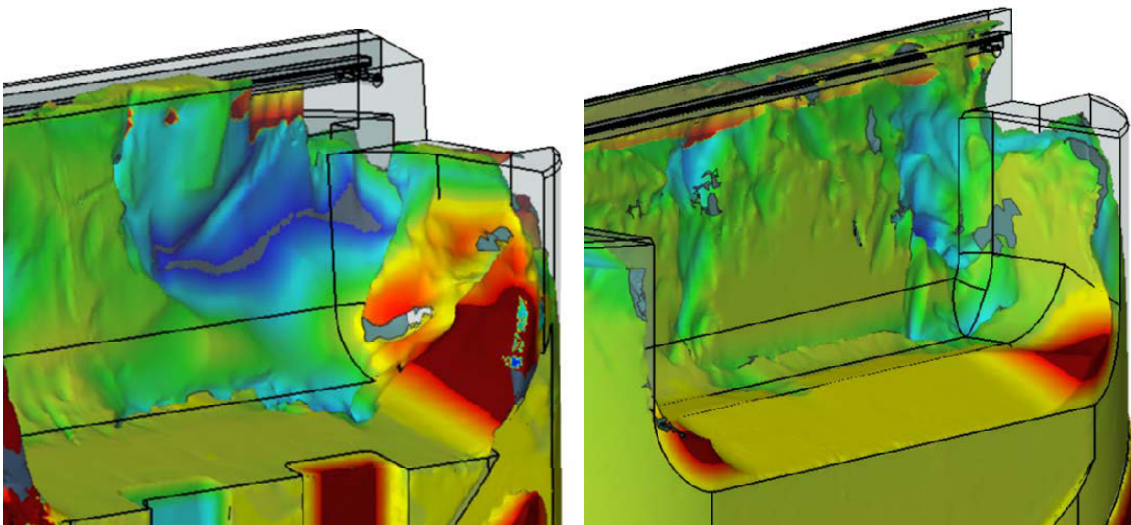
**Revised Figure 34 Three-Dimensional Laser Scan of Port-Side (Lower) BSR Block**

- Page 76:
  - Substitute “Revised Figure 34 (b) Bottom View – Kill Side and 34 (c) Top View – Choke Side” (below)
  - In place of “Figure 34(c) Bottom View – Kill Side and 34 (d) Top View – Choke Side”
  - Note: Revised Figure 34 represents revised CAD geometry for the lower BSR block supplied by Cameron on March 31, 2011.

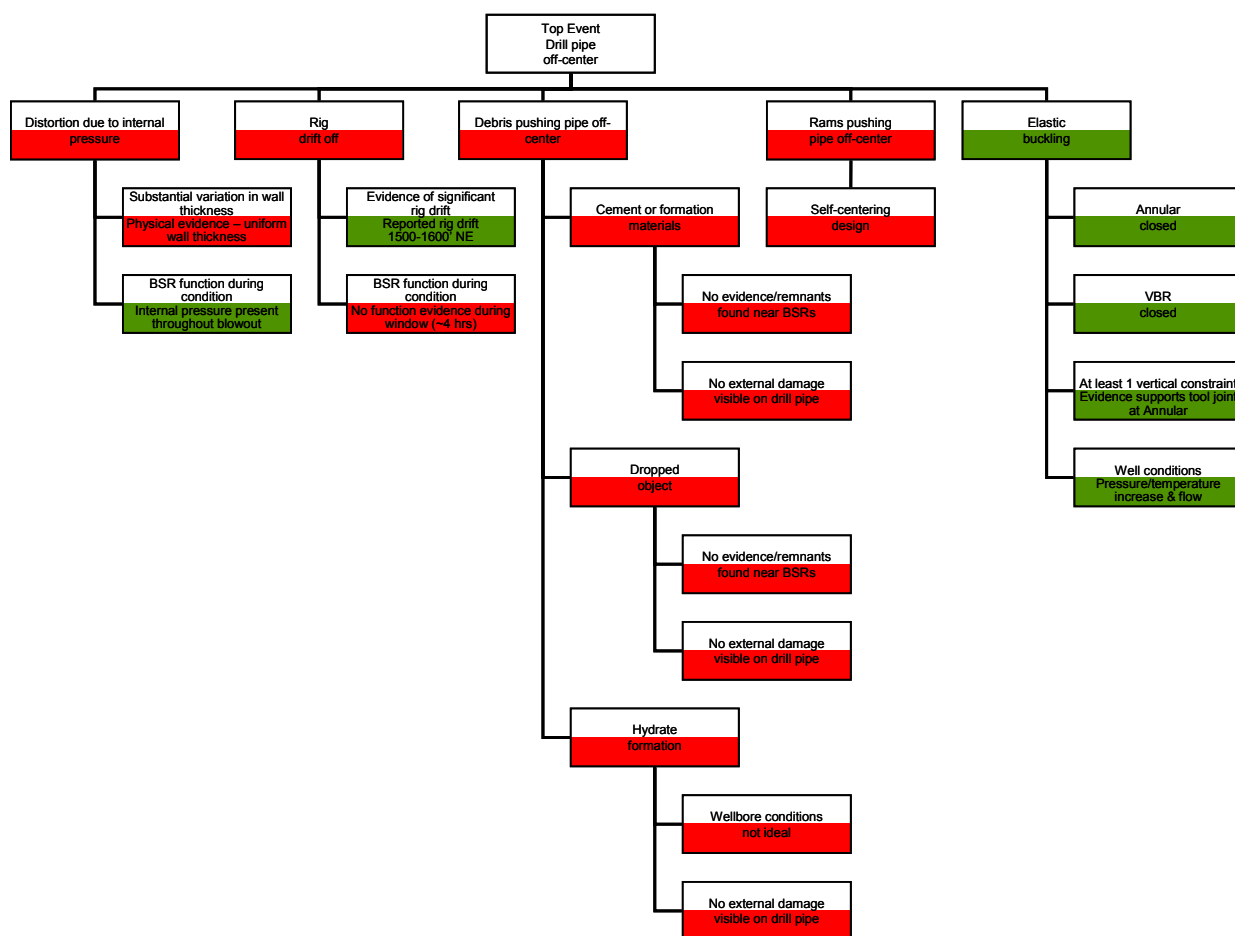
**Figure A Fault Tree for Drill Pipe Off-Center**

Alternate theories for what could have caused the drill pipe to be off-center when the BSRs closed were considered. A fault tree approach was used which requires the listing of conditions necessary to satisfy or allow a fault to occur. In this case the ‘fault’ is defined as the cause or contributing factors for the drill pipe to be off-center. The theories (faults) and conditions necessary are outlined below and illustrated in Figure A.

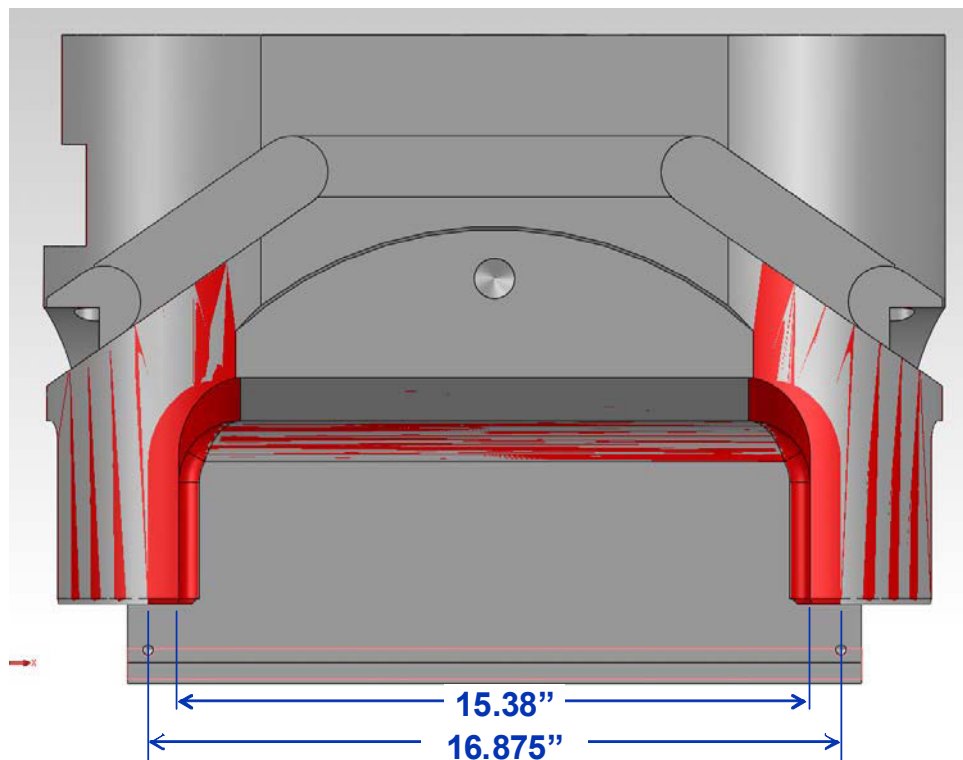
**Figure B Comparison of the original CAD file compared to the updated CAD file for the Lower BSR block (red) provided on March 31, 2011**

Ad 1: The CAD files originally provided by Cameron for the lower BSR block reflected geometry different from the lower BSR block recovered from the Deepwater Horizon BOP. Cameron discovered this and provided the updated CAD file for the Lower BSR block on March 31, 2011. The primary difference noted between the CAD files for the two BSR blocks was the size of the opening of the relief cavity on the top side of the lower BSR block. A comparison between the original and revised versions is given in the Figure B, with the updated lower BSR block geometry shown in red. The cavity opening was measured as 15.38 inches in the updated lower BSR block, compared to 16.875 inches for the originally provided lower BSR block CAD geometry. The revised FEA model used the updated lower BSR block geometry.

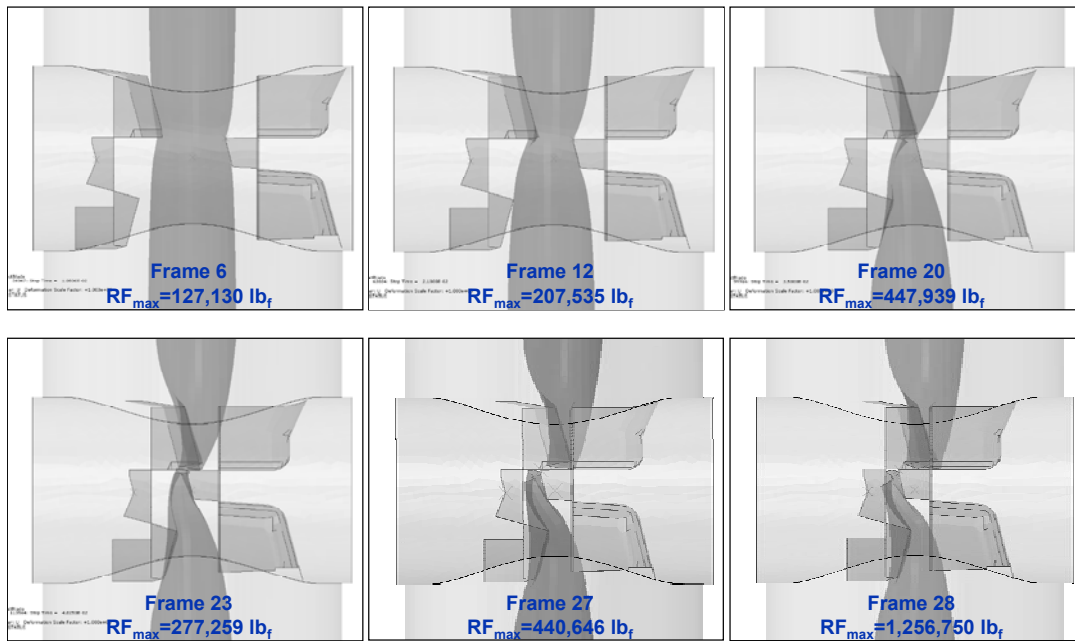
**Revised Figure 139 Progression of Off-Center BSR Shear Model - Side View**

The point at which the sheared pipe is being deformed between the upper and lower BSR block faces (Revised Figure 139 and Revised Figure 140, Frames 27 and 28), the force to produce additional displacement increases very rapidly.

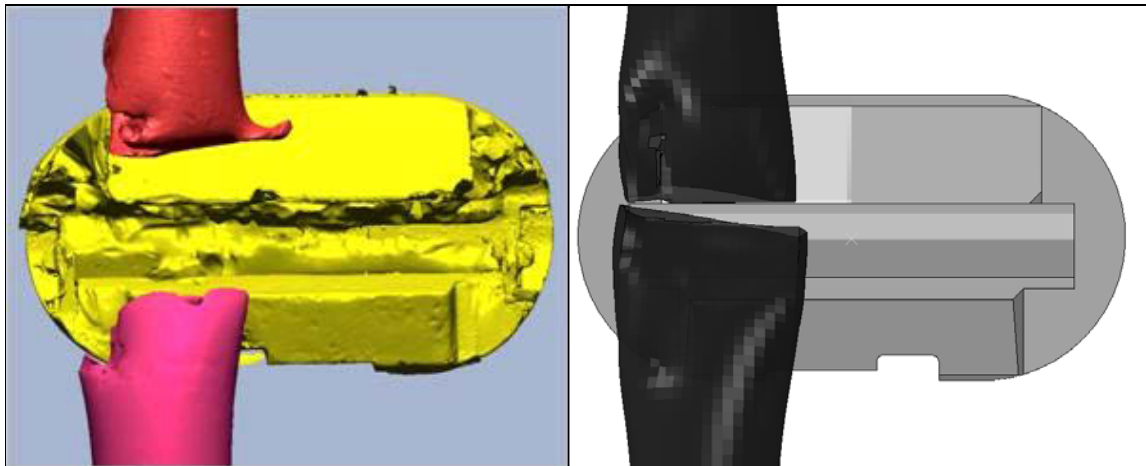
**Revised Figure 144 Comparison of Recovered Drill Pipe Segments and Final Model (Viewed facing the Upper BSR Block)**

- The notched (corners) missing on both the upper and lower segments of drill pipe correspond to the end of the top and bottom faces of the upper BSR block (Revised Figure 144).

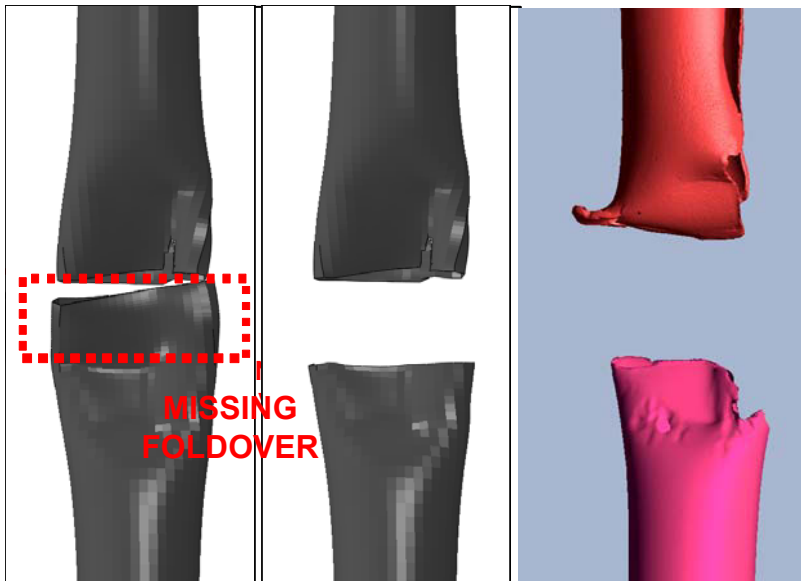
**Revised Figure 145 Final Model Deformation Compared with Recovered Drill Pipe Laser Scans - 83-B and 94-B**

- The vertical “cuts” of the notches (Figure 61 and Revised Figure 145) of the top and bottom drill pipe sections correspond respectively to (1) the tight tolerance between the BSR upper ram block top face and the opposite relief cavity of the lower ram block (sharp vertical cut of the notch on the top drill pipe – 83-B) and (2) the larger gap between the BSR upper ram block bottom face and the opposite relief cavity of the lower ram block (more deformation and tearing of the vertical cut of the notch on the bottom drill pipe – 94-B).

- If the fold-over on the lower drill pipe segment was sheared (center image in Revised Figure 145), the FEA model matches the recovered lower drill pipe segment of the BSR cut.

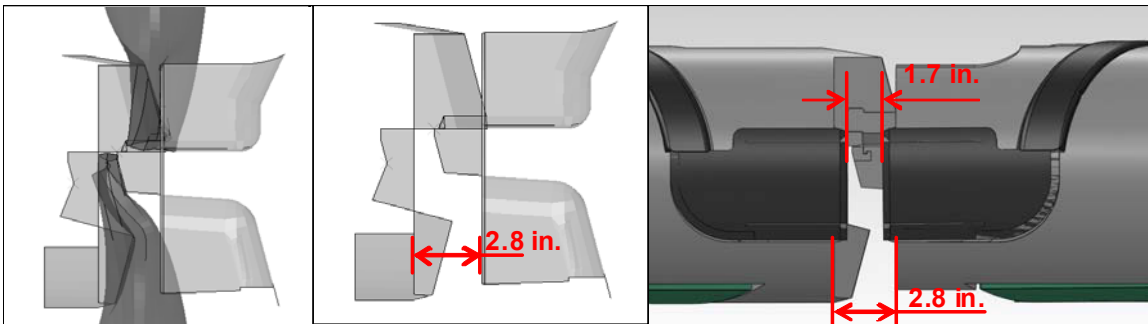
**Revised Figure 146 Spacing of Upper and Lower BSR Blocks in Partially Closed Position**

With an applied equivalent pressure of 5,280 psi (which is greater than the available hydraulic pressure), the upper and lower BSR blocks were 2.8 inches from being fully closed (Revised Figure 146 and Revised Figure 148). The side packers were 1.7 inches from making initial contact and sealing. The lower BSR blade was 2.2 inches from contacting the rear packers and sealing.

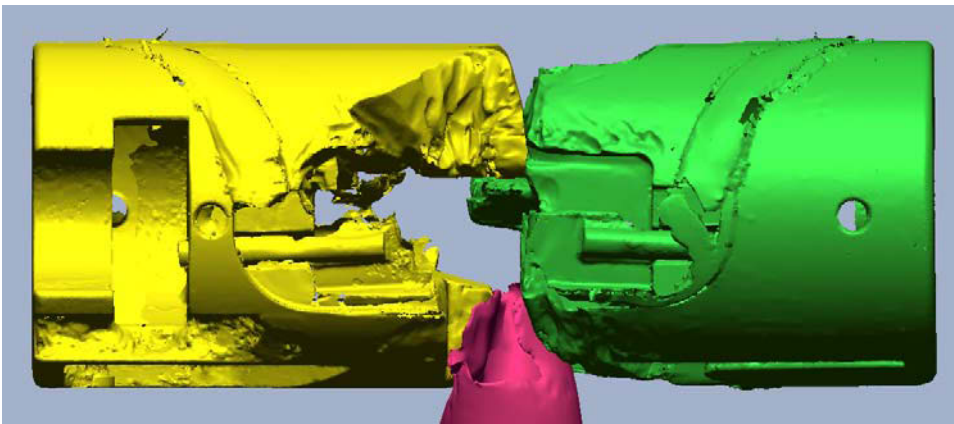
**Revised Figure 147 Alignment of Scan Models – 2.8 Inch Standoff between Blocks**

Further investigation was performed using the laser scanned models. The models of the upper and lower BSR blocks, and drill pipe segment 94 were assembled with segment 94 contacting the upper block (deformation features aligned – Revised Figure 147). With the blocks spaced 2.8 inches from fully closed and the lower block fit against segment 94 a large gap exists partly created by the BSR blocks not fully closing and partly due to erosion of the side packers, rear blade seal packers, and the ram blocks (especially on the Kill Side of the blocks).

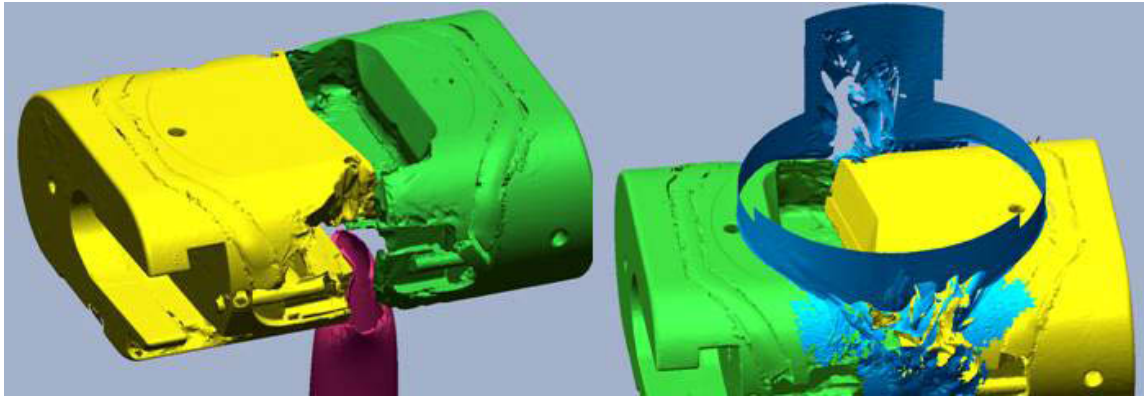
**Revised Figure 149 Erosion Damage - BSR Blocks and Wellbore**

With the VBRs closed below the BSR, well flow was diverted through the inside of the drill pipe. After the BSR was activated and closed on the off-center drill pipe, the well flow was concentrated through the partially sheared drill pipe on the kill side of the BSR. The kill side of the blocks and wellbore experienced the most erosion damage. This concentrated flow condition remained until the CSRs were activated (April 29, 2010) shearing the drill pipe. This created a new flow condition that was no longer concentrated on the kill side of the BSR. Flow then exited the cut drill pipe below the CSR and impinged upon the bottom of the CSR blocks (evidenced by erosion pattern on recovered blocks). The CSR was intended only to cut tubulars. It was not designed to seal the wellbore. Without a sealing mechanism in the CSRs, flow traveled around the CSR blocks and continued up the entire wellbore cross-section below the BSRs. Without contact between the lower blade and rear packer (forming a seal), flow occurred across the entire face of the BSR blocks. This flow condition existed from April 29, 2010, until the well was brought under control.

Revised Figure 149 shows the open cavity through the upper BSR block above the cut lower drill pipe segment. The image on the right shows the scan of the erosion in the wellbore along the kill side of the BSRs.
