**Investigation of Fatal Fall from Rig Pollution Pan
Galveston Area Block 151, Well No. 6
OCS-G 15740
28 January 2008**

**Gulf of Mexico
Off the Texas Coast**

Jack Williams – Chair
Tom Perry
Craig Pohler
Glynn Breaux

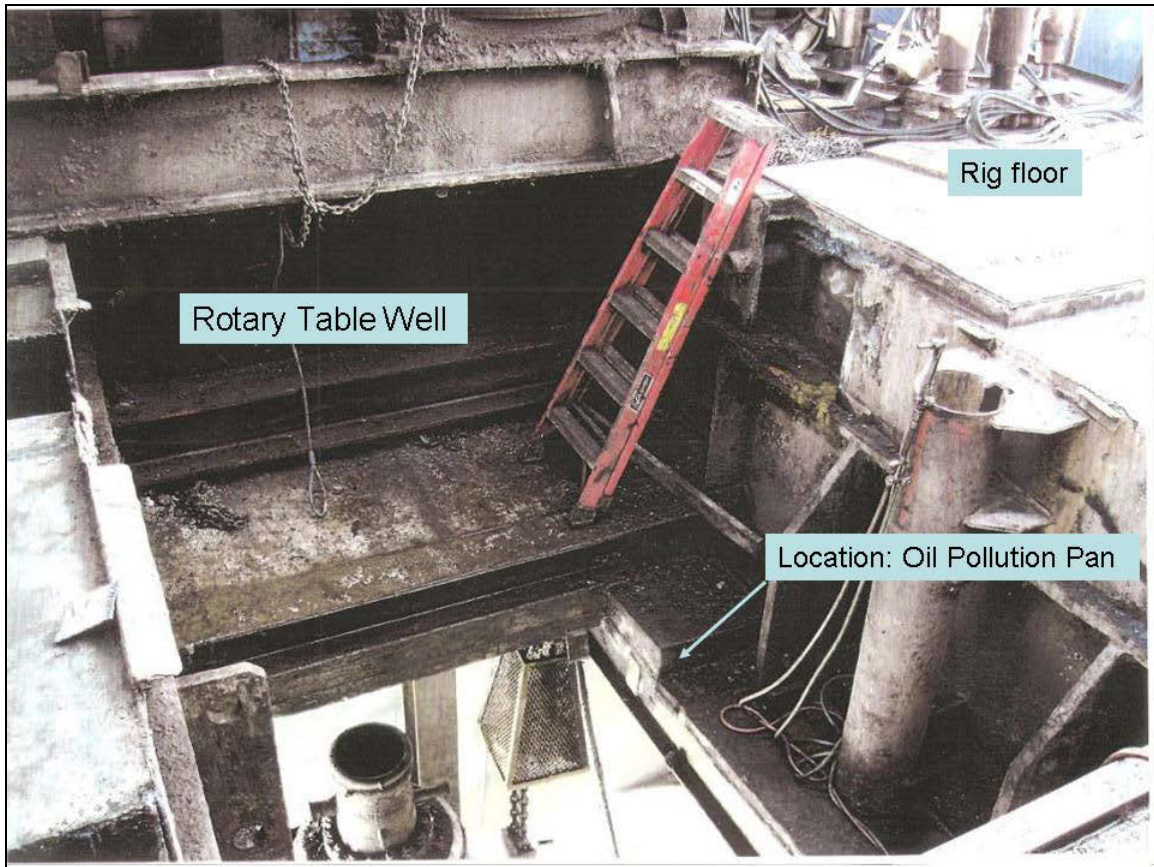
0500-hrs, 28 Jan: Removal of the rotary table was completed by the Rig crew. This exposed a 12-ft x 9-ft x 6-ft deep "well" beneath the rotary table (the Rotary Table Well), bottoming on the top of the Oil Pan, (*see figure 2*). The Franks crew then was mobilized to prepare to run the 60-inch drive pipe.

Figure 2 – Rotary table well and location of oil pollution pan

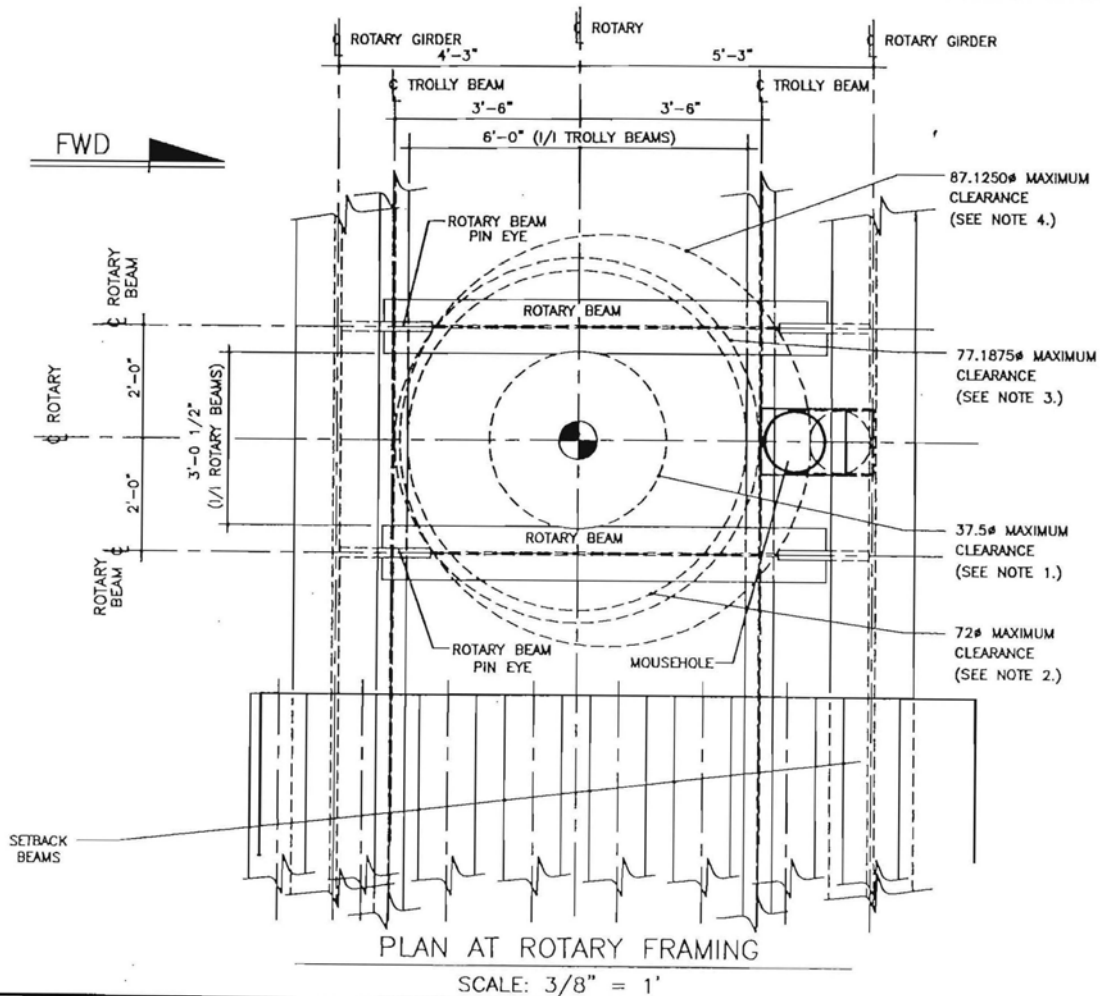
Dwg. No.
 251-15

DRIVE PIPE	REMOVE
36" OR LESS	NOTHING REQUIRED
ABOVE 36" UP TO 72"	ROTARY SKID, ROTARY BEAMS & ROTARY DRIP PAN.
ABOVE 72" UP TO 86"	ROTARY SKID, ROTARY BEAMS, ROTARY DRIP PAN, TROLLEY BEAMS & MOUSE HOLE
- RIG MANAGER IS TO BE NOTIFIED FOR OVERDRIVE OPERATION PLANNING.

Figure 4: Rotary area clearances

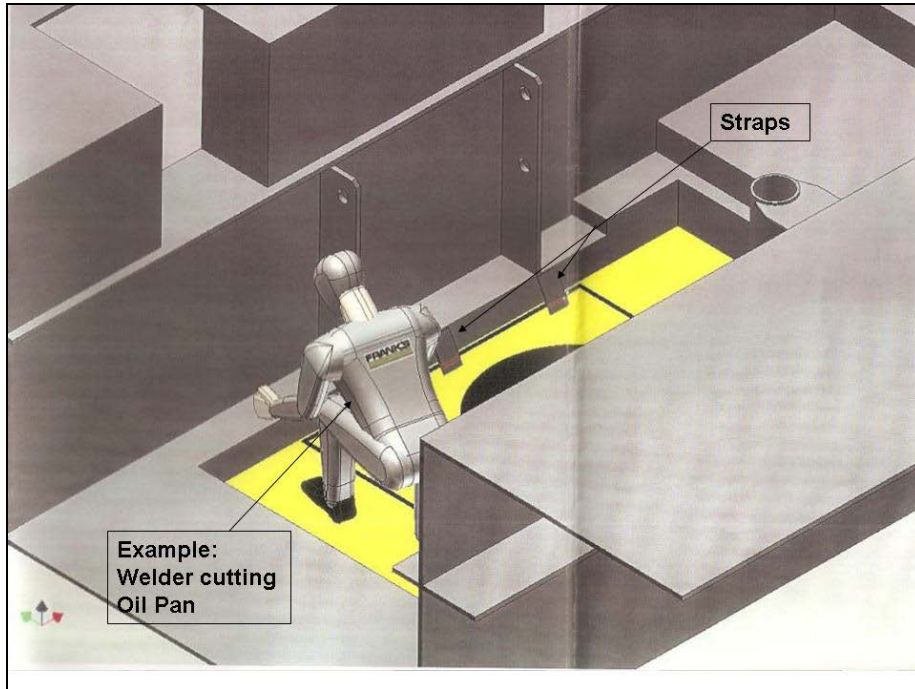
0715-hrs: Two Frank's personnel continued to cut the oil pan under the supervision of the Welding Supervisor (*see figure 5*). The Derrickman approached a Frank's personnel (unidentified) and repeated the Driller's previous admonition to refrain from cutting the Oil Pan. Other Hercules personnel continued maintenance and other operations on the Rig floor to ready the Rig to pickup and run 60-inch drive pipe.

Figure 5 – Diagram of position of a welder while cutting oil pan (graphics from Frank's)

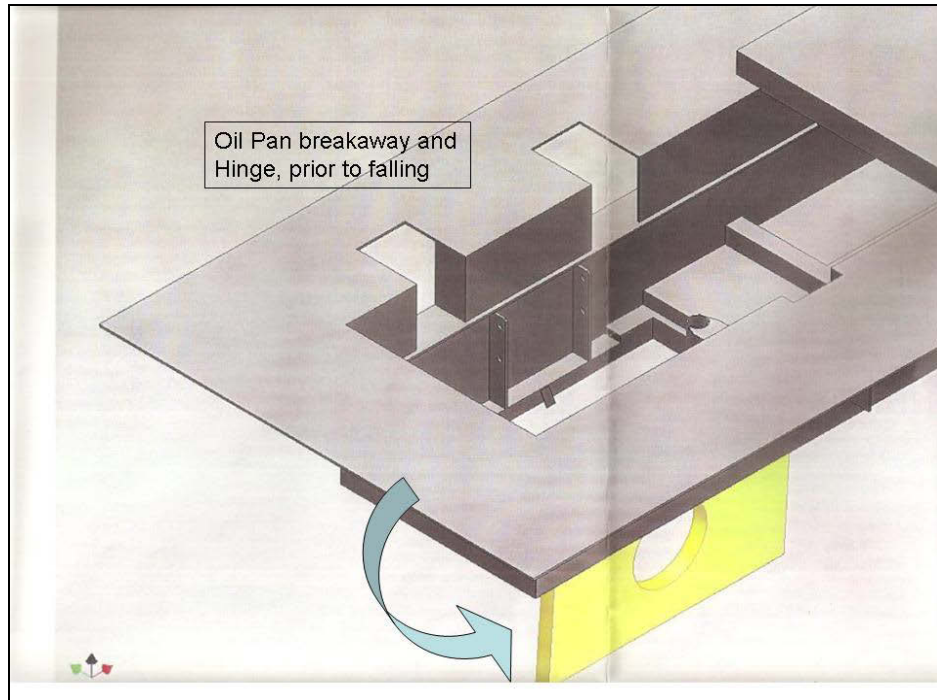
0733-hrs: The Welder #1 continued cutting another of the metal straps that needed to be removed to complete the opening in the Oil Pan. Without warning the entire Oil Pan suddenly dropped downward

hinging on the side being cut by Welder #2 (see figure 6), and then almost immediately fell away from beneath the two welders working on the cut.

Figure 6 – Diagram showing how the oil pan hinged, and then fell (graphics from Frank's)

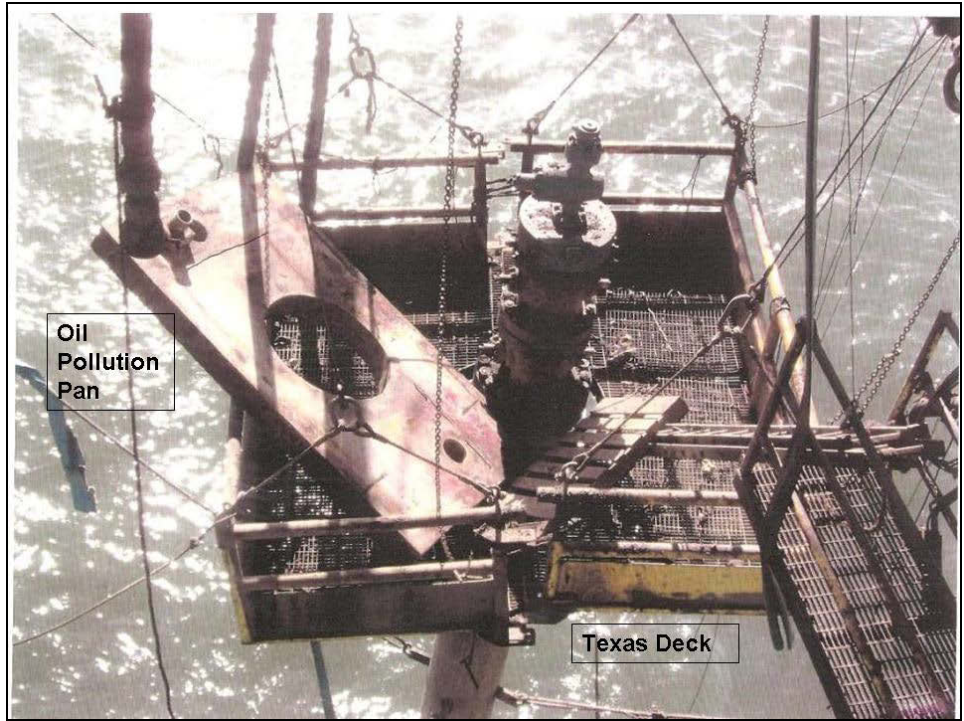
The Welder #1 who had continued to cut the Oil Pan after Welder #2 had stepped out, attempted to grab a hand hold on a sub-structure beam along the side of the Rotary Table Well as the Oil Pan fell. He was able to momentarily hold onto a beam but shortly lost his handhold and fell after the Oil Pan. He struck the Wellhead and/or the Texas Deck some 50-ft below the Rig floor, then continued to fall, finally landing in the Gulf of Mexico (see figures 7 and 8).

Figure 7 – End location of the oil pan and pallet on the Texas deck

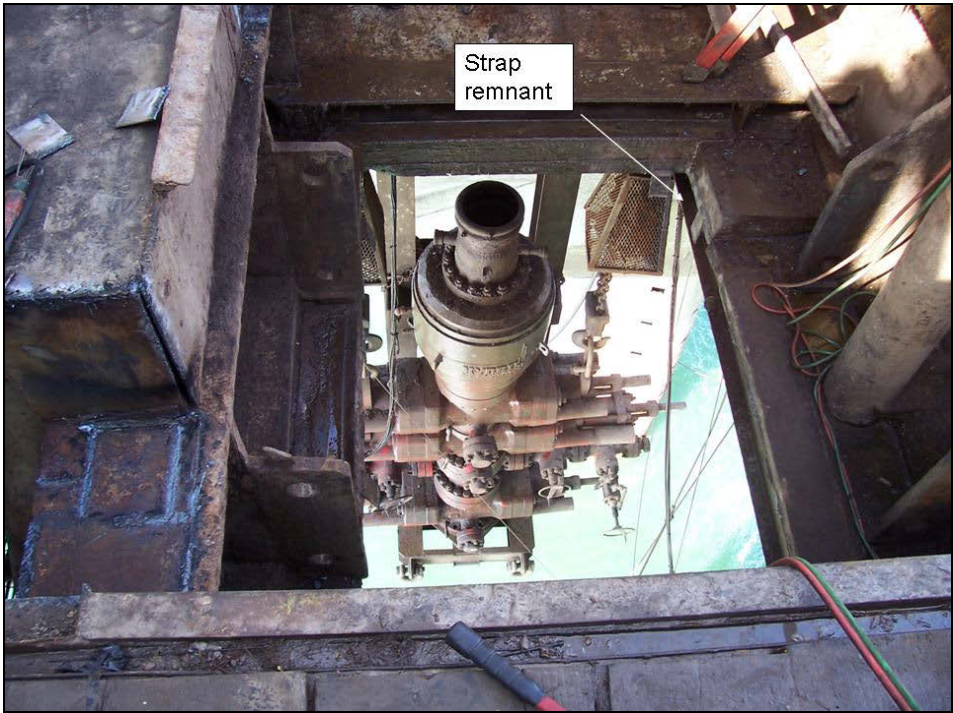
Figure 8 – View down through the rotary table well after fall of the oil pan

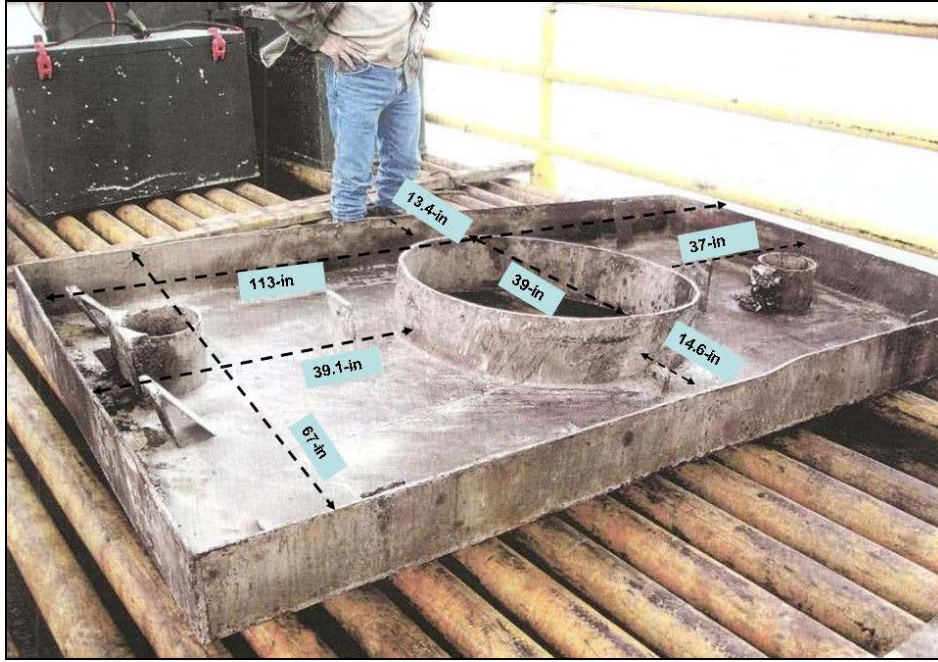
The Oil Pan installed on the Rig could accommodate drive pipe up to 36-inches without modification. Larger pipe would require its removal. The Oil Pan was installed about 6-ft beneath the rotary table. It was tray-shaped, approximately 9’7” x 5’7” and approximately 8-inches deep (*see figure 9*). Because of

the nature of the sub-structure of the Rig, the top edges of the Oil Pan “tray” were not visible from inside the Rotary Table Well. The view of those edges was blocked by sub-structure beams.

Figure 9 – Dimensions and view of the oil pollution pan

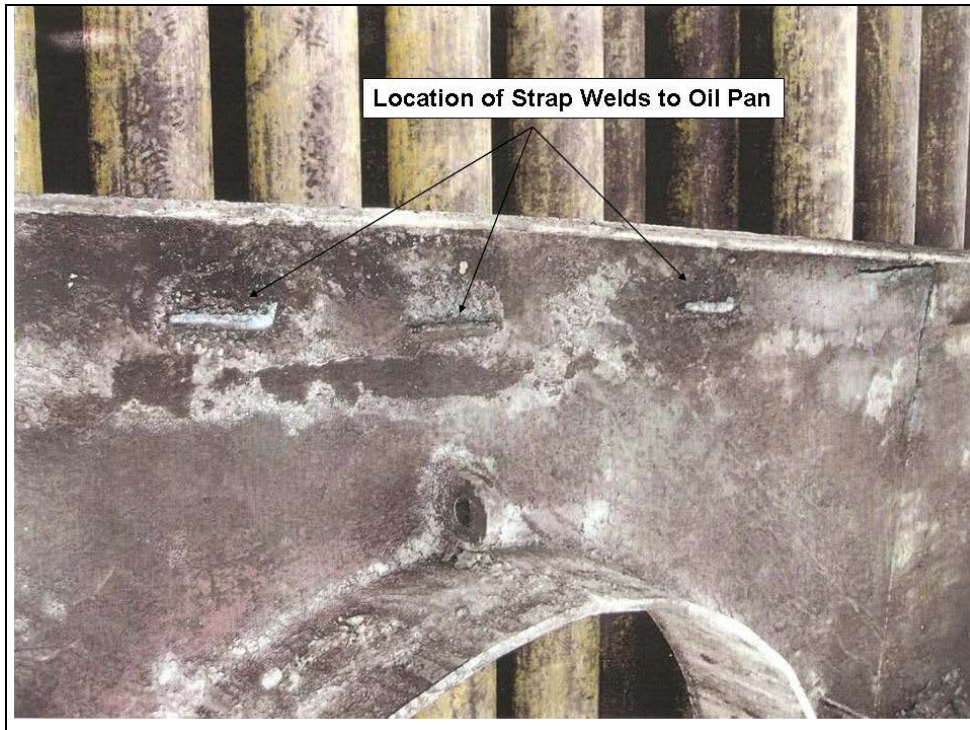
According to testimony, the Oil Pan of the Rig was attached in a different manner from that usually encountered on other rigs. The Oil Pan was not hard-welded around the lips of its sides, nor was it bolted to the rig sub-structure. Instead, it was attached to the Rig sub-structure beams by means of six metal straps (Straps) that were welded to the bottom of the Oil Pan, and then individually welded to substructure beams (*see figure 10 and 11*).

Figure 10 – View of the location of some strap welds on the oil pan

- (1) The Straps were the only connection holding the Oil Pan in place. Therefore, cutting the straps allowed the Oil Pan to fall out from beneath the welders.
- (2) Neither the welding supervisor nor the welders knew the straps were the only support for the Oil Pan and no one had reviewed the set up before cutting the pan. They assumed the entire top edge of the Oil Pan was welded to the Rig sub-structure and formed a solid floor.
- (3) Because of the above assumption, the welders working in the Oil Pan were not wearing fall protection.
- (4) Planning for the operation was inadequate, and were not conducted according to Rig or Contractor policy.
 - None of the Contractor crew and only part of Rig personnel attended the JSA/think plan meeting;

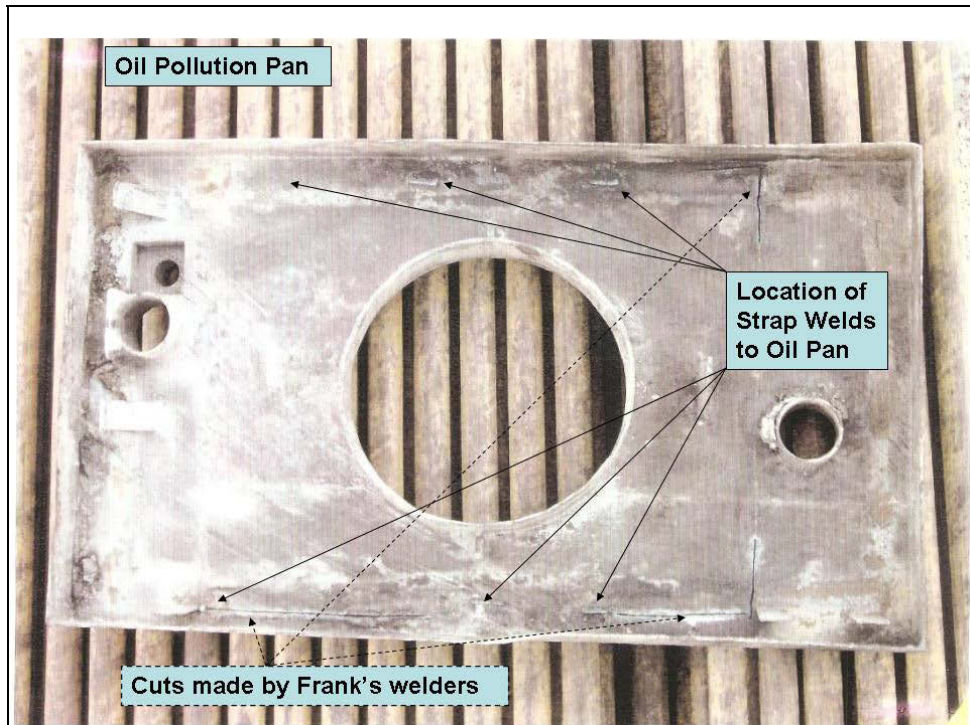
Figure 11 – Top view of oil pan showing cuts and some strap weld locations

In order to create an opening large enough to pass the drive pipe, the welders found that it was necessary to cut six steel “straps” attached to the surface of the Oil Pan and also welded to the side of the sub-structure support beams. After a number of the straps were cut the Oil Pan abruptly fell free, dropping approximately 50-ft before landing on the Texas deck. When the Oil Pan dropped away, one of the welders working in the pan also fell striking the wellhead and/or the Texas deck before landing in the Gulf of Mexico. The fall resulted in a fatal injury to the welder.
