**Investigation of Fatality**  
**South Pass Area, South and East Additions, Block 90**  
**Pipeline Right-of-Way OCS-G 26857**  
**18 July 2006**

Gulf of Mexico  
Off the Louisiana Coast

OCS Report  
MMS 2009-028

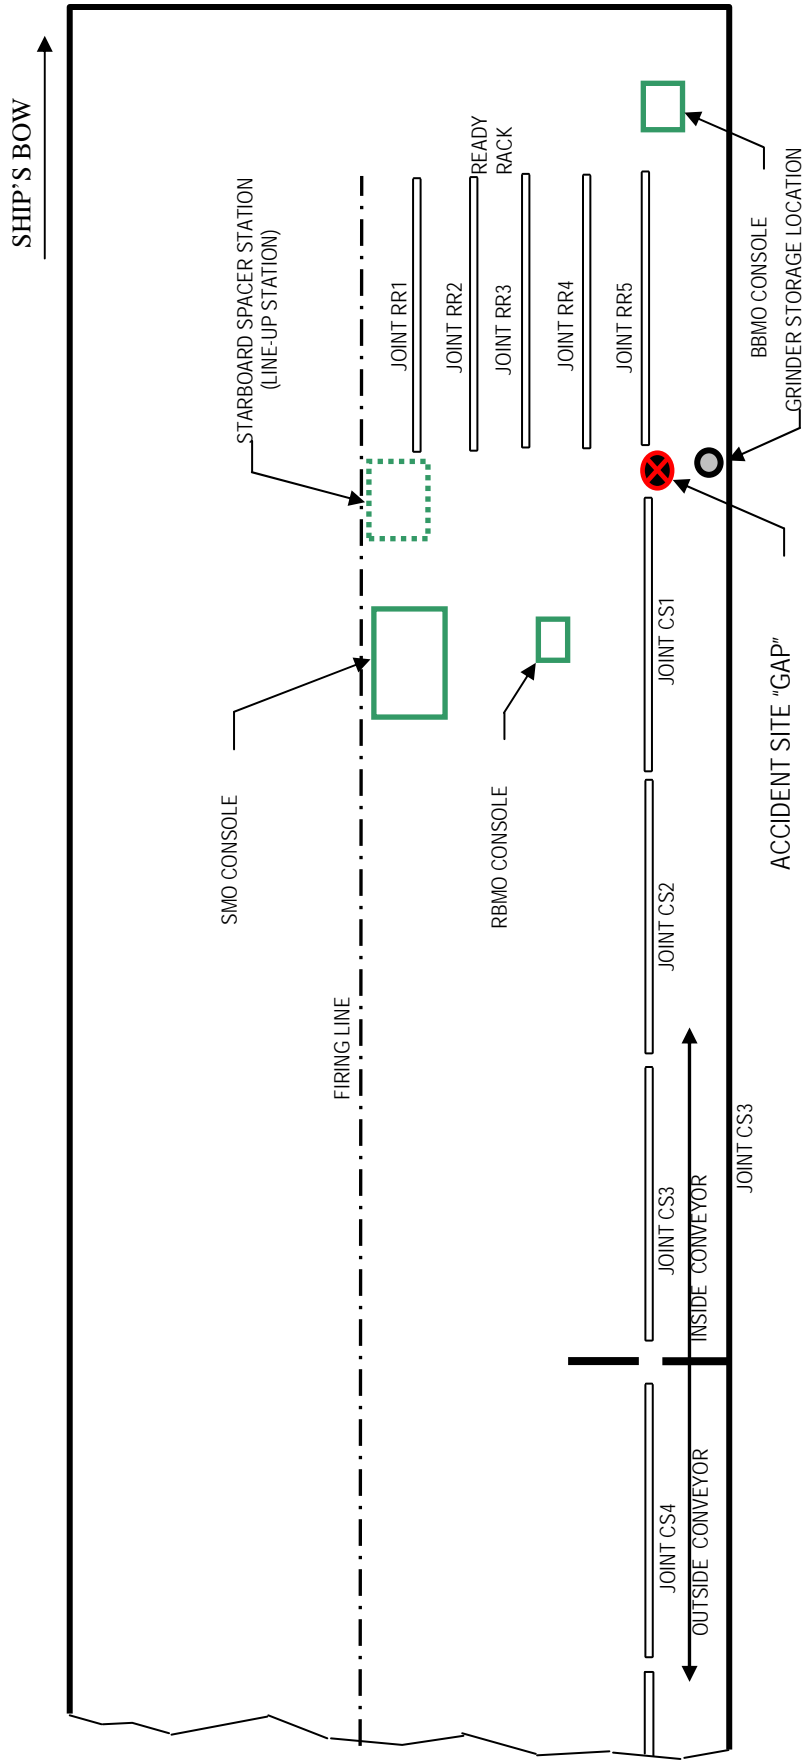
Configuration of the bead stall and ready rack areas at the time of the accident

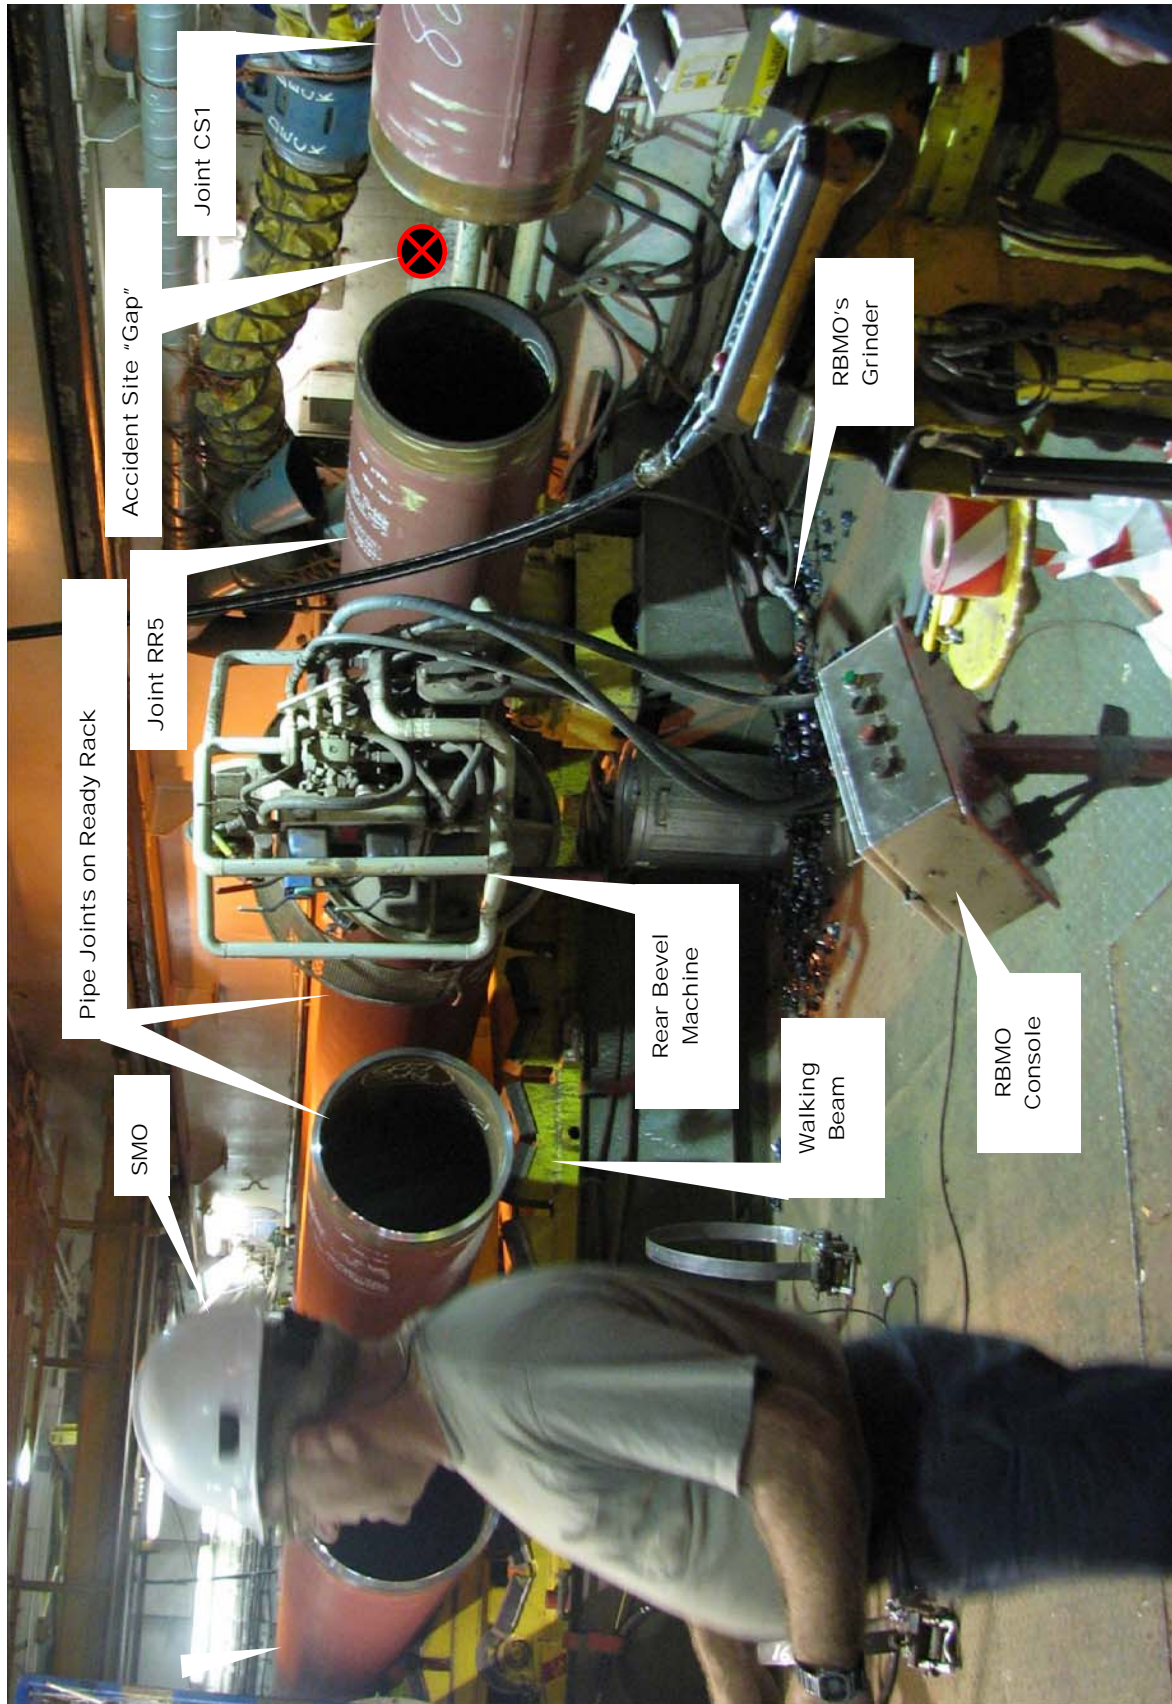
Pipe joint CS1 became energized and advanced towards RR5 while RR5 remained stationary. The investigative panel has not been able to identify a logical explanation of what caused CS1 to begin moving.

Accident Scene – Looking Toward Bow

- A safety barrier was placed in the area where the RBMO was crushed to prevent personnel from walking or working between the pipe joints at CS1 and RR5.
- A selector switch that controls the inside conveyor system, along with two limit switches, were replaced with new ones. The old switches were shipped out to a lab for further review.
- Allseas evaluated and updated their hazards analyses in the conveyor system and ready rack areas.
- The storage location of the RBMO grinder was moved from the starboard wall to a location on the near side of the conveyor system. This eliminated the need for the RBMO to walk in the gap between RR5 and CS1 to retrieve the grinder

- In addition to the safety barrier placed in the area where RBMO was crushed, more safety barriers should be placed around all exposed pinch point areas along the conveyor system to prevent personnel from also entering those hazardous areas.

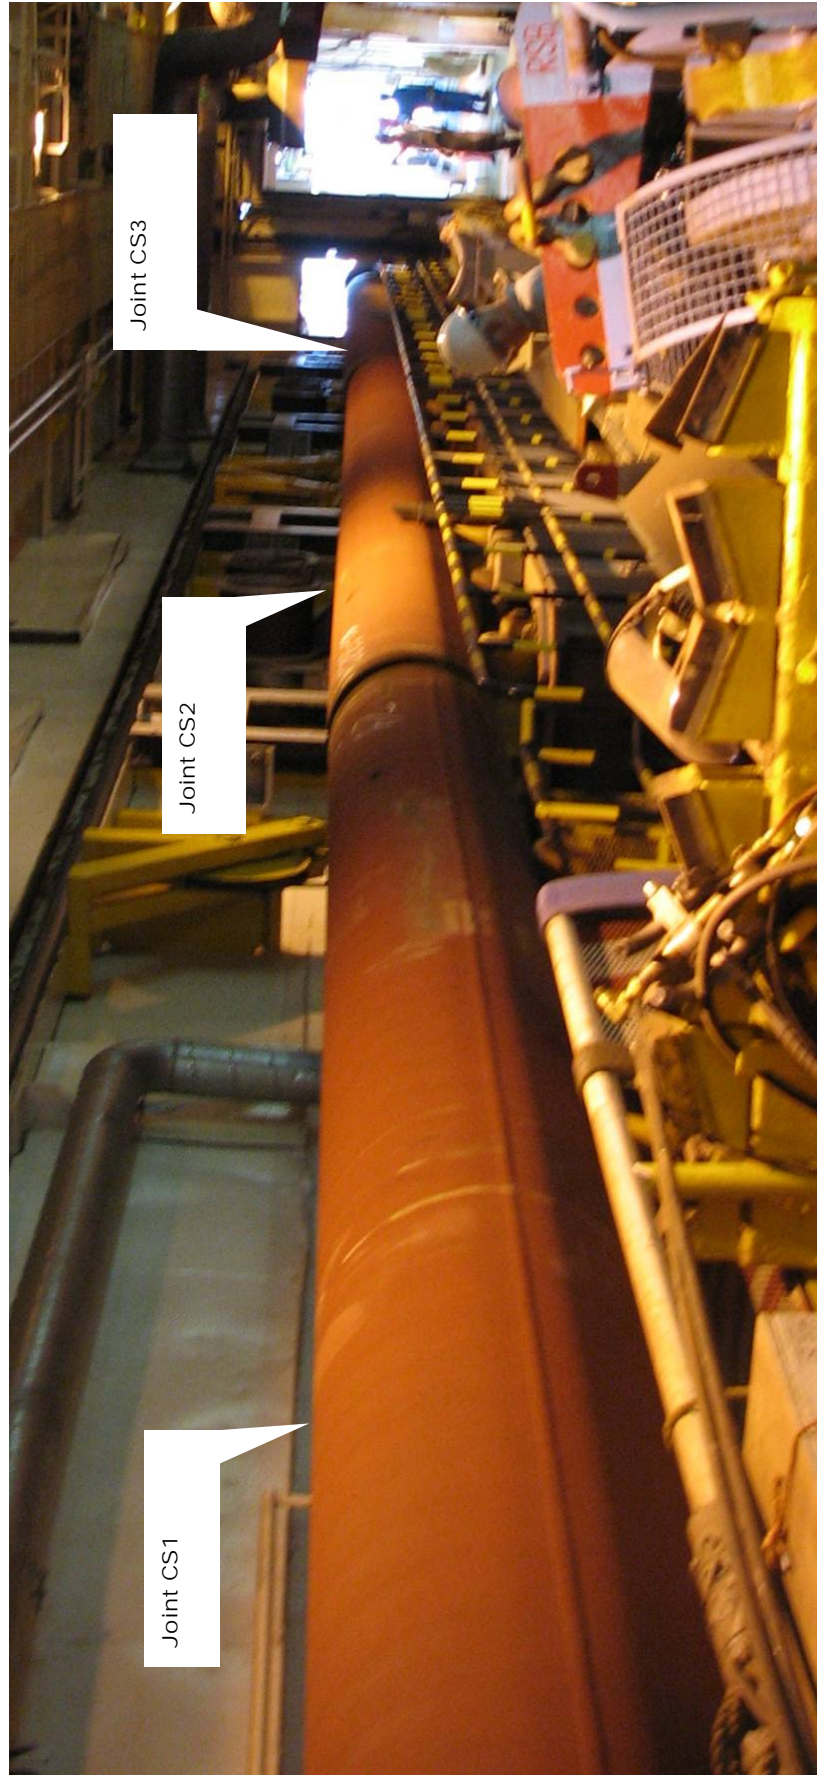
Pipe Conveyor System – Looking Toward Stern

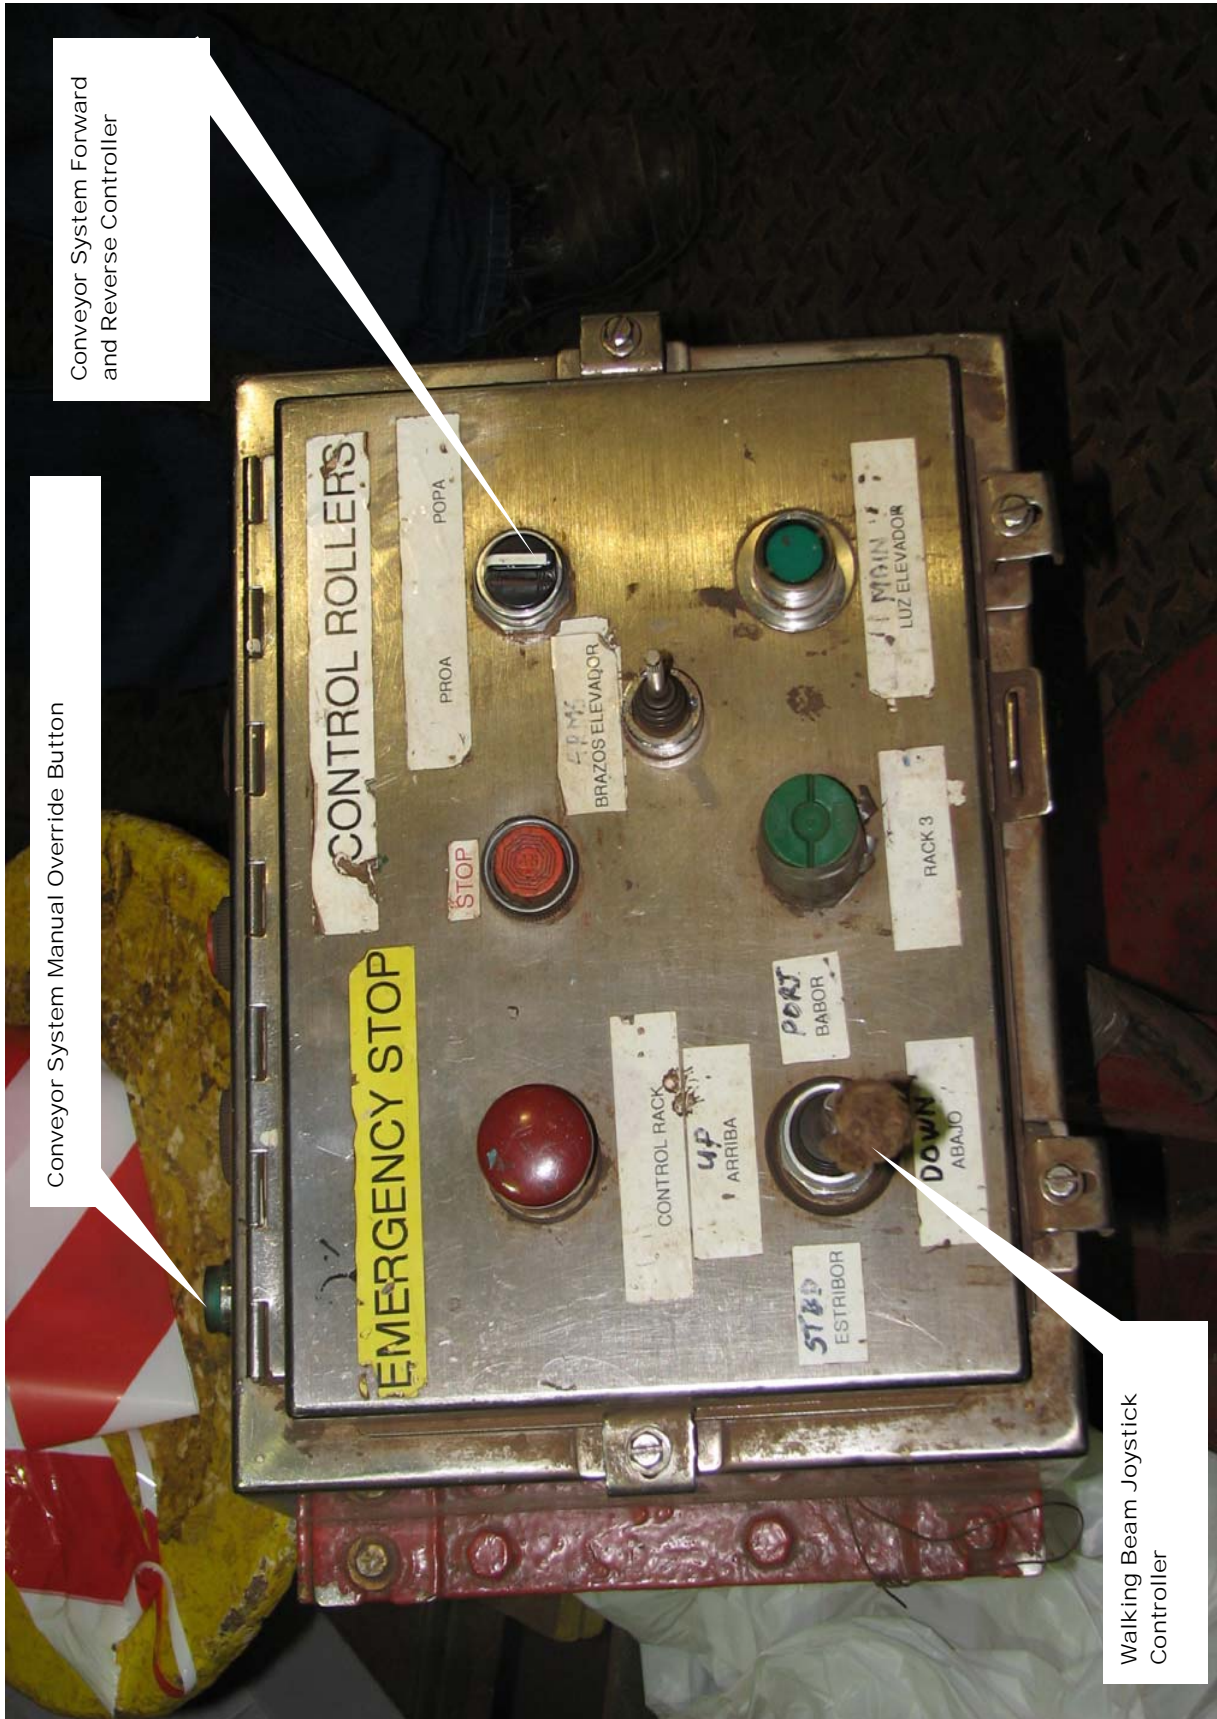
- 1) Independent Maritime Consulting (Gulf) Ltd. conducted tests on the limit switch'. Results from the tests showed that the operation of the inside conveyor selector switch felt sluggish and sometimes stuck in the "on" position when it was turned left. Dirt was found in the actuator upon disassembly. A piece inside the actuator was cracked.

- 7) Possible inadequate inspection/maintenance of the control panel switch was a contributing cause of the accident. None of the crew interviewed mentioned the sluggish action of the conveyor switch. However, Allseas and the third party engineering firm, that analyzed the limit and control panel switches after the accident, did find that the conveyor switch was sluggish and that it was dirty and cracked. This condition could indicate inadequate inspection/maintenance of the switch, although no maintenance guidelines were available for the panel to confirm this. It should also be noted that there is no conclusive evidence that proves the condition of the conveyor switch was a contributing factor to the accident.

Rear Bevel Machine Operator (RBMO) Console – front view
