Investigation of October 27-28, 1985, Structural Failures:

Ocean Drilling & Exploration Company Platforms:
Outer Continental Shelf Lease 0605,
South Timbalier Block 86
& Outer Continental Shelf Lease 0073,
South Pelto Block 19

Gulf of Mexico,
off the Louisiana Coast

F. Dyhrkopp
G. Schonekas
M. Stewart

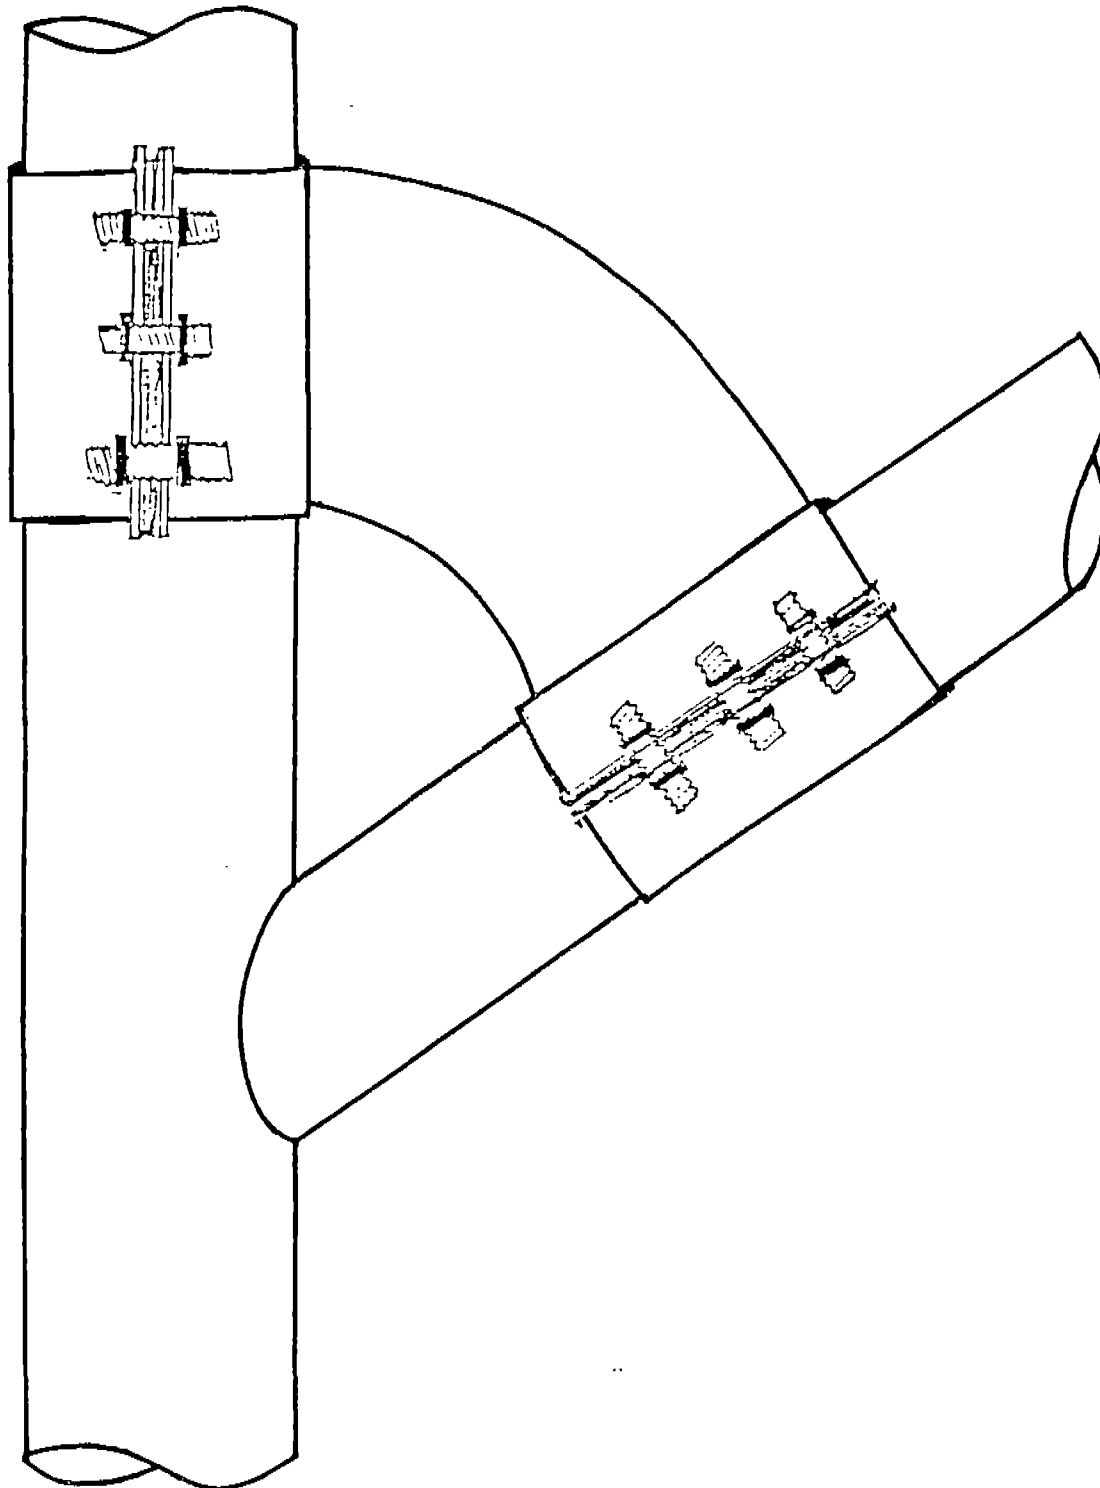
Mechanical clamp

(c) Thirty locations throughout the underwater structure where mechanical clamps had been used to repair brace joints that were badly cracked or corroded were identified. Of these, 13 were located on horizontal braces and 17 were located on vertical braces. Some of these clamps were reported in the limited 1982 survey discussed in section 2 above. It is inferred these clamps were installed before the installation of the wet-welded replacement members, that is, sometime before 1982. For an example of such a clamp, see appendix, attachment 7.

The use of numerous mechanical clamps to repair cracked, corroded, or otherwise parted member connections is a probable contributing cause of platform failure. Analysis of the inspection report data indicates that at some point in time the owner recognized the undesirability of using clamps, for repairs made after the early 1980's were carried out by replacing and rewelding members. Those repairs more appropriately restored the structure to its original design condition in that drastically altered load paths, reduced joint stiffnesses, increased bending moments, and additional stress concentrations were not introduced at the rewelded connections. More importantly, replacement removed the entire member that had been subject to years of corrosion attack, whereas clamps were installed on partially deteriorated members. However, there is no evidence suggesting that an attempt was also made to remove and replace the existing clamped members.
