# Investigation of Shell Offshore Inc. Hobbit Pipeline Leak Ship Shoal Block 281 January 24, 1990

Gulf of Mexico  
Offshore Louisiana

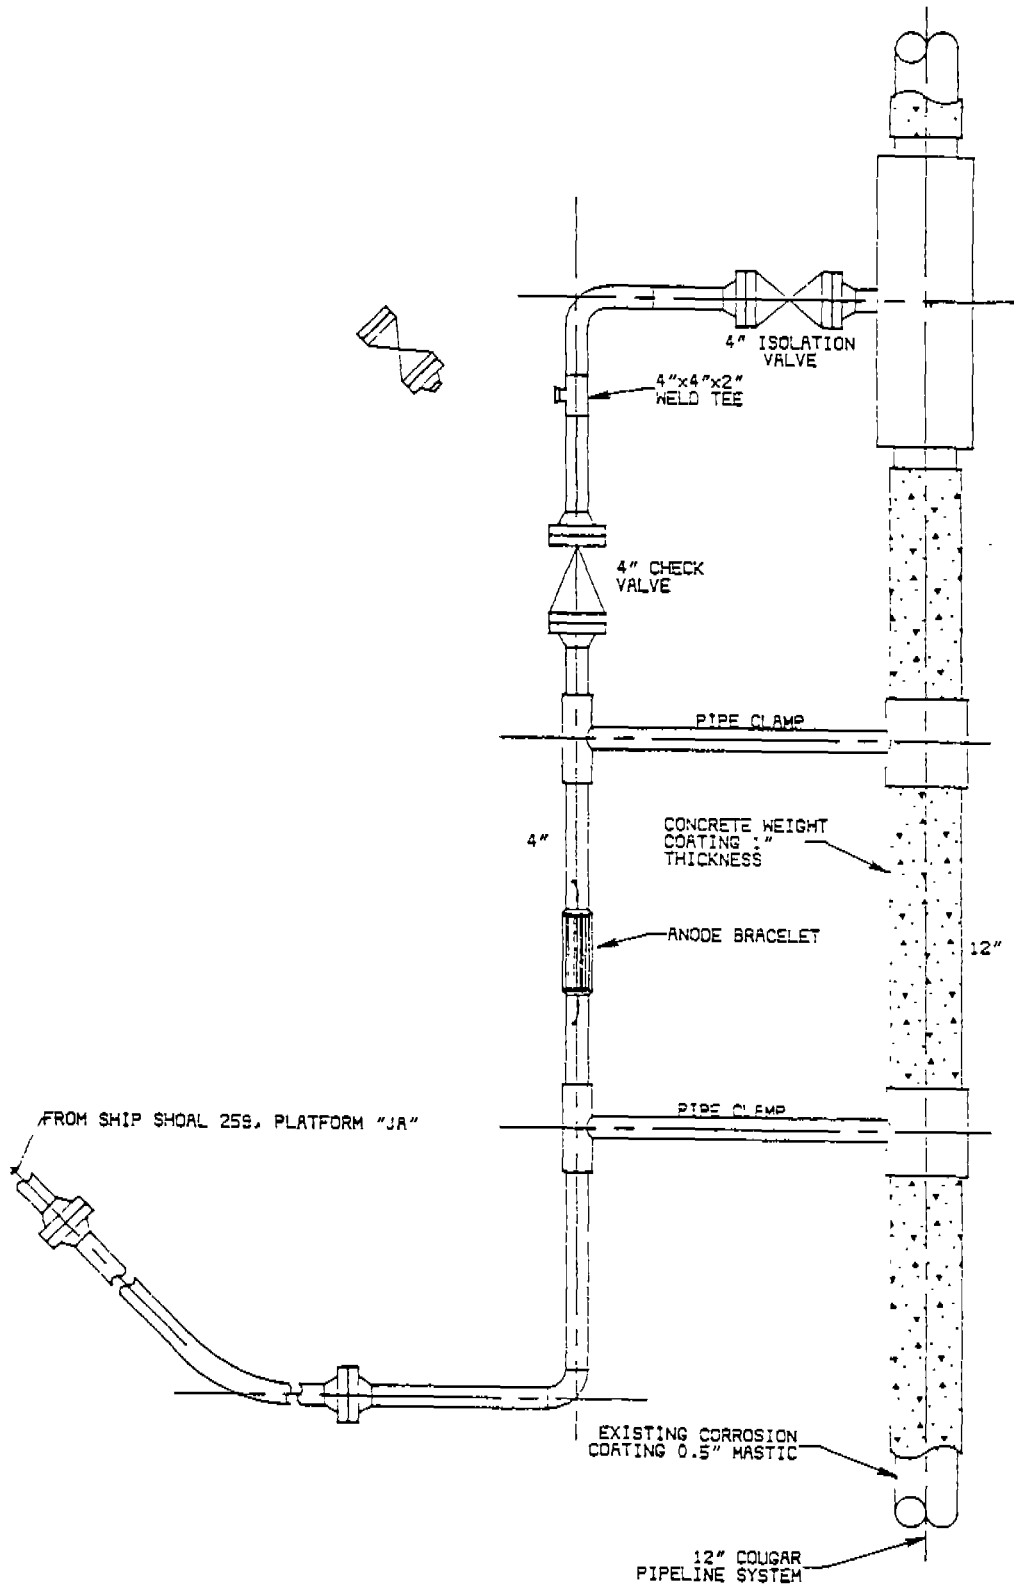
Hobbit Subsea Tie-in Assembly

Cal-Dive International in Morgan City, Louisiana, was contracted to locate and repair the leak. In the early afternoon of January 25, 1990, an inspection of the SSTI by Cal-Dive International revealed that a 2-inch valve on the 4-inch SSTI assembly had been separated from a 4-inch by 4-inch by 2-inch reducing weld-tee. The valve and the parted flange were found on the sea floor approximately 18 inches from the SSTI assembly (see Attachment 2).

The diver reported that the SSTI assembly was covered with approximately 12 inches of sand and deteriorated pieces of burlap bags. The sand bags that were originally over the top of the manifold were rotten and disintegrated. He noted that three parts of the assembly were protruding above the sand cover and surmised that the actuator on top of the 2-inch valve had also been exposed prior to the spill. He reported that the sand had been scoured out of an area approximately 2 feet in diameter where the valve had been attached. The scour appeared to have been caused by flow from the break.

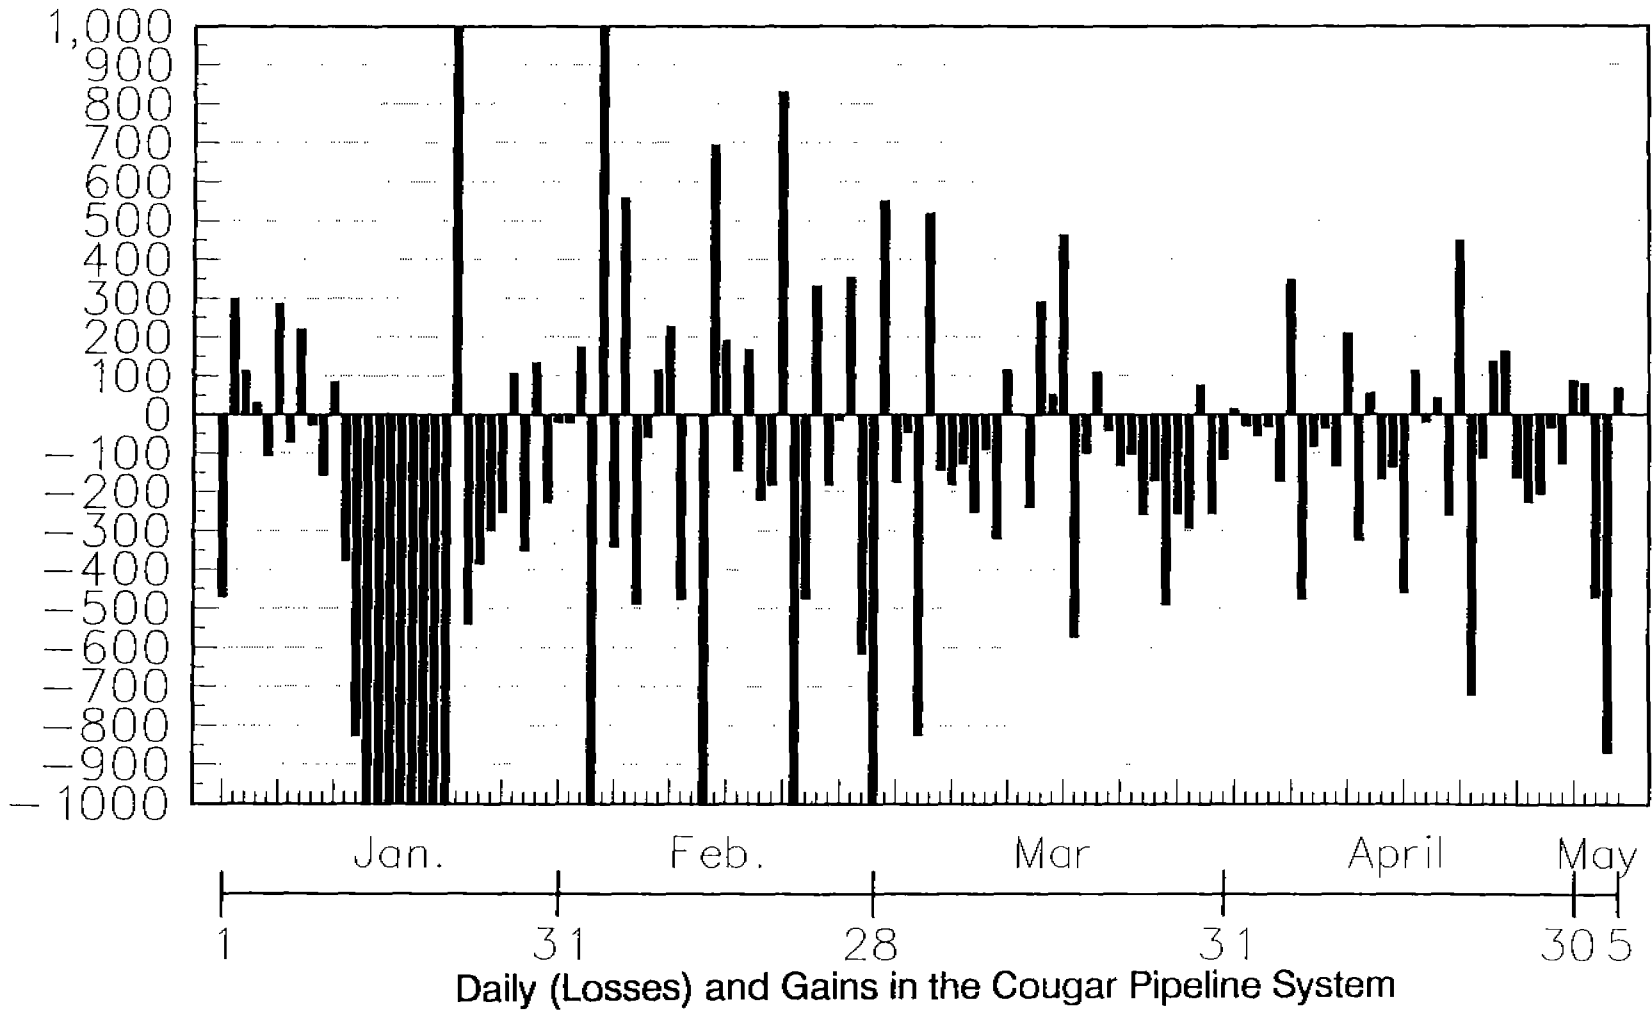
Attachment 4

Table 1 lists the actual losses and gains of the Cougar Pipeline System throughput, as calculated by the investigating panel members using run tickets from each input source and the readings from the check meter at Ship Shoal Block 208 for the beginning of 1990. (Graphical representation of this data can be found in Attachment 4.)

Upon reviewing this data, considerable losses, indicative of an upset in the system, can be seen for the 12-day period from January 12, 1990, through discovery of the leak on January 24, 1990. This prompted the panel to investigate the high probability that oil had leaked from the pipeline for several days prior to its discovery. Although this information was available to SPLC, the huge shortage was not discovered until tabulation of the data after January 31, 1990. Despite the fact that the Cougar Pipeline System had a slight tendency to show a shortage during the first quarter of Calendar Year 1990, the losses shown in Table 1 lead the panel to believe that a significantly larger amount of oil had been spilled than was present on the water surface on January 24, 1990.

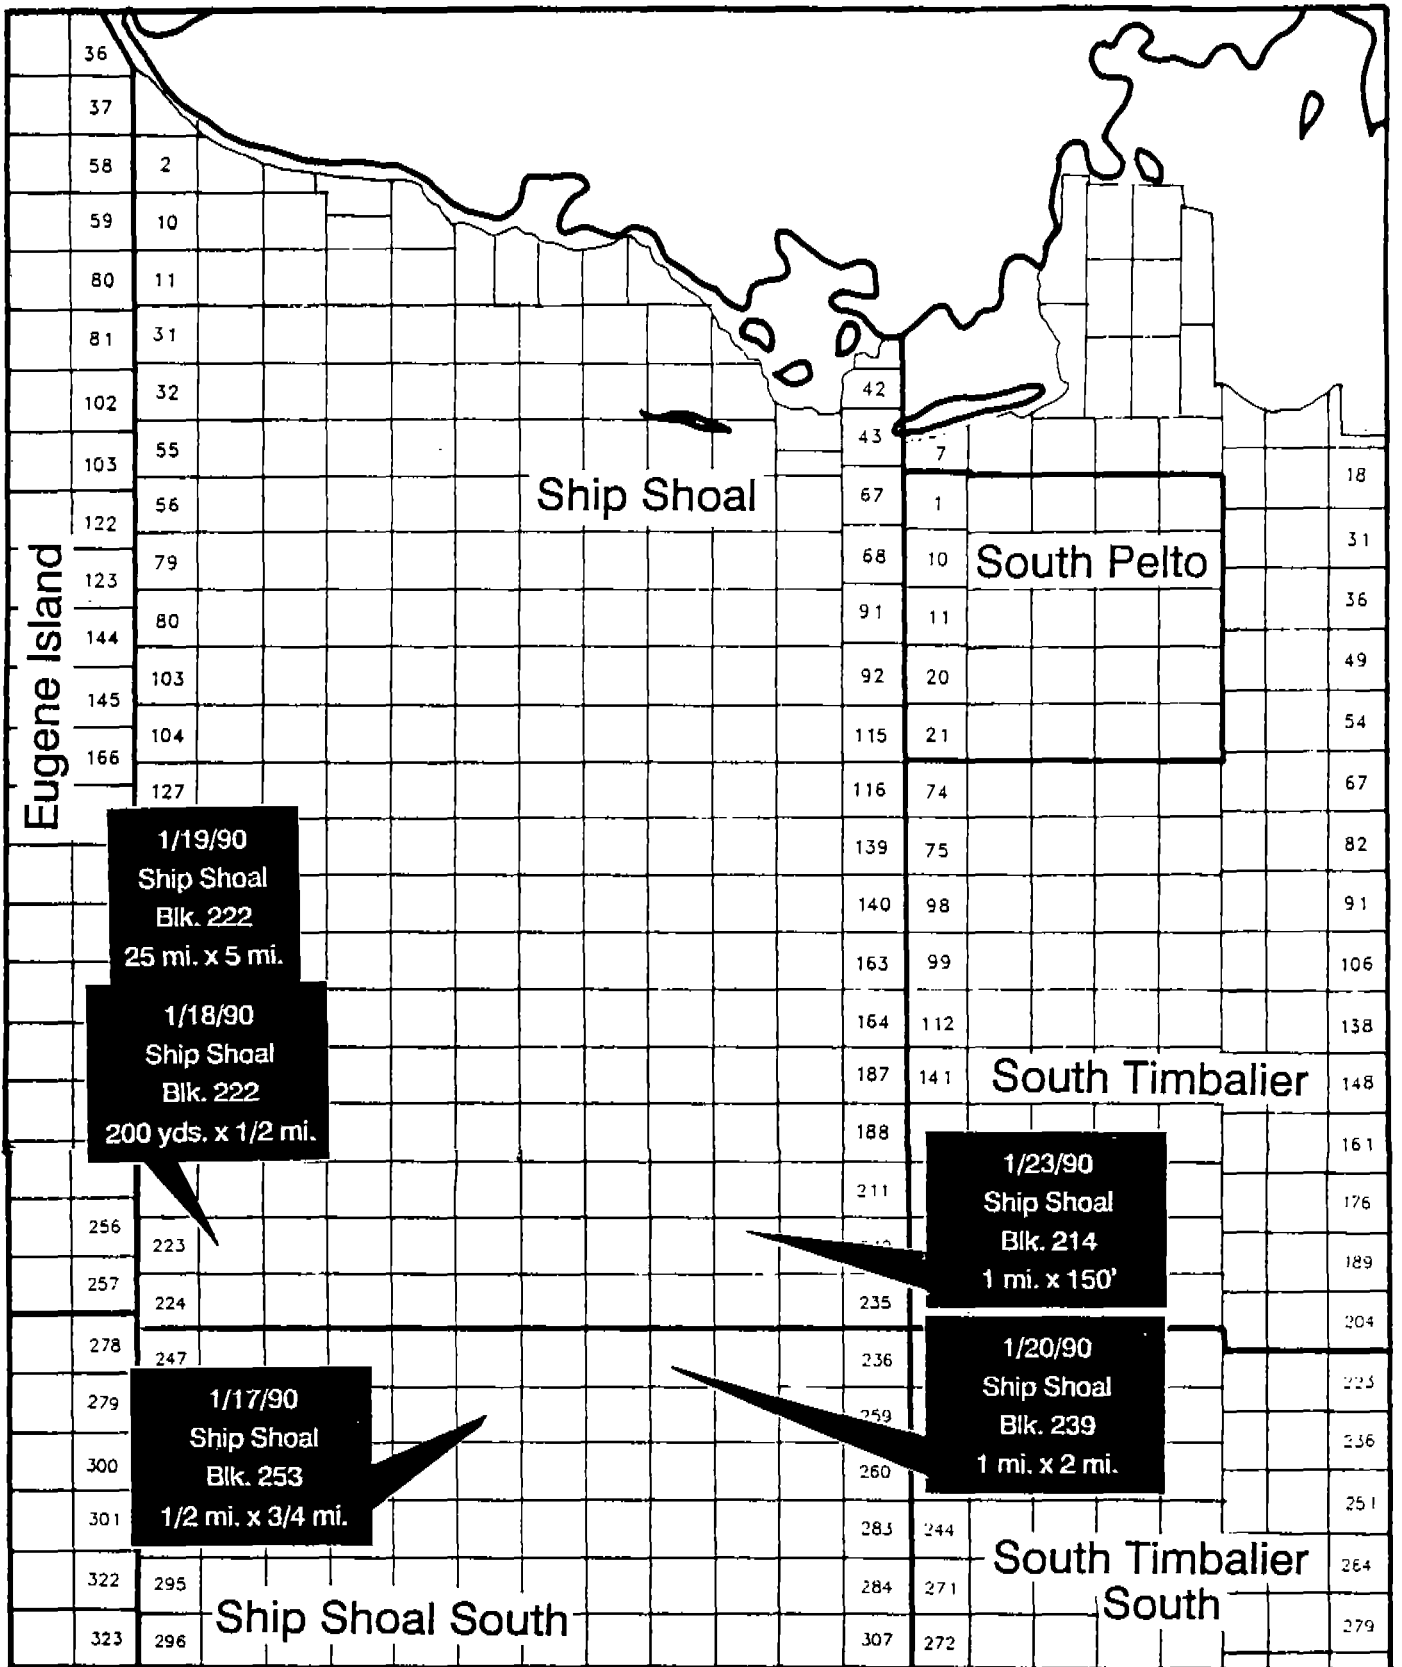
Projected Trajectories of Cougar Pipeline Oil Spills

The prevailing weather data for this period and a trajectory analysis simulating both a continuous leak and batch release of oil during the 12-day period were also reviewed. The plotting of the trajectory information and the unidentified sightings supported the theory that the pipeline had probably intermittently spilled varying quantities of oil over a period of several days (see Attachment 5).

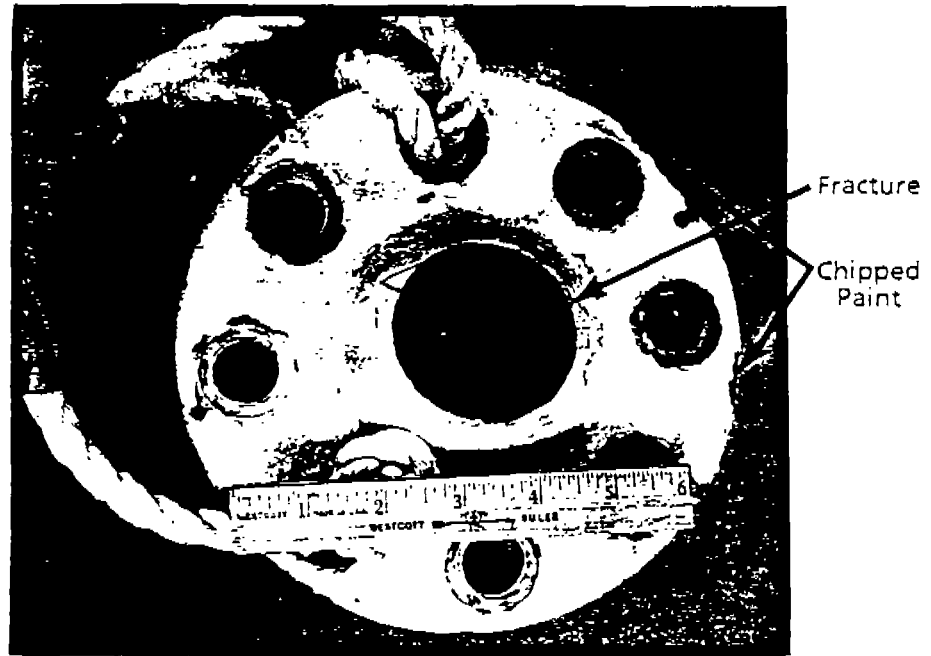
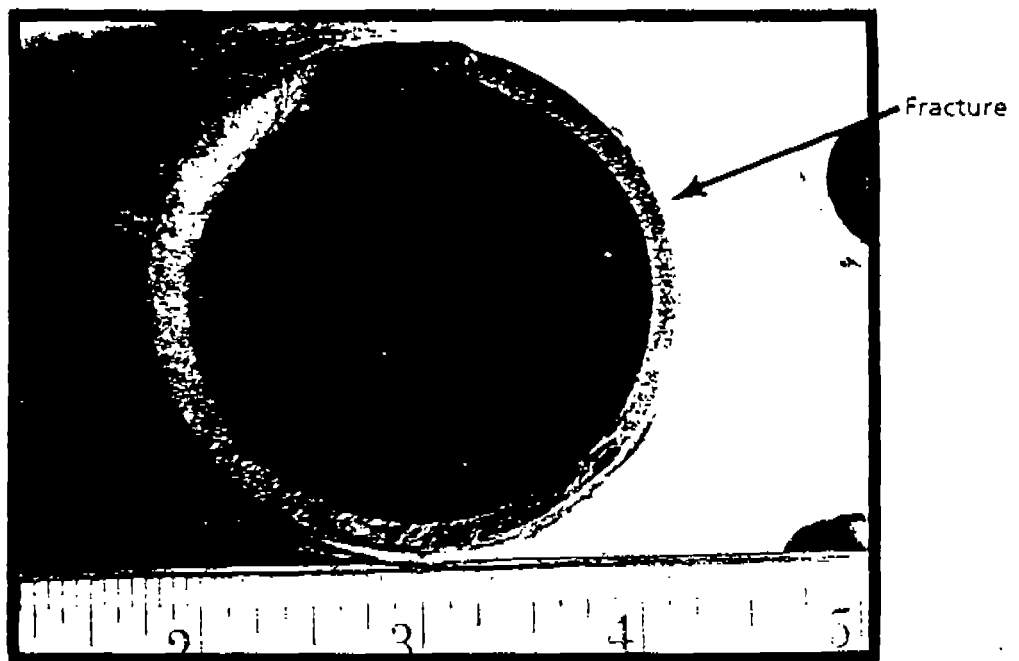
Fractured Flange from Subsea Manifold, Cougar Pipeline

The break in the weld-tee was fairly clean in the heat-affected zone and almost perpendicular to the center line of the flange. The repair crew believes the damage was caused by an anchor or a cable of a fishing net that hooked the 2-inch valve handle and broke it off. However, there was no indication of anchor scars in the vicinity of the SSTI.

*"Our analysis of the failure indicates that large tensile or bending loads would have been necessary to fracture the flange; the load from the cantilevered components would be insufficient to have caused the failure. Although we saw no evidence of any mechanical damage to the flange, it is possible that the cantilevered ball valve may have been pulled by something such as an anchor."*

The fracture at the weld neck was in the area of minimum cross-section. Wall thickness measurements made approximately 1/4 inch from the fracture varied between 0.140 inch and 0.199 inch. The nominal thickness of a Schedule 40 flange is 0.154 inch.

The entire fractured surface was at 45° to the axis of the flange, suggesting an overload-type failure. No evidence of any flat fractures, typical of what might be encountered in fatigue, could be found (see Attachment 6).

- The metallurgical and failure analysis, as well as the initial diver's survey, identified the cause of the damage to the pipeline as external forces exerted on the 2-inch valve.

- Due to the absence of anchor scars around the SSTI assembly and the lack of external damage to the 2-inch valve, the consensus of the panel is that the 2-inch valve was protruding from the sand covering and was snagged by cable from a fishing net or anchor.

- The MMS should investigate the applicability of pipeline leak detection systems other than low-pressure sensors.
- The MMS should modify current regulations to require improved protection of subsea appurtenances and periodic inspection of all subsea appurtenances to ensure adequate protection from damage.
- The MMS should immediately issue a Safety Alert to notify all lessees and pipeline ROW holders of the potential problems with protecting subsea appurtenances.
- The SPLC and other operators associated with the Cougar Pipeline System should immediately implement an automated or manual system of routinely balancing deliveries and receipts at a frequency greater than once daily.
