Investigation of February 15, 1989 Sandefer Offshore Operating Company Oil Spill, Lease OCS-G 5558 Ship Shoal Block 202

Gulf of Mexico
Off the Louisiana Coast

Report - 90-00-0048

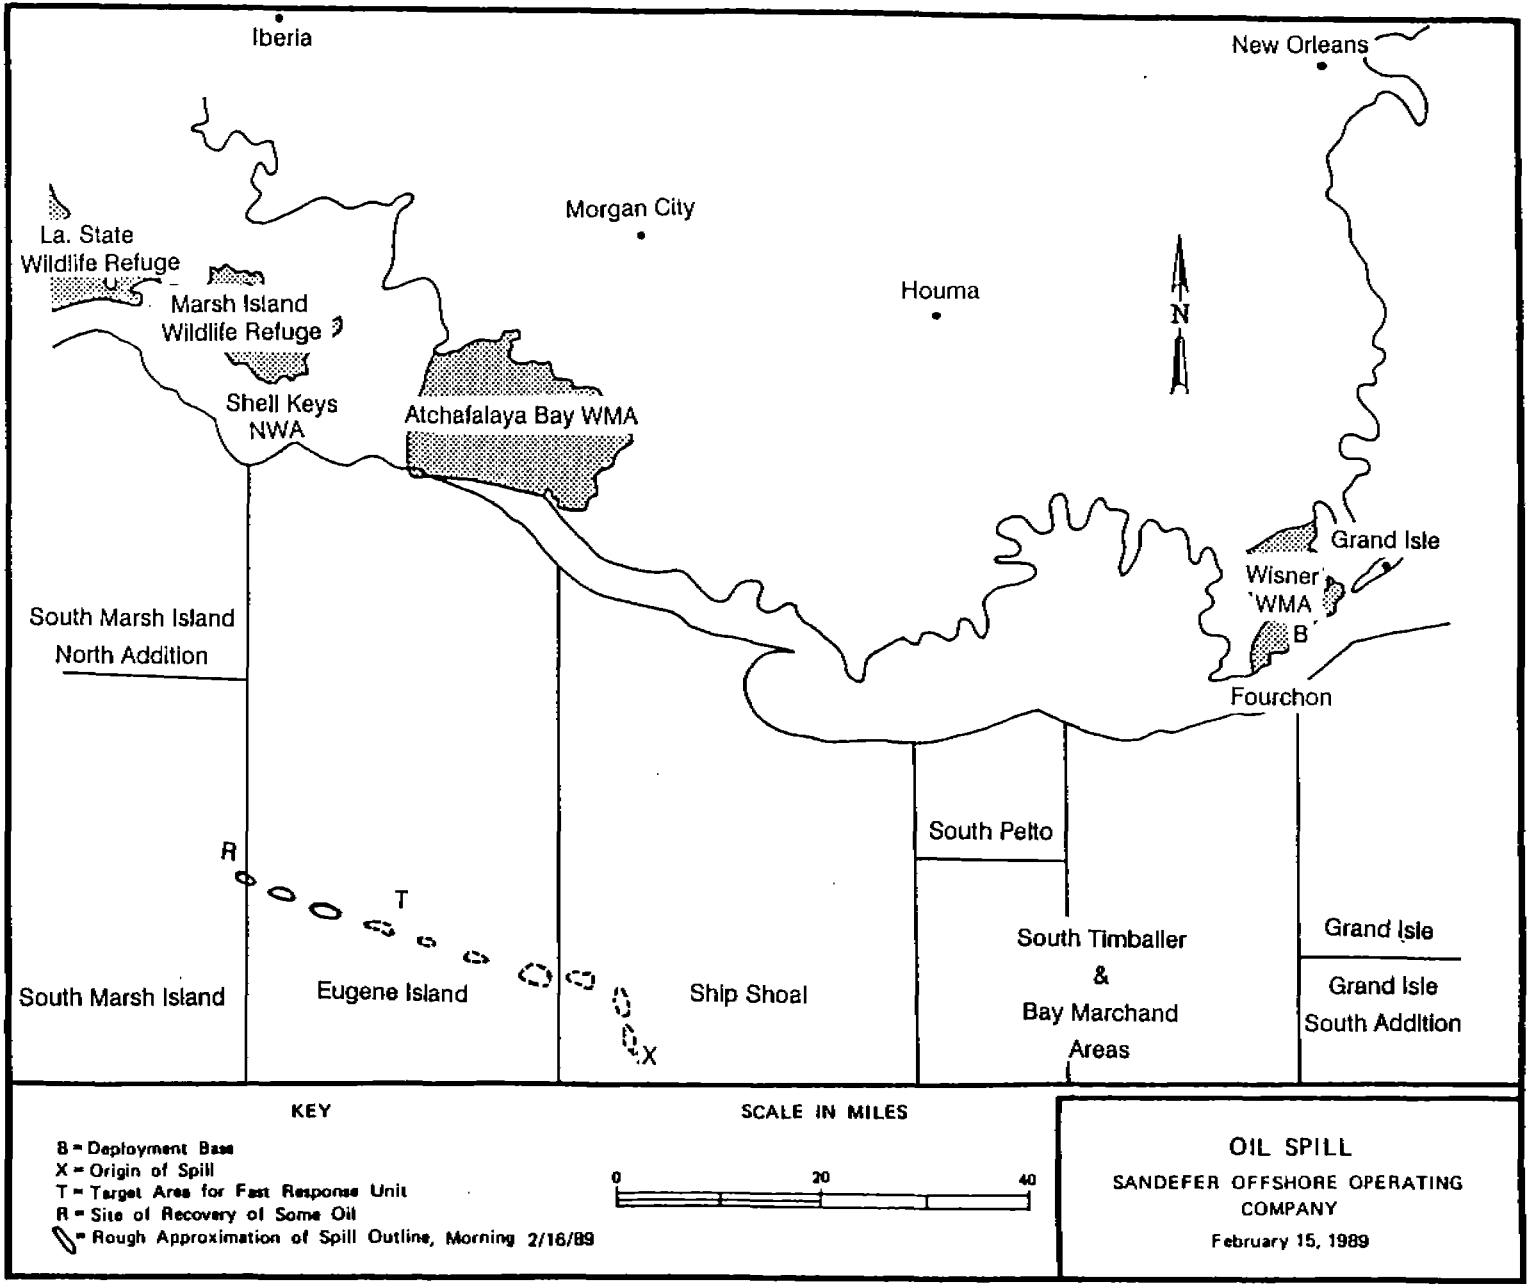
When the fast-response unit arrived in the Eugene Island Area, on February 16, 1989, it encountered heavy fog, which further delayed the oil-spill recovery. By that time, the spill was badly broken up. Some oil was found in South Marsh Island Block 36, and an attempt was made to recover same. An estimated 1/2 barrel was recovered. After tying up overnight, the cleanup operations were to continue the next day, February 17, 1989, but heavy fog and seas of 6 to 7 feet aborted this attempt. The search was then canceled by the Coast Guard at 6:30 p.m. on February 17, 1989, and the fast-response unit returned to Fourchon. (See attachment 3.)
