**Investigation of the
Exxon Company U.S.A.
Pipeline Leak
Eugene Island Block 314
May 6, 1990**

Gulf of Mexico
Off the Louisiana Coast

U.S. Department of the Interior
Minerals Management Service
Gulf of Mexico OCS Region

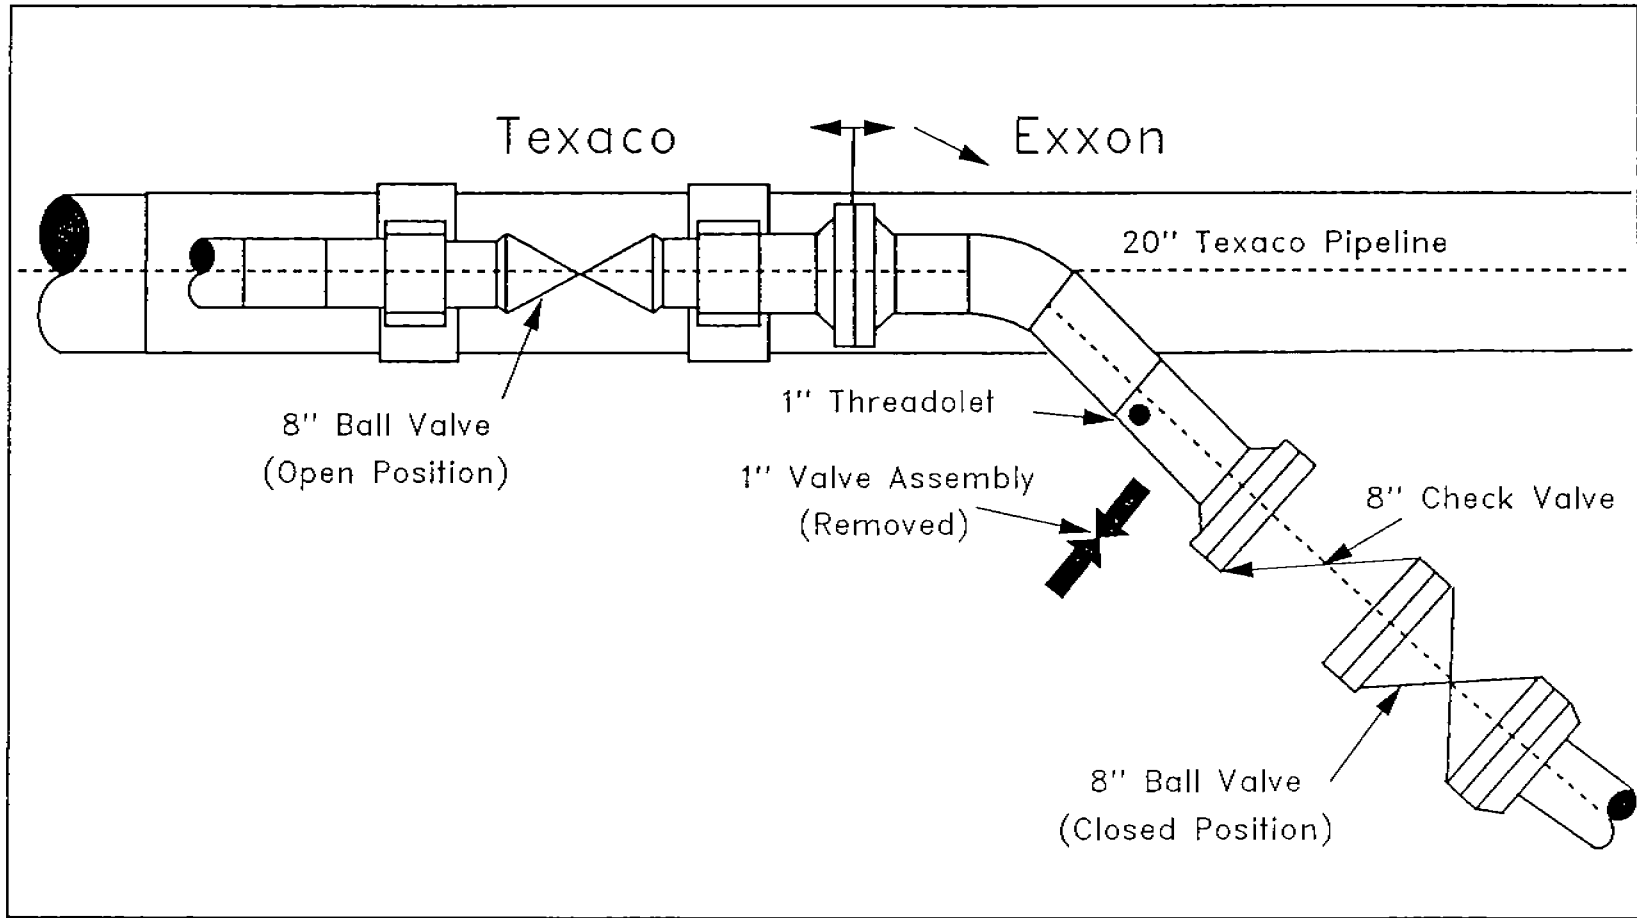
Subsea Tie-in at Time of Incident (Plan View).

The leak involved an 8 5/8-inch spool piece, connecting an 8 5/8-inch Exxon pipeline to the EIPS 20-inch pipeline. The pipeline Segment No. 4030 extends 5,000 feet from Exxon's Platform B to a subsea tie-in (SSTI) on the EIPS 20-inch pipeline, all located in Eugene Island Block 314, Lease OCS-G 2111. (See Attachment 1.) Pipeline Segment No. 4030 was

On May 9, 1990, a diver found the source of the leak. A 1-inch valve had been torn out of a threadolet. The valve's pipe threads had been torn, indicating the valve had been forcibly removed. It was found on the seafloor near the threadolet. The 1-inch valve had been located on a spool piece of 8 5/8-inch pipe between Texaco's block valve and Exxon's block valve. Texaco's block valve was open and Exxon's block valve was closed. (See Attachment 2.) When the valve was removed, oil backflowed from the EIPS 20-inch pipeline through the open Texaco valve to the spool piece and out of the threadolet.

The SSTI assembly did not have the required minimum coverage and was not protected by a structure to prevent damage from commercial fishing operations at the time of the spill incident.

The proper way to place a pipeline segment out of service is to close all valves servicing that segment at a subsea tie-in. In this instance both the Exxon and Texaco valves should have been closed.

Subsea pipeline tie-ins should be buried in accordance with Department of Transportation Regulations or, in lieu of burial, cages, domes, or sandbags should be placed to protect tie-ins from damage.

Pipeline operators should orient subsea tie-in assembly bleed-off valves whereby if coverage is lost the valve would not pose a hazard to commercial fishing operations.

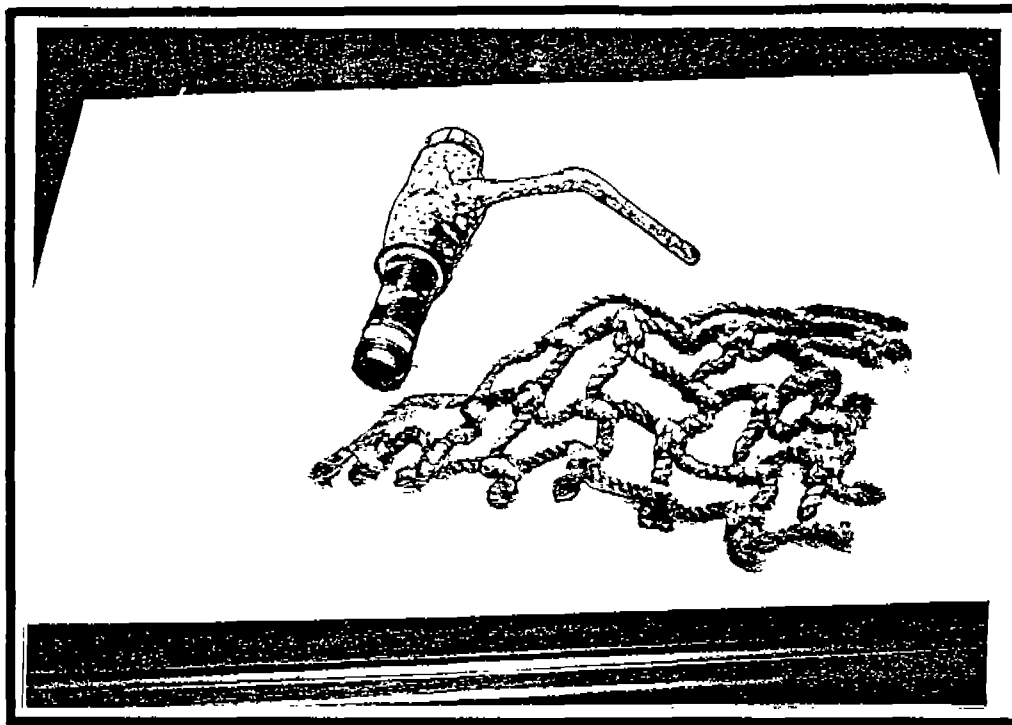
One-inch Valve Assembly.

The underwater video and photographs of the 1-inch pipe threadolet and the 1-inch valve indicate that a lateral, external force pulled or pushed the 1-inch valve from the threadolet, stripping its threads. The 1-inch valve appeared to have been initially positioned vertically. It was found on the seafloor near the location of the threadolet. Inspection of the damaged valve and threadolet showed no corrosion on the surfaces that had made a metal-to-metal seal; this lack of corrosion indicated that the valve had been removed recently. Further, the valve piping had been bent approximately 15 degrees before the threads stripped, allowing the pipe to separate from the threadolet.

The diver reported that the subsea tie-in (SSTI) assembly was not buried below the mud line and that there were pieces of a trawling net in the area, which he recovered along with the 1-inch valve. (See Attachment 3.) The repair crew believes that the damage was caused by a trawling net that hooked the 1-inch valve and stripped it from the threadolet.

Because of the absence of anchor scars near the SSTI assembly, the panel concluded that the protruding 1-inch valve was snagged by a trawl net and pulled from the threadolet.
