UNITED STATES COAST GUARD

Report of Investigation into the Circumstances Surrounding the
Explosion, Fire, Sinking and Loss of Eleven Crew Members

DEEPWATER HORIZON

April 20 – 22, 2010

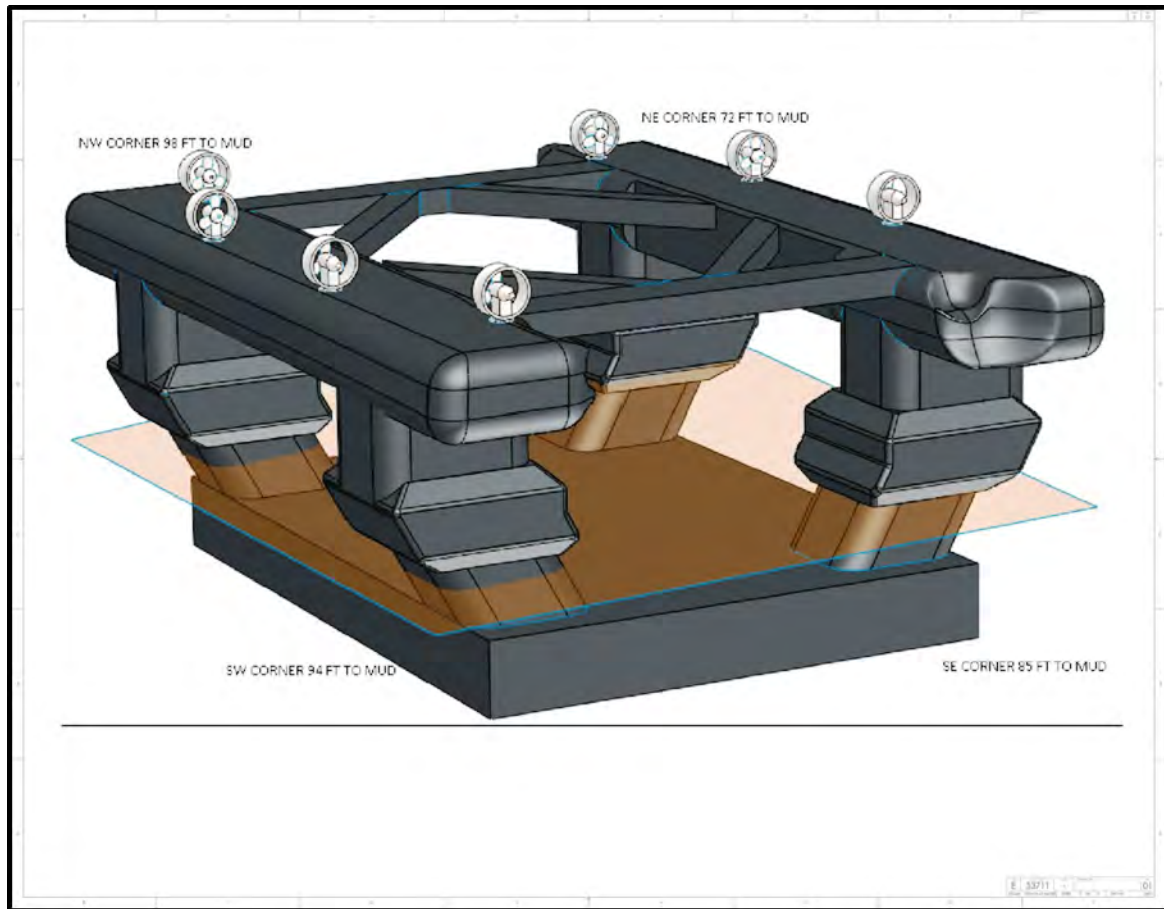
Figure 13 – *DEEPWATER HORIZON* on the Ocean Floor

Figure 13 shows *DEEPWATER HORIZON* as it came to rest on the ocean floor, depicting some of the damage and showing that the upper hull was buried and is not visible.²⁷⁸

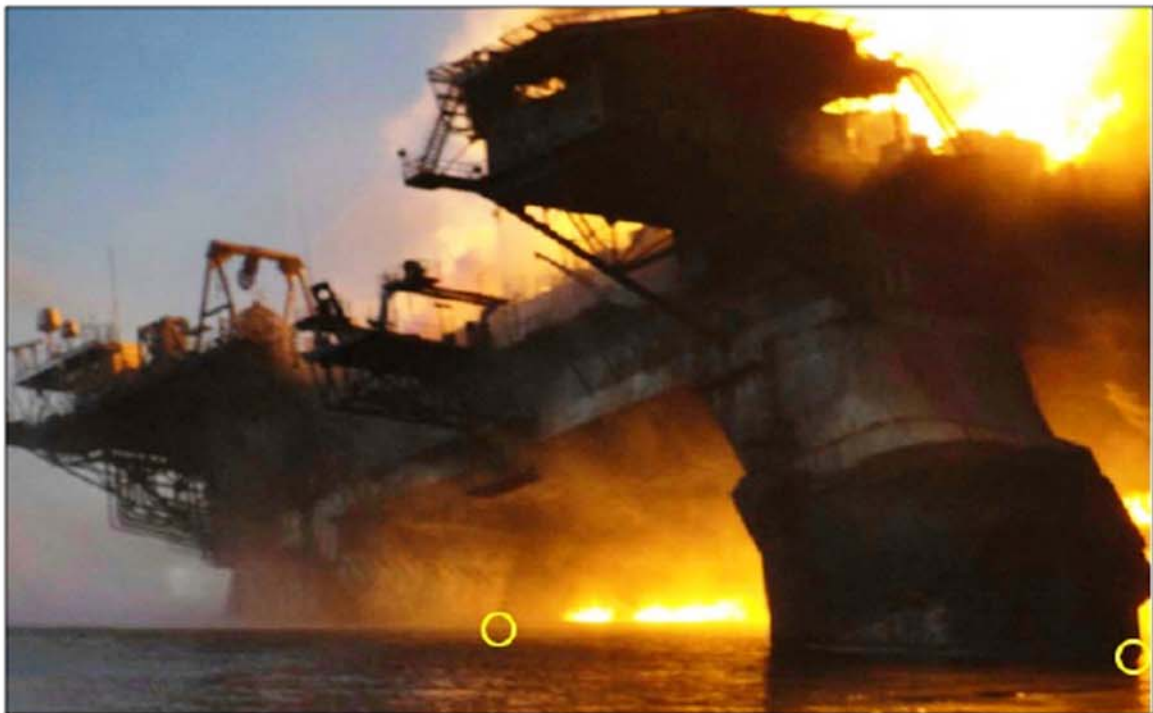
Figure 3: DEEPWATER HORIZON, Port Bow Aspect (0612 on 22 April 2010)

Without information on the rig’s loading prior to the casualty, it is impossible to analyze specific damage scenarios. We also lack precise information regarding the rig’s draft, heel, and trim as the casualty progressed. However, using photographs of the *DEEPWATER HORIZON* during the casualty, we estimated her waterplane in the damaged, floating condition. To estimate the waterplane, we used photographs taken at known times and identified three recognizable hull locations that intersected the waterline. The hull locations at the waterline that we used are marked on the photographs (see below) with yellow circles. Figure 3 and Figure 4 were reportedly taken at 0612 on April 22, 2010. Figure 5 and Figure 6 illustrate how the waterplane estimated from these photographs looks when applied to our computer model. Figure 7 and Figure 8 were taken at approximately 1030 on April 22, 2010, just prior to the rig sinking. Figure 9 and Figure 10 illustrate how the waterplane that was estimated from these photographs looks when applied to our computer model. Although the extent of damage shown in Figure 7 and Figure 8 indicate that some hull deflection may exist, our waterplane estimates cannot account for deflection and necessarily assume that the hull was not deflecting in the pictures.

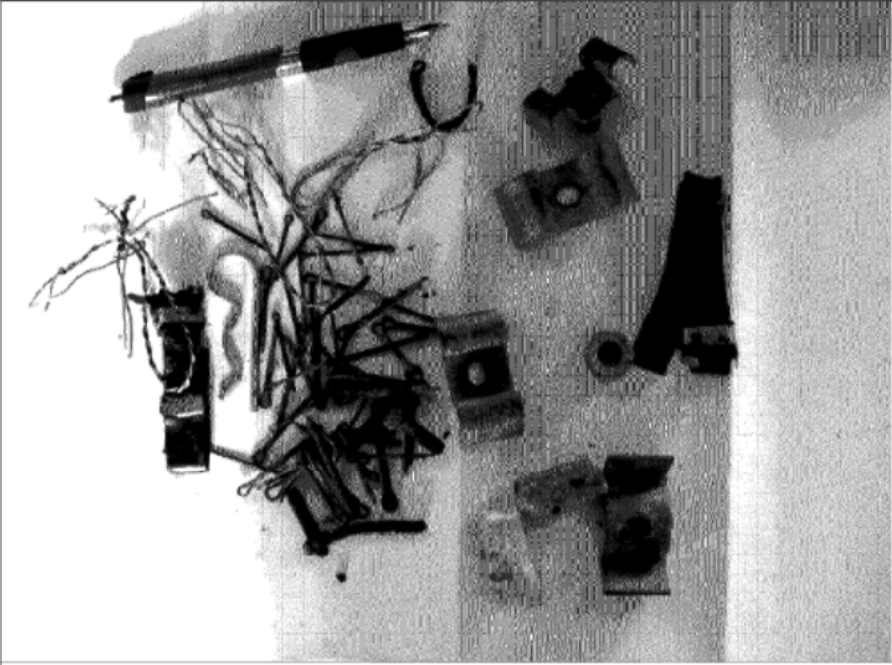
Rig Name:	Deepwater Horizon
Date:	September 2009
ARAS Reference:	2.2.5

Observations or Comments: Trash and loose items recovered from the derrick. The rig crew had made a derrick inspection the shift before our inspection was performed.

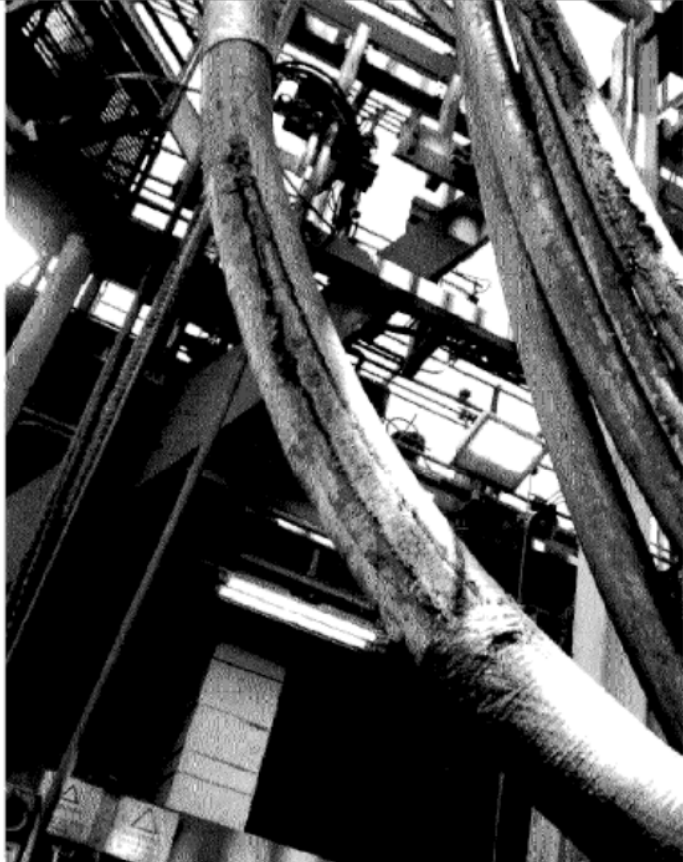
Rig Name:	Deepwater Horizon
Date:	September 2009
ARAS Reference:	2.2.8

Observations or Comments: Poor condition of mud hose and top drive service loops
