**THE BUREAU OF OCEAN ENERGY MANAGEMENT,
REGULATION AND ENFORCEMENT**

**REPORT REGARDING THE CAUSES OF THE APRIL 20, 2010
MACONDO WELL BLOWOUT**

September 14, 2011

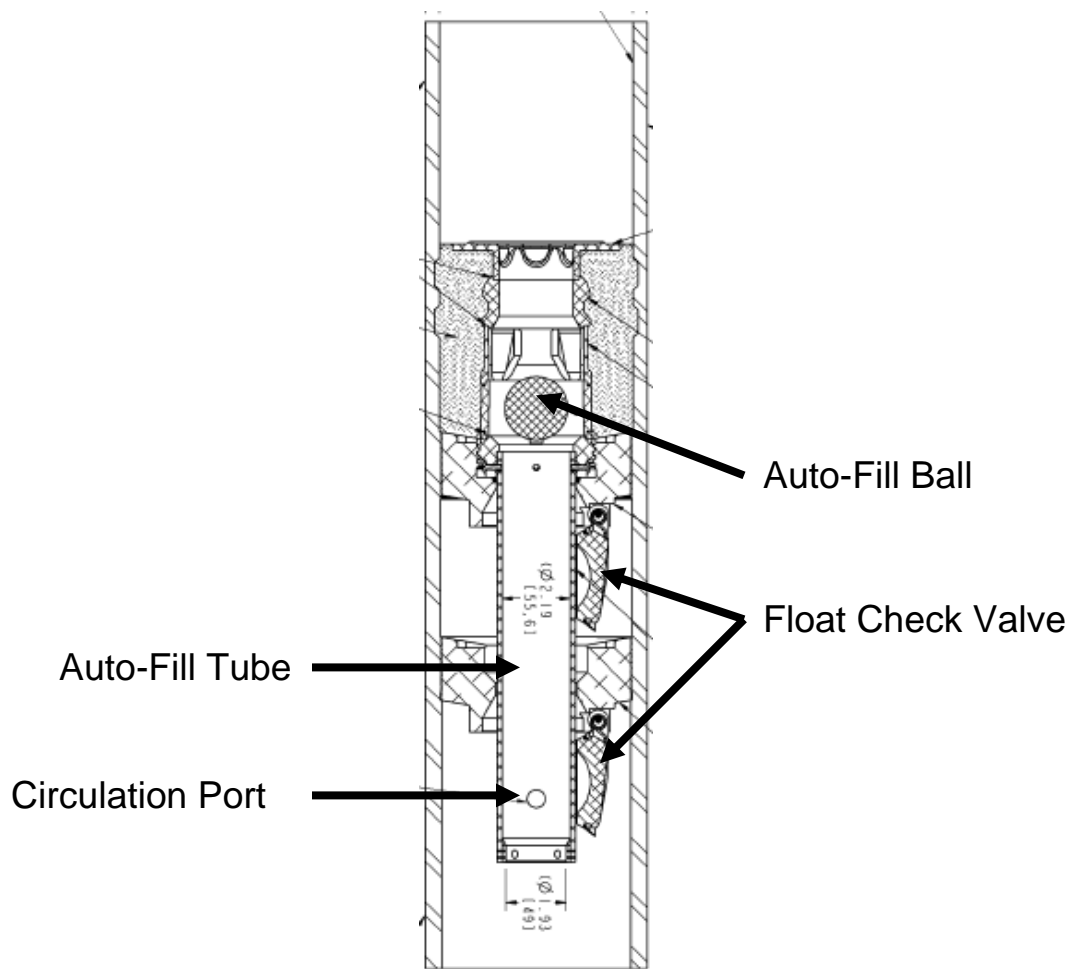
Figure 4 – Float Collar Utilized in the Macondo Well

The float collar uses a double-check valve – a mechanical valve that permits fluid to flow in one direction – that is held open by an auto-fill tube. When running the casing into the well, the auto-fill tube allows mud to flow into the casing, thereby reducing the force exerted by the mud on the formation and helping to prevent loss of fluids into the formation. To convert the float collar, a ball (in this case an "Allamon ball" because the float collar was manufactured by Allamon) rests in the auto-fill tube when running the casing into the well and when mud pumping starts it restricts the flow of mud by diverting the mud through two small ports in the auto-fill tube. Circulation through these ports creates a differential pressure in the float collar, forcing the auto-fill tube out of the float collar and allowing the check valves to close. In doing so, a float collar, which is set near the bottom of the casing string, acts as a check valve and prevents cement that is pumped down through the casing from flowing back into the shoe track (which is the distance between the float collar and end of the casing) once the cement is in place. If the float collar fails to convert, it is possible for "reverse flow" or "u-tubing" flow to occur from the bottom of the casing up the wellbore toward the rig.

As discussed above, the float collar was set at 18,115 feet measured depth, within the primary hydrocarbon reservoir sands (see Figure 2, above). Typically, an operator sets the float collar below the primary hydrocarbon sands to allow for perforation of the pay zone without the need to drill out the float equipment to get below the pay zone during the completion of the well. In addition, the lower primary sand was less than 100 feet from the bottom of the production casing shoe.¹¹⁶ Normally, an operator would set the production casing shoe 200 to 300 feet below the primary sand to improve the chances of proper isolation of the pay sand.

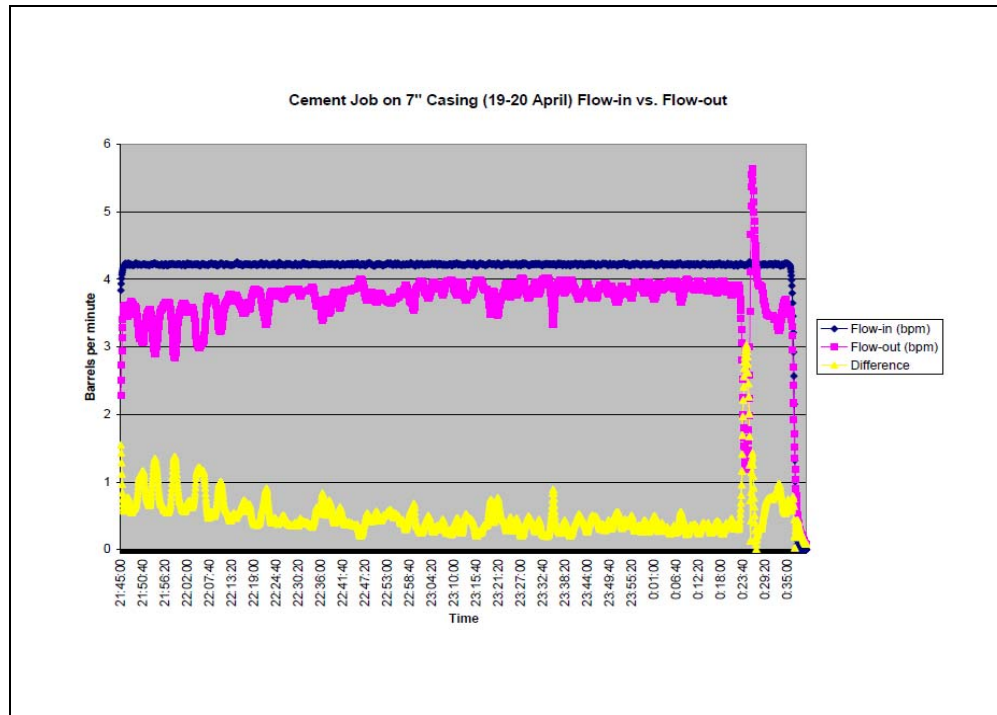
Figure 5 - Flow-out vs. Flow-in on the Production Casing Cement Job (Calculated by Panel)

This possible range of loss exceeded the entire volume of cement pumped during the production casing cement job. This could indicate that over-displacement of cement occurred in the shoe track. In other words, the cement could have been pumped into the well, past the shoe track, which would have left spacer and no cement in the shoe track to isolate the center of the production casing. If over-displacement occurred, it would have resulted in insufficient cement coverage in the shoe track.
