Aviation Safety Support Services for the Bureau of Safety and Environmental Enforcement

Task C.4.5: Study on Effects of Combustible Gas on Helicopter
Operations

August 31, 2015

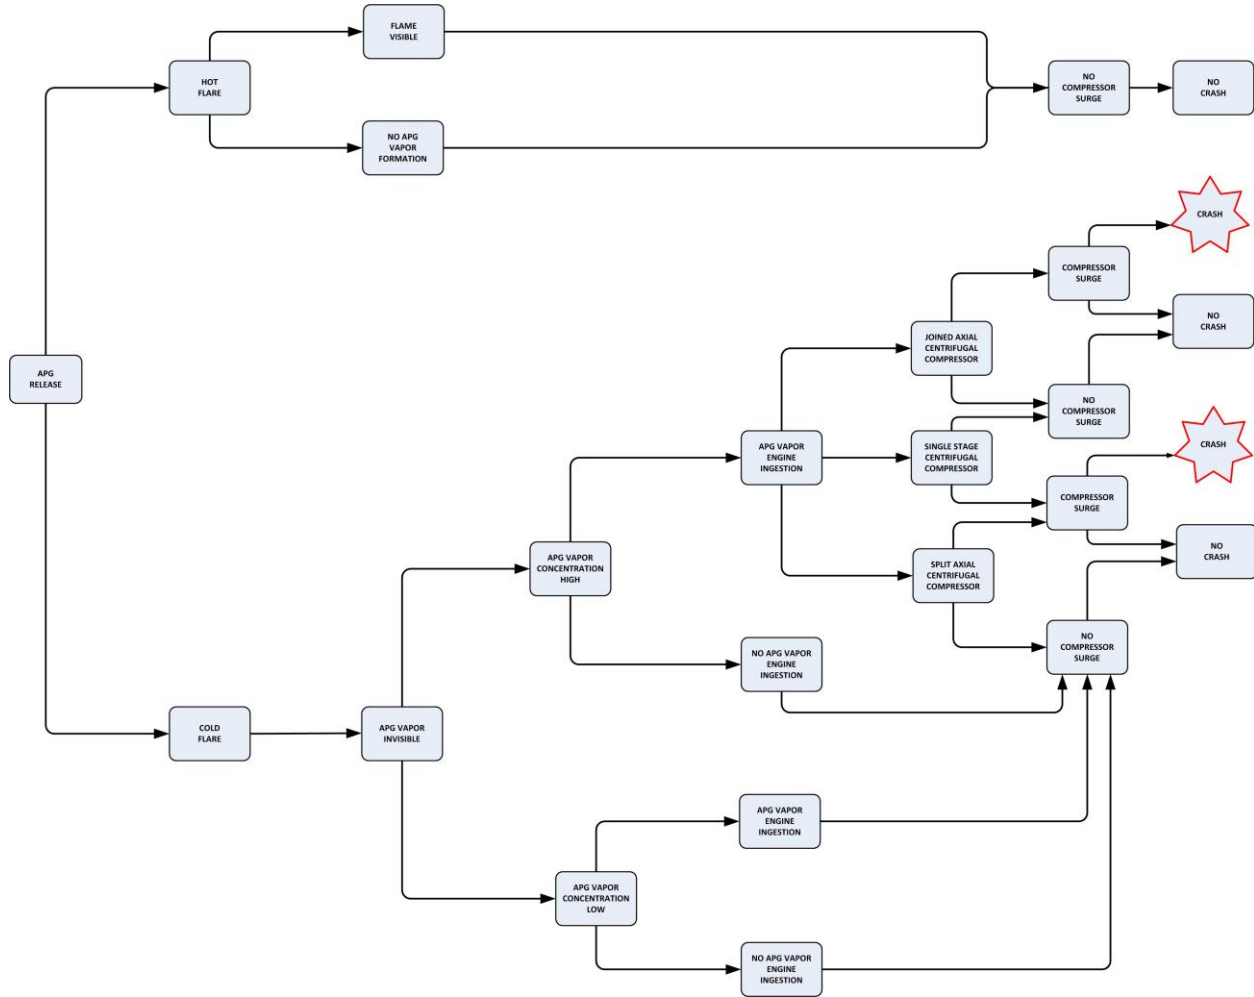
Figure 17: APG Ingestion Event Tree

Figure 17 presents a cause and effect diagram of possible events due to APG ingestion in a turboshaft engine. The dependent variables are ingestion of APG, compressor surge, and actual crash of the aircraft; conversely, the independent variables are the APG stoichiometric concentration in air, and the compressor configuration of the representative engine. For example, a helicopter may or may not encounter an invisible APG vapor cloud, depending upon wind direction. If the helicopter encounters an APG vapor cloud, the stoichiometric concentration may cause a compressor surge. The effect of the compressor surge, perforce, depends on its severity and the time that the fuel control or the pilot has to respond to the event to prevent a mishap.

Due to the thermodynamic operating characteristics of gas turbine turboshaft engines, methane gas ingested into the engine could either be ignited through adiabatic compression heating above the autoignition temperature causing a compressor surge, or enrich the fuel causing an over-temperature condition with associated internal engine pressure increase, increase in compressor backpressure, or over-speed condition, all of which may cause a partial or total loss of engine power.

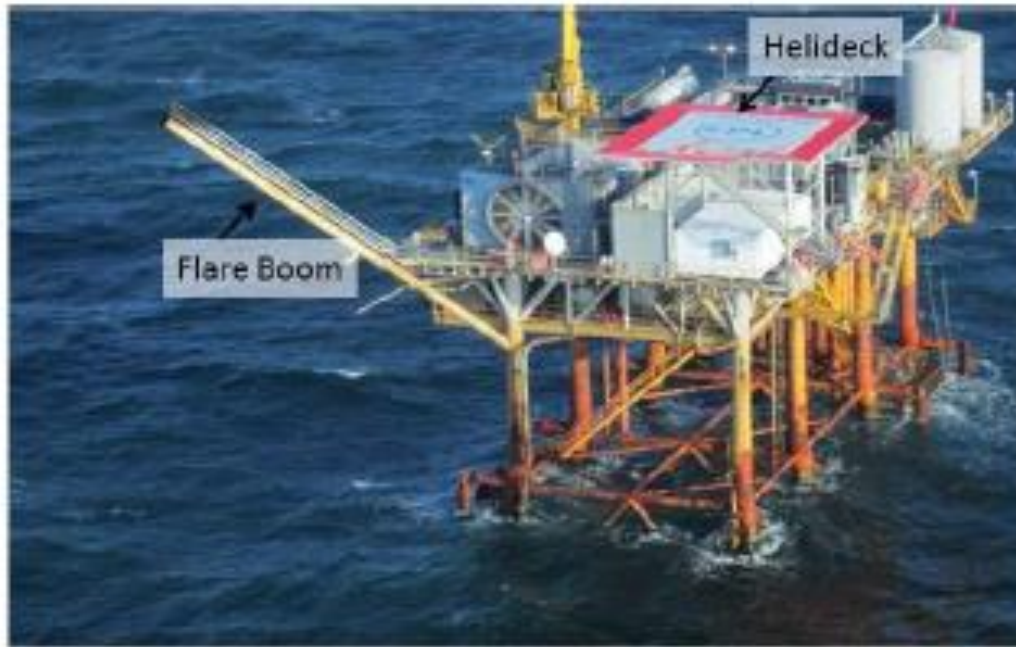
Figure. SS208H showing the helideck and flare boom.

The pilot later reported that before departure, he brought the helicopter into a stationary hover in the middle of the helideck and made a "left pedal turn into the wind and in a direction to avoid the flare boom." According to a monthly gas flaring and venting volume summary provided by the platform operator, the volume of methane vented on the day of the accident was the highest of the month and about 20 times the volume of the second highest day. The pilot was not aware before departing that methane gas was being vented. While a wind sock is located on the platform to assist pilots in determining the prevailing wind direction, as recommended in industry guidance, the platform does not have a system visible to pilots indicating when gas is venting; such a system is particularly helpful since methane gas is colorless and odorless and pilots are not able to discern its presence. The following figure shows SS208H with its helideck and flare boom.

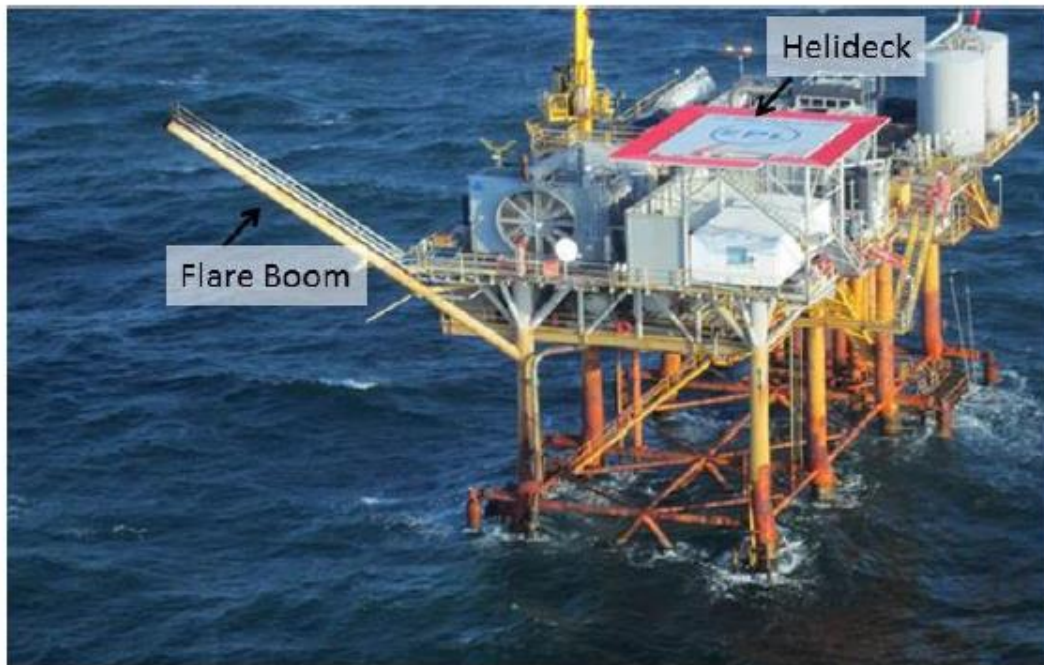
Figure. SS208H showing the helideck and flare boom.

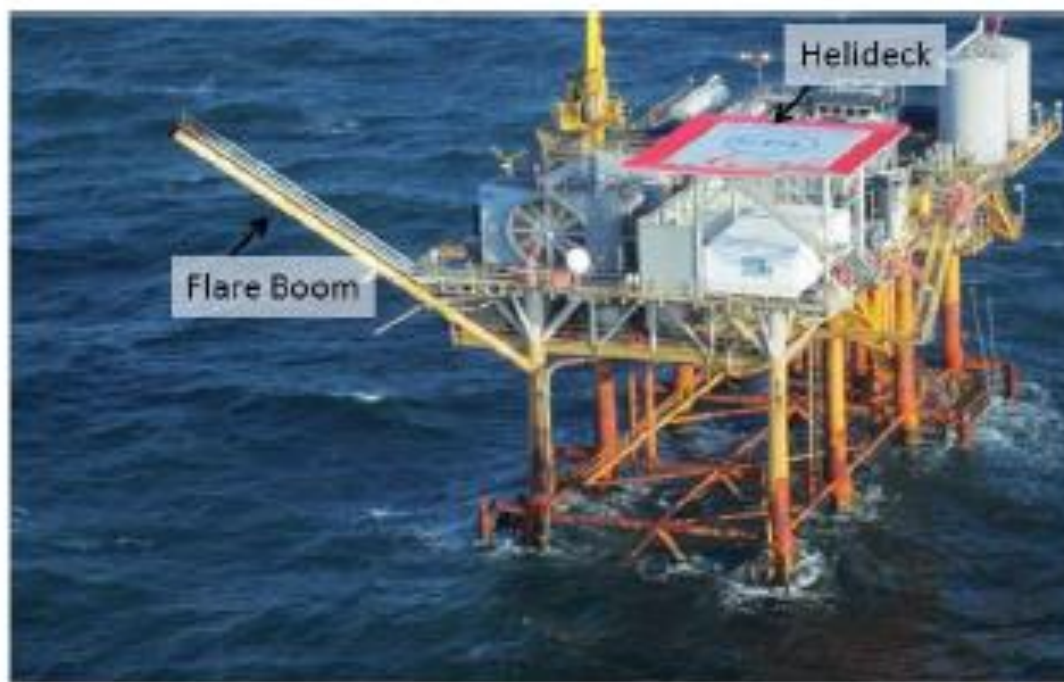
Figure. SS208H showing the helideck and flare boom.
