Investigation of February 17, 2018, Fatality West Cameron Block 215 Platform “A”

Lease No. G-04087
Gulf of Mexico Region,
Lake Charles District
Off Louisiana Coast

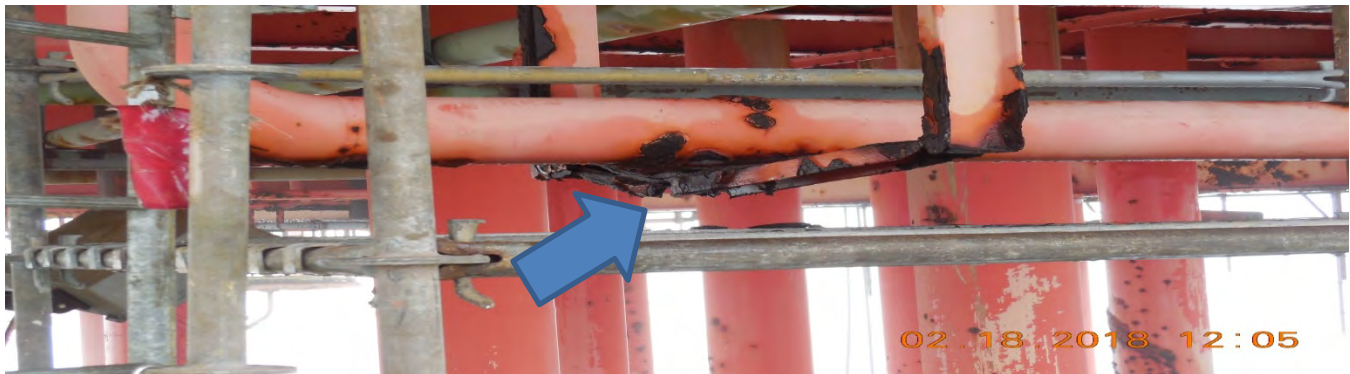
Figure 3: Rusted firewater piping support bracket

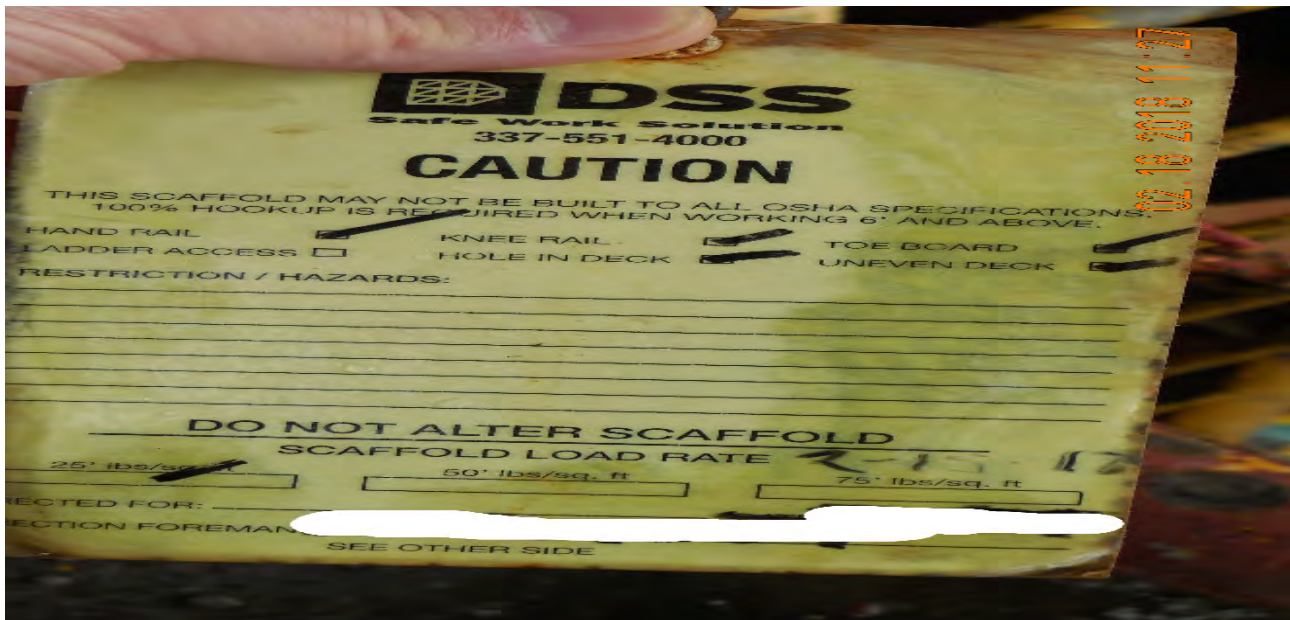
Figure 5: Yellow scaffolding tag attached at access point on the southwest side of cellar deck.

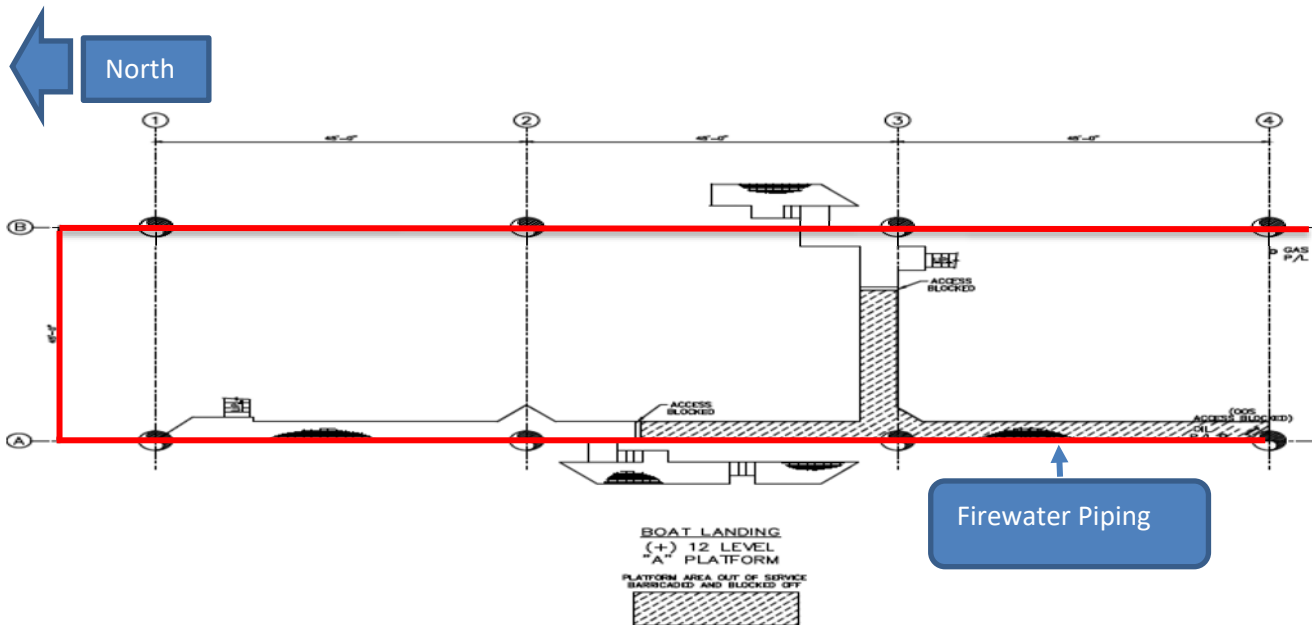
Figure 7: Facility drawing showing Out of Service area on +10

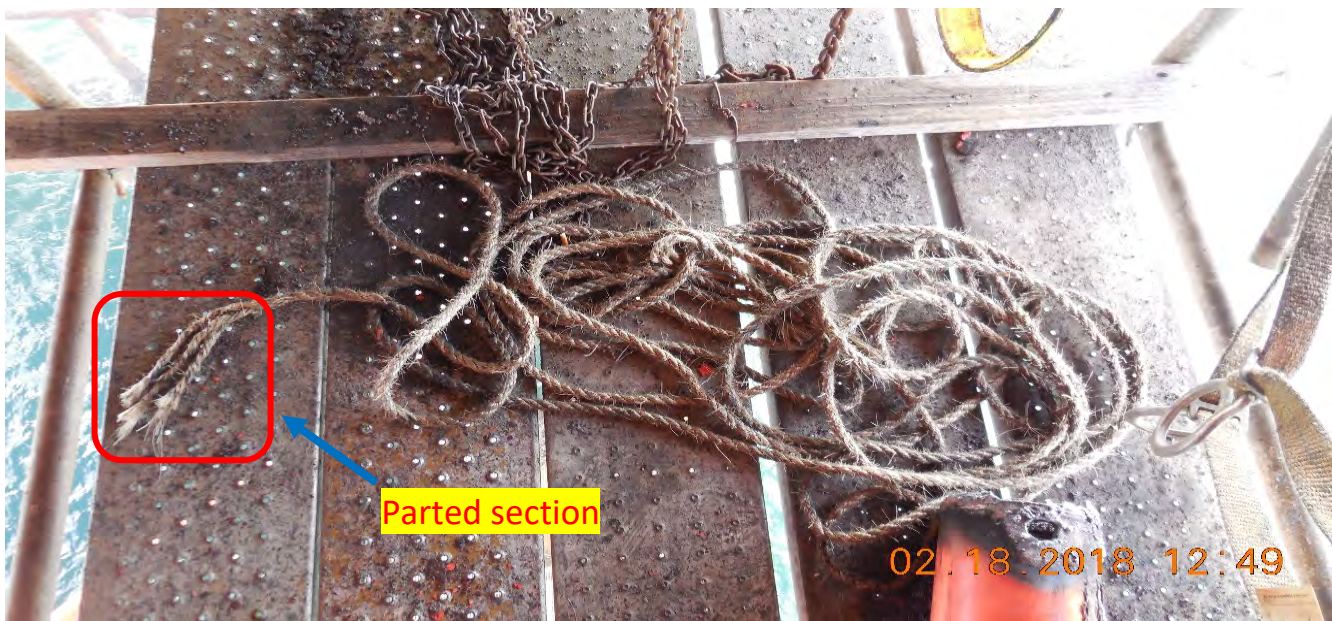
Figure 12: ½-inch manila rope that parted during firewater piping removal.
