# Aviation Safety Support Services for the Bureau of Safety and Environmental Enforcement (BSEE)

Task 5: Study on Effects of Combustible Gas on Helicopter  
Operations

September 28, 2015

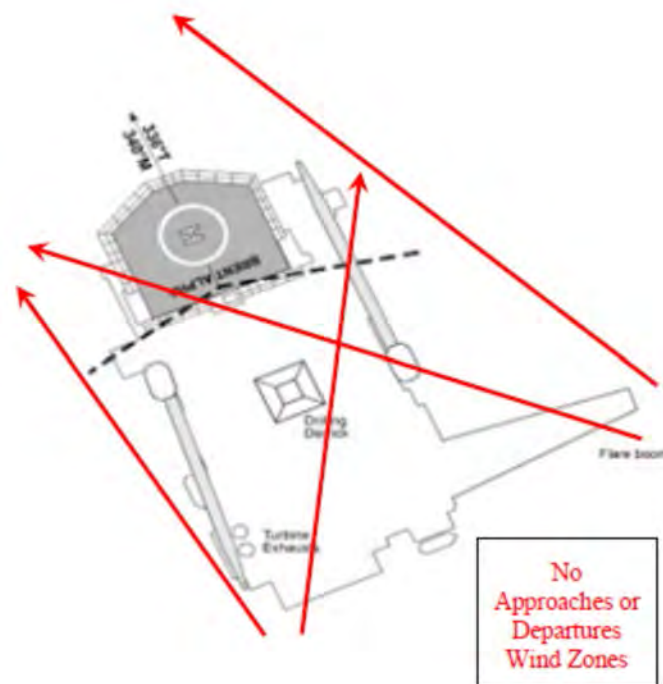
*Figure 12: No Approach or Departure Wind Zones*

Figure 12 depicts an imaginary flare/vent boom and helideck configuration. The footprint of the facility and proximity of the flare/vent tip will determine a triangular-shaped region of wind directions within which approaches and departures would be ill-advised, when flaring or venting was in progress. The facility would have to be manned with a person capable of reading available wind information and transmitting it in real-time to an approaching or departing helicopter.

An equally useful and cost effective engineering safety control would be a system that warned of cold venting in-progress. This reporting mechanism should be highly visible in all light and weather conditions and should also broadcast venting and wind information over the facility frequency used for pilot-to-facility communications.

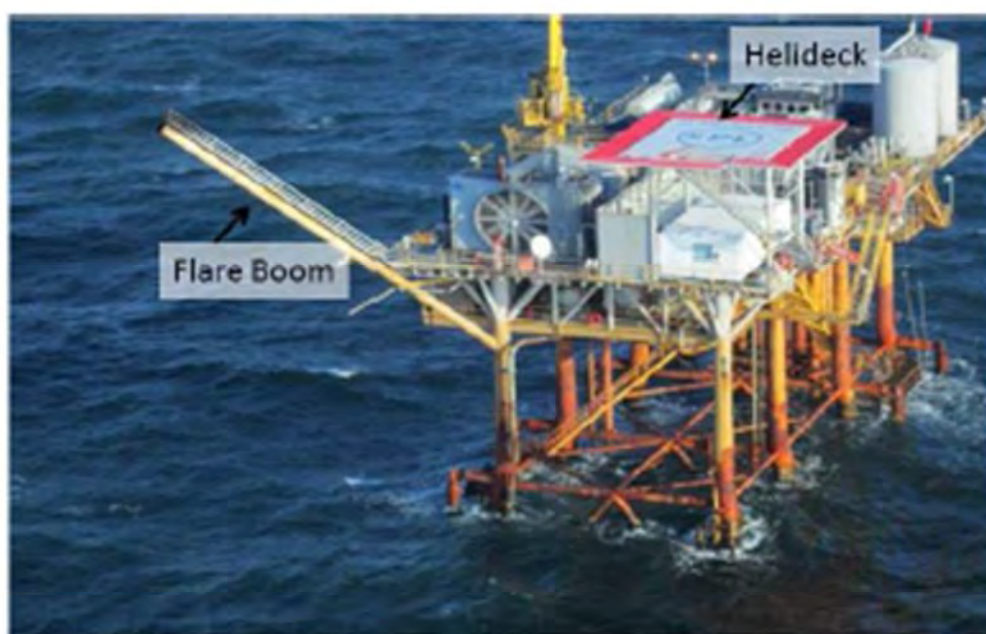
Figure. SS208H showing the helideck and flare boom.

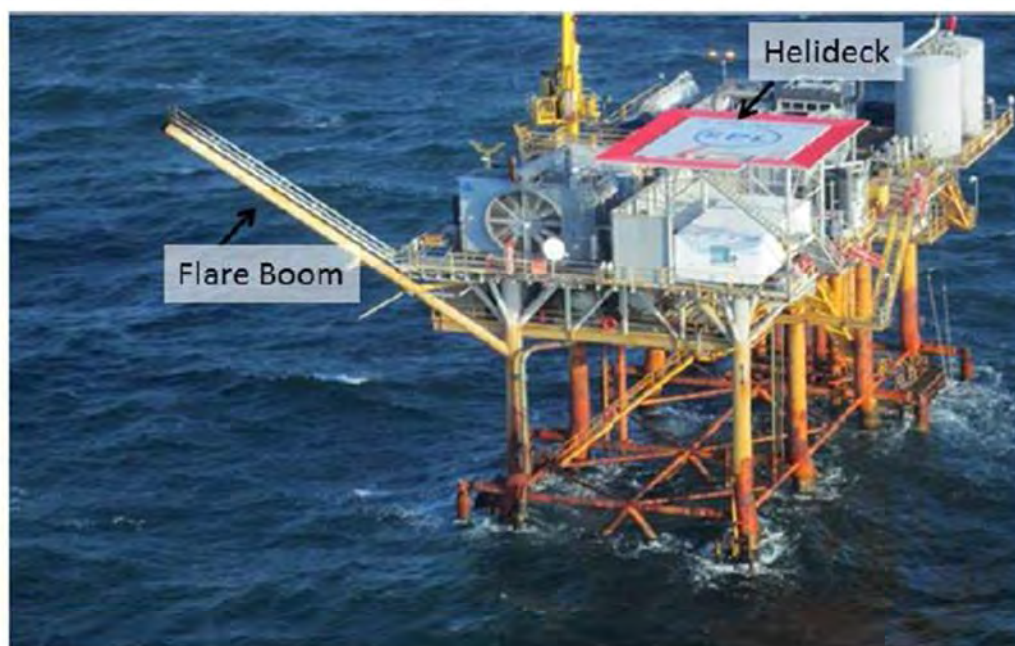
**Figure.** SS208H showing the helideck and flare boom.

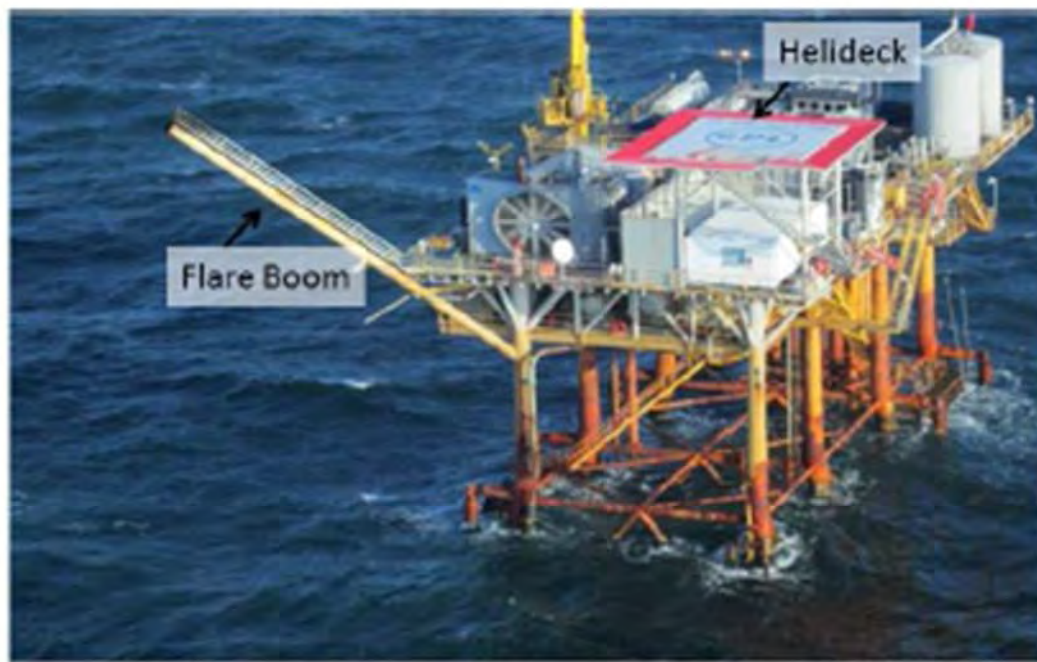
Figure. SS208H showing the helideck and flare boom.
