DET NORSKE VERITAS

Final Report
for
**UNITED STATES DEPARTMENT
OF THE INTERIOR**

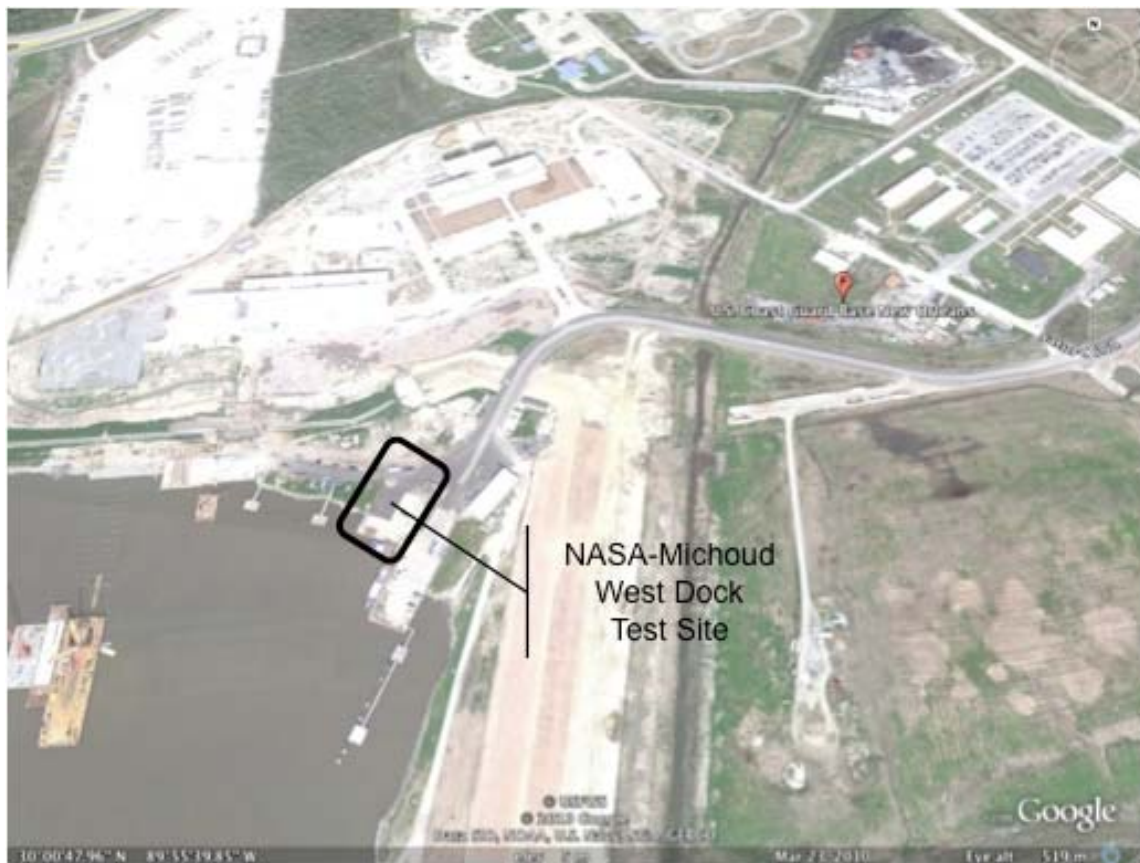
Figure 1 NASA-Michoud West Dock Test Site

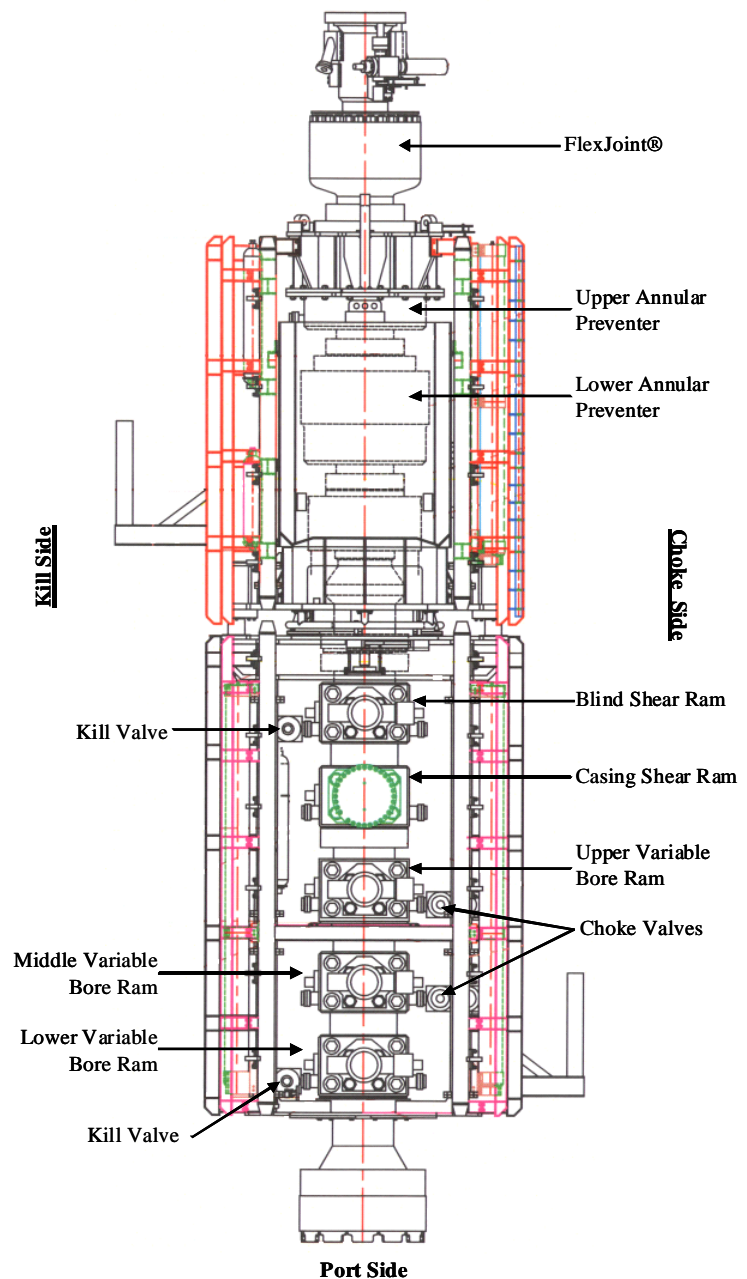
Figure 5 Deepwater Horizon BOP Port Side

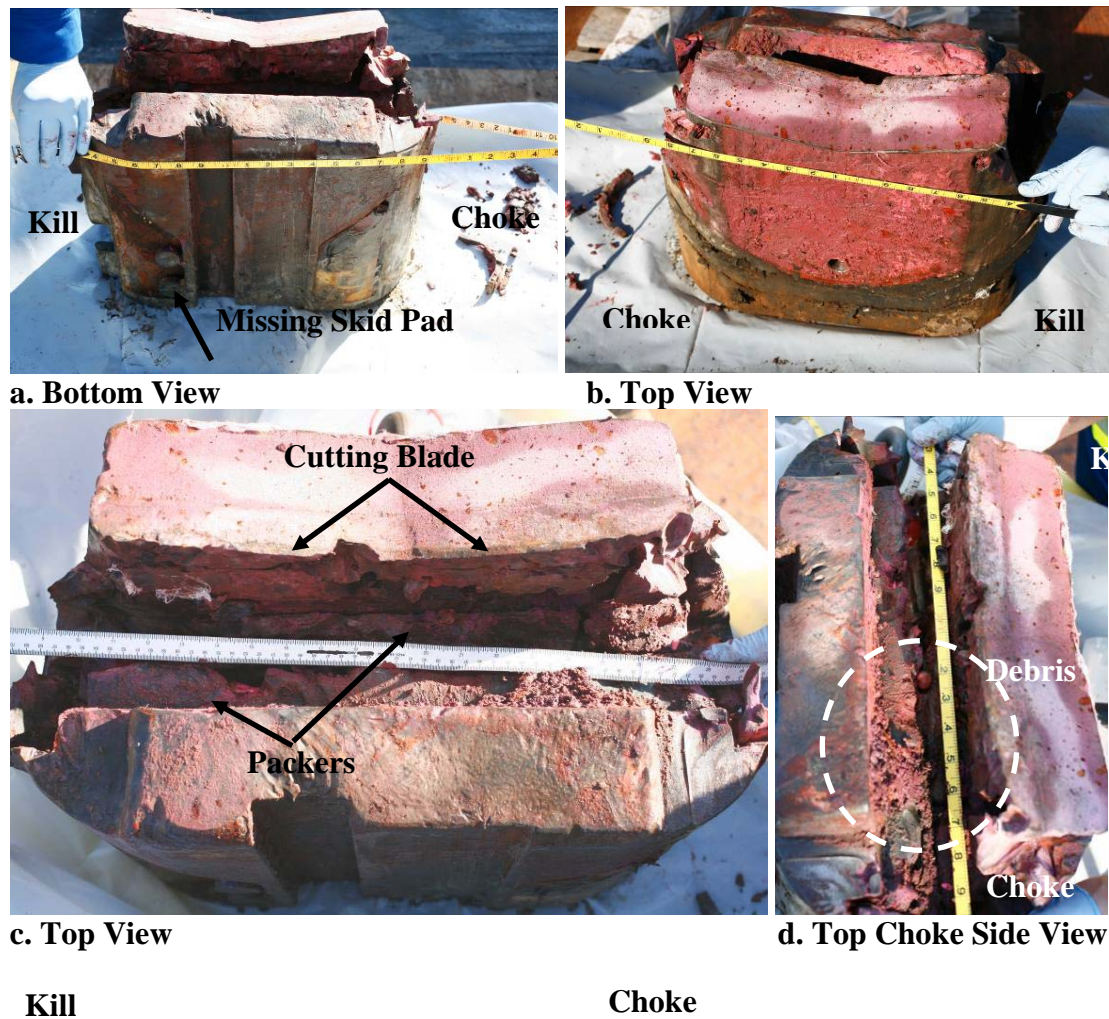
The Blind Shear Ram Blocks (BSRs) in the as-recovered condition are shown in Figure 8 and Figure 9. Figure 10 and Figure 11 show the blocks following collection of viscous materials and any solid materials/objects and cleaning.

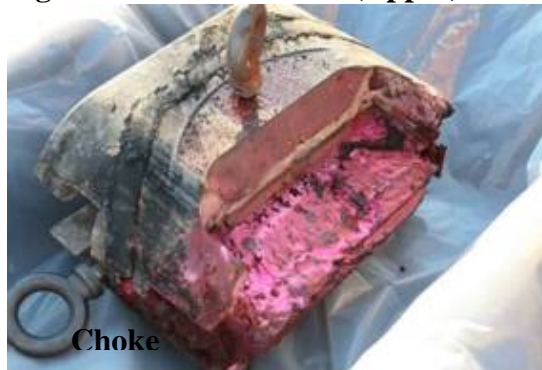
a. Top View - Choke Side

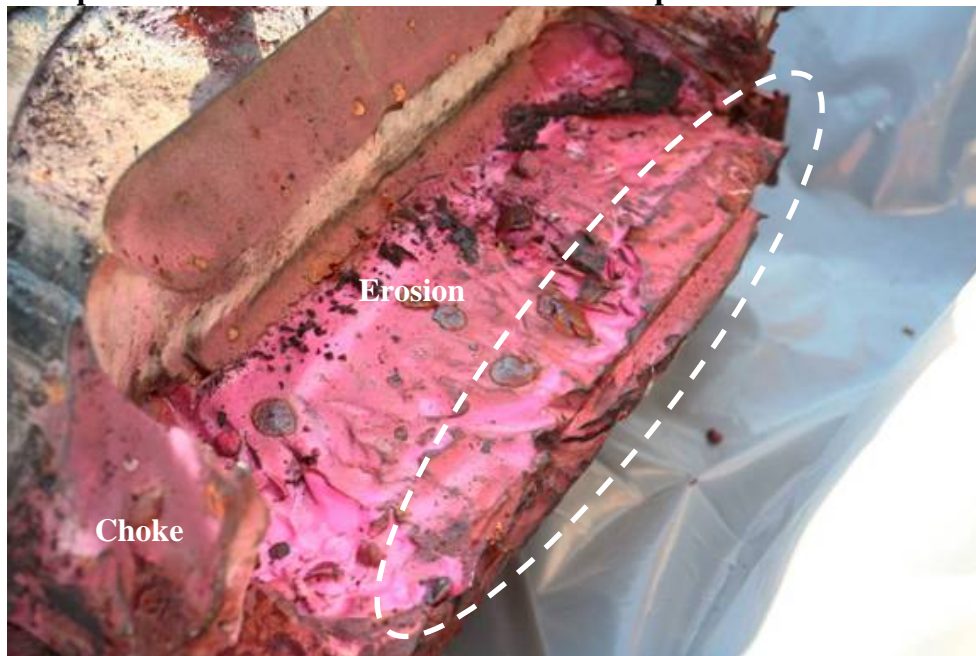
c. Detail of Cutting Blade

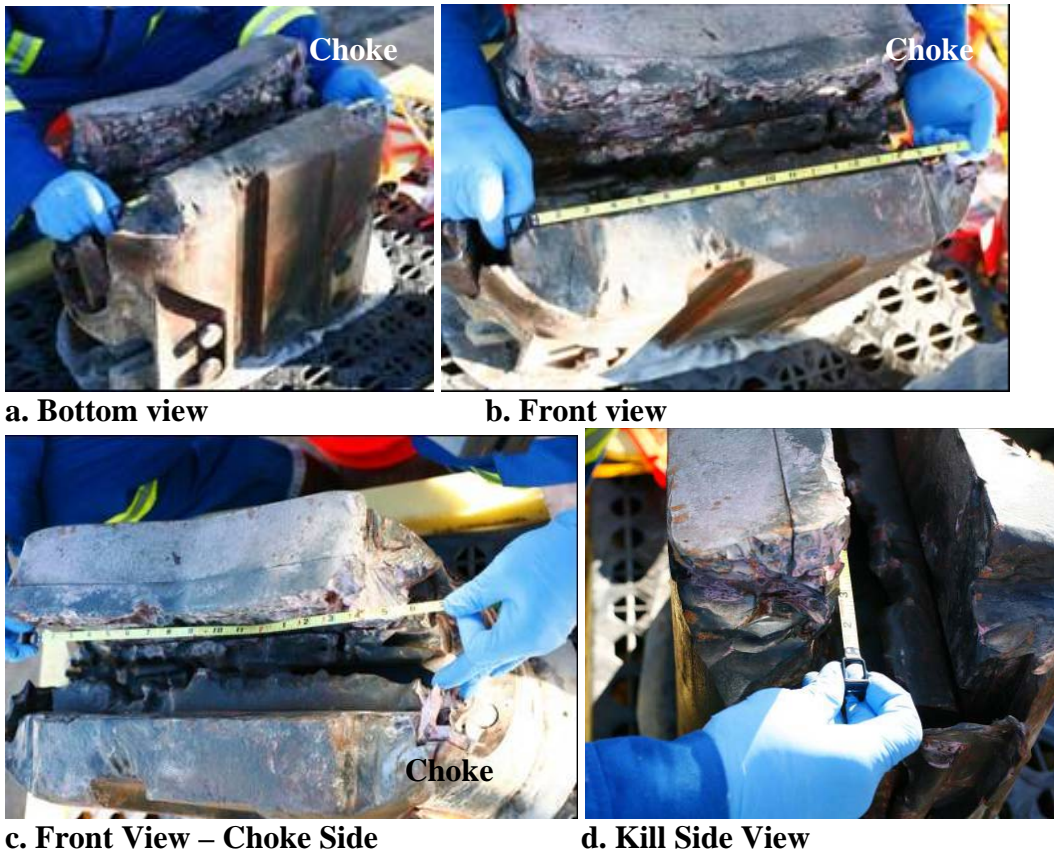
Figure 10 Starboard Side (Upper) BSR Following Cleaning

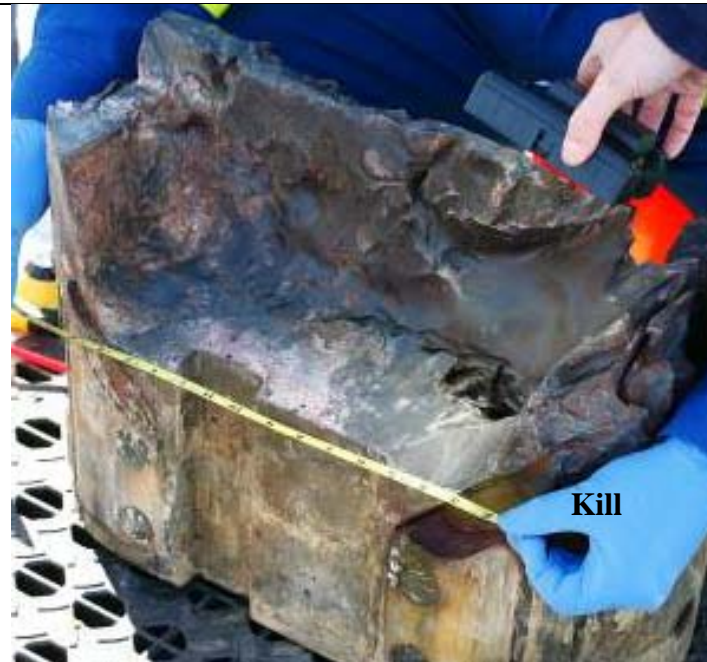
**b. Bottom View****Figure 11 Port Side (Lower) BSR Following Cleaning**

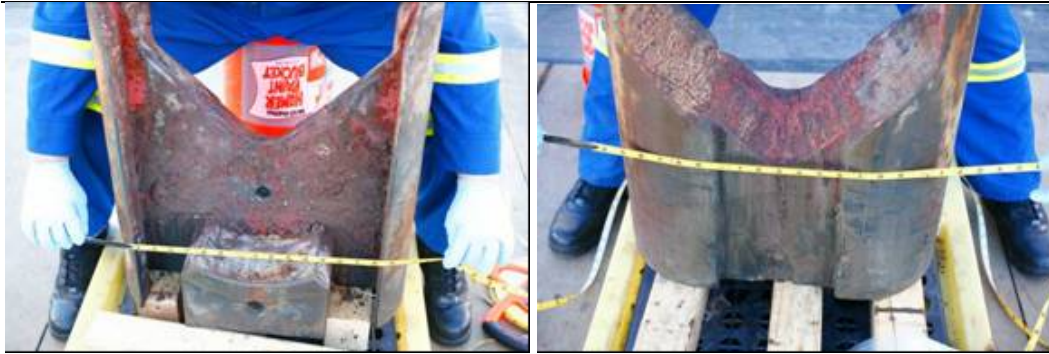
The Casing Shear Ram Blocks (CSRs) in the as-recovered condition are shown in Figure 12 and Figure 13. Figure 14 and Figure 15 show the CSRs following collection of viscous and any solid materials/objects and cleaning.

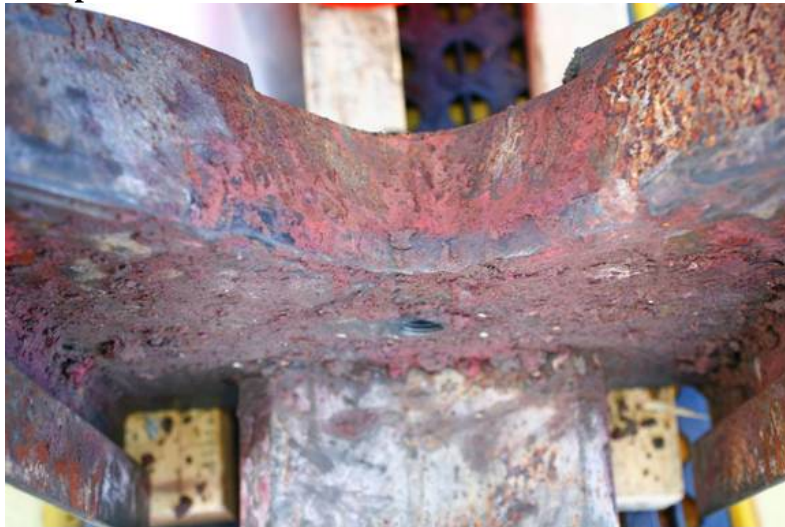
c. Front View - Cutting Blade

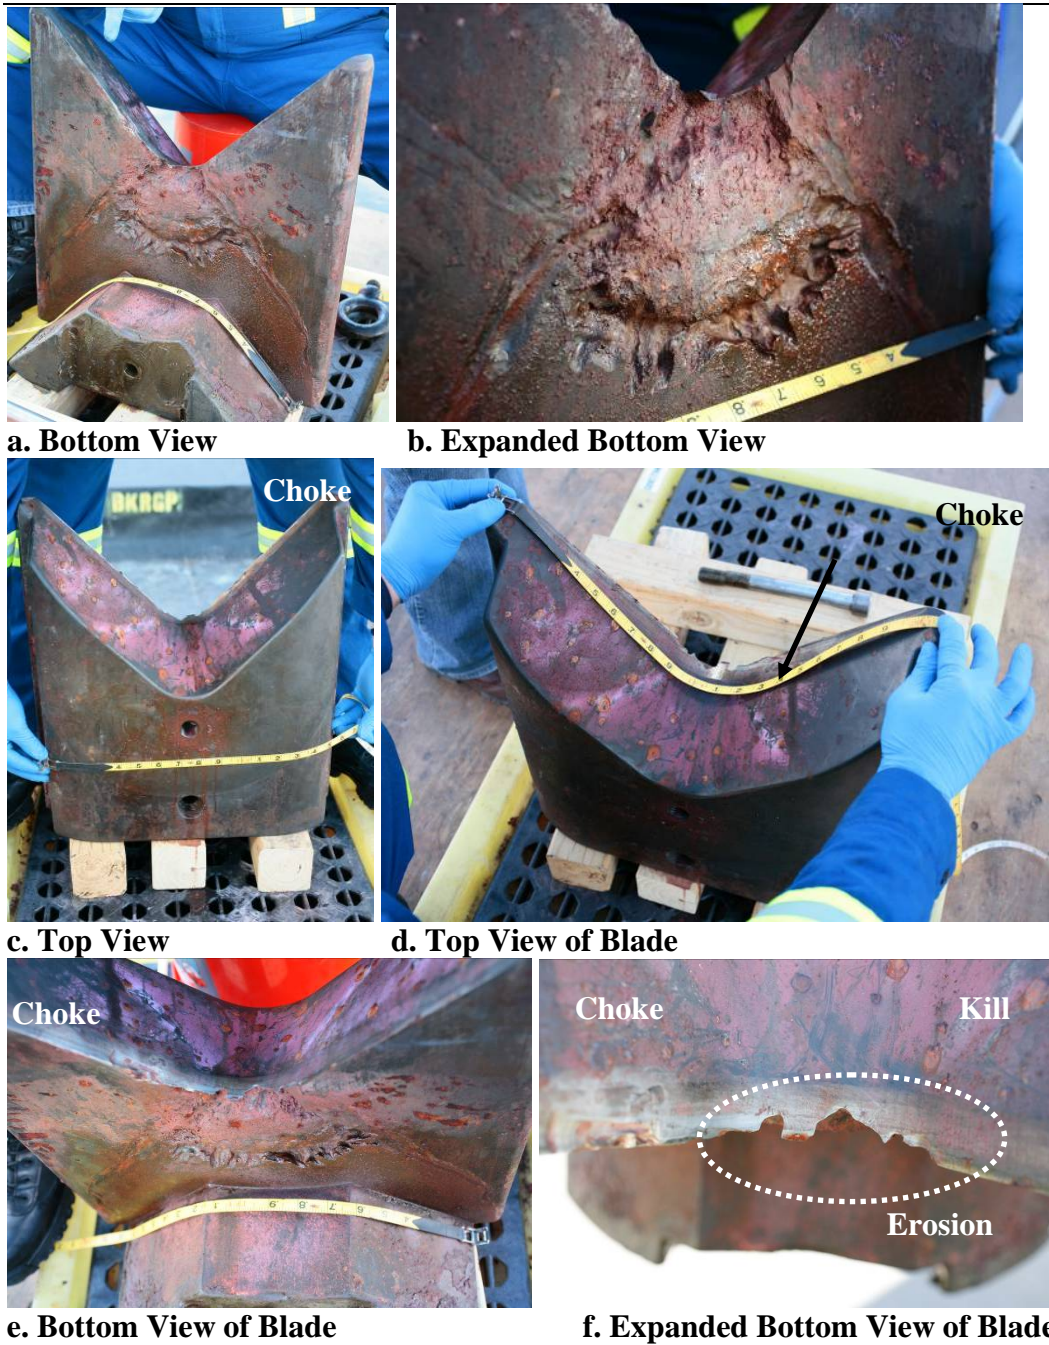
Figure 13 Port Side (Upper) CSR As-Recovered Condition

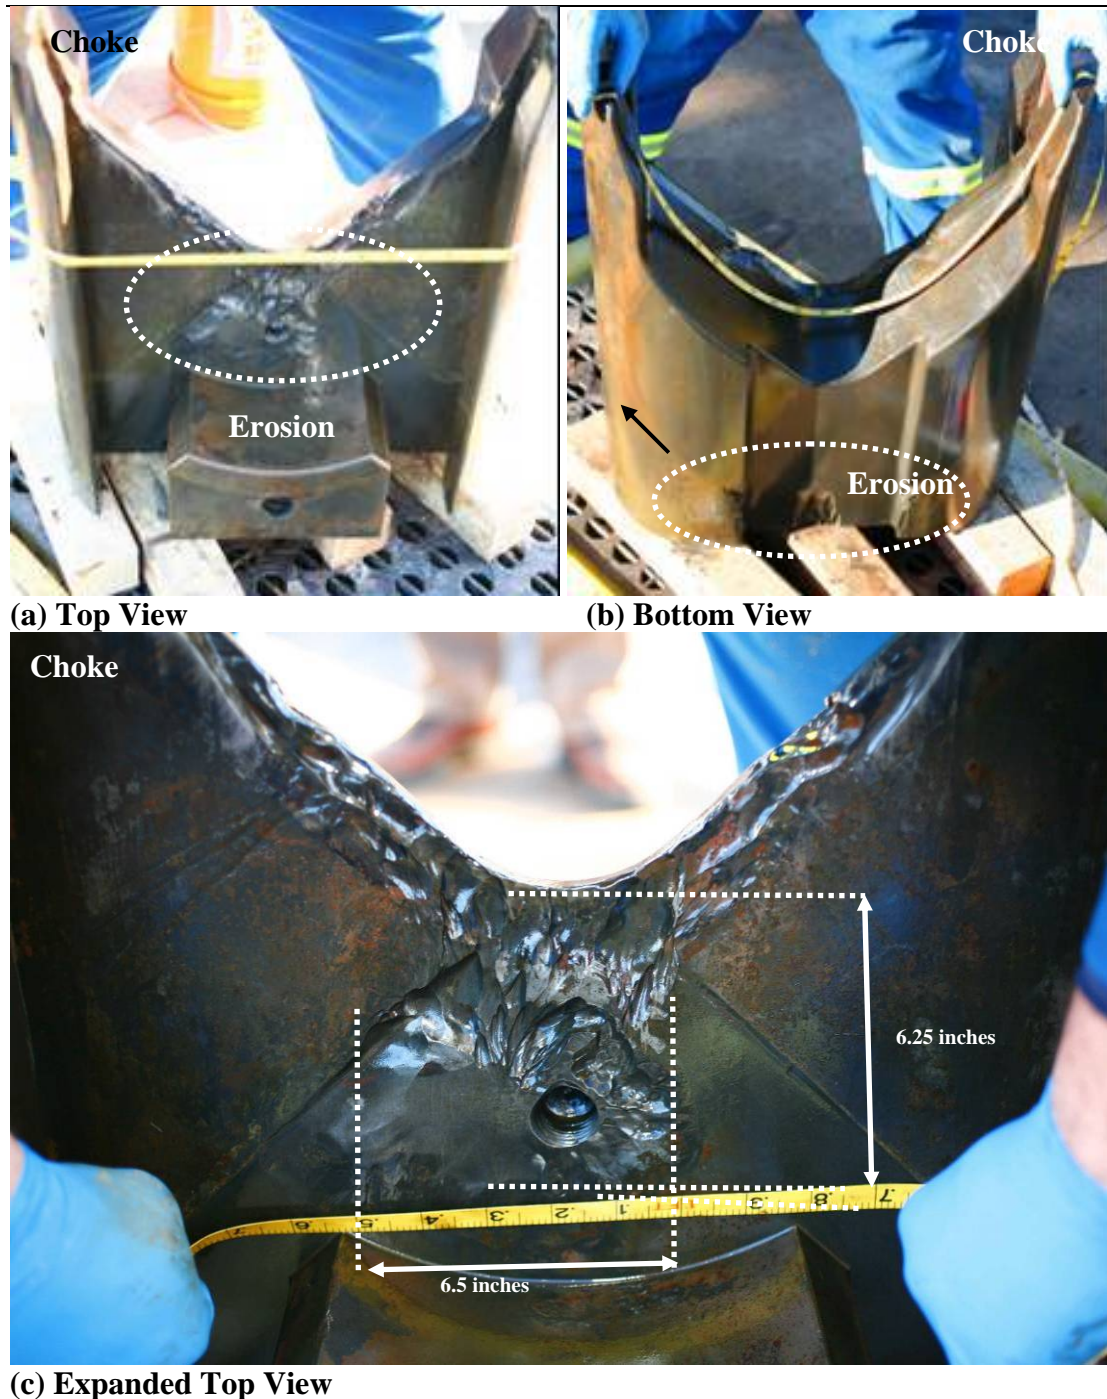
Figure 14 Starboard Side (Lower) CSR Following Cleaning

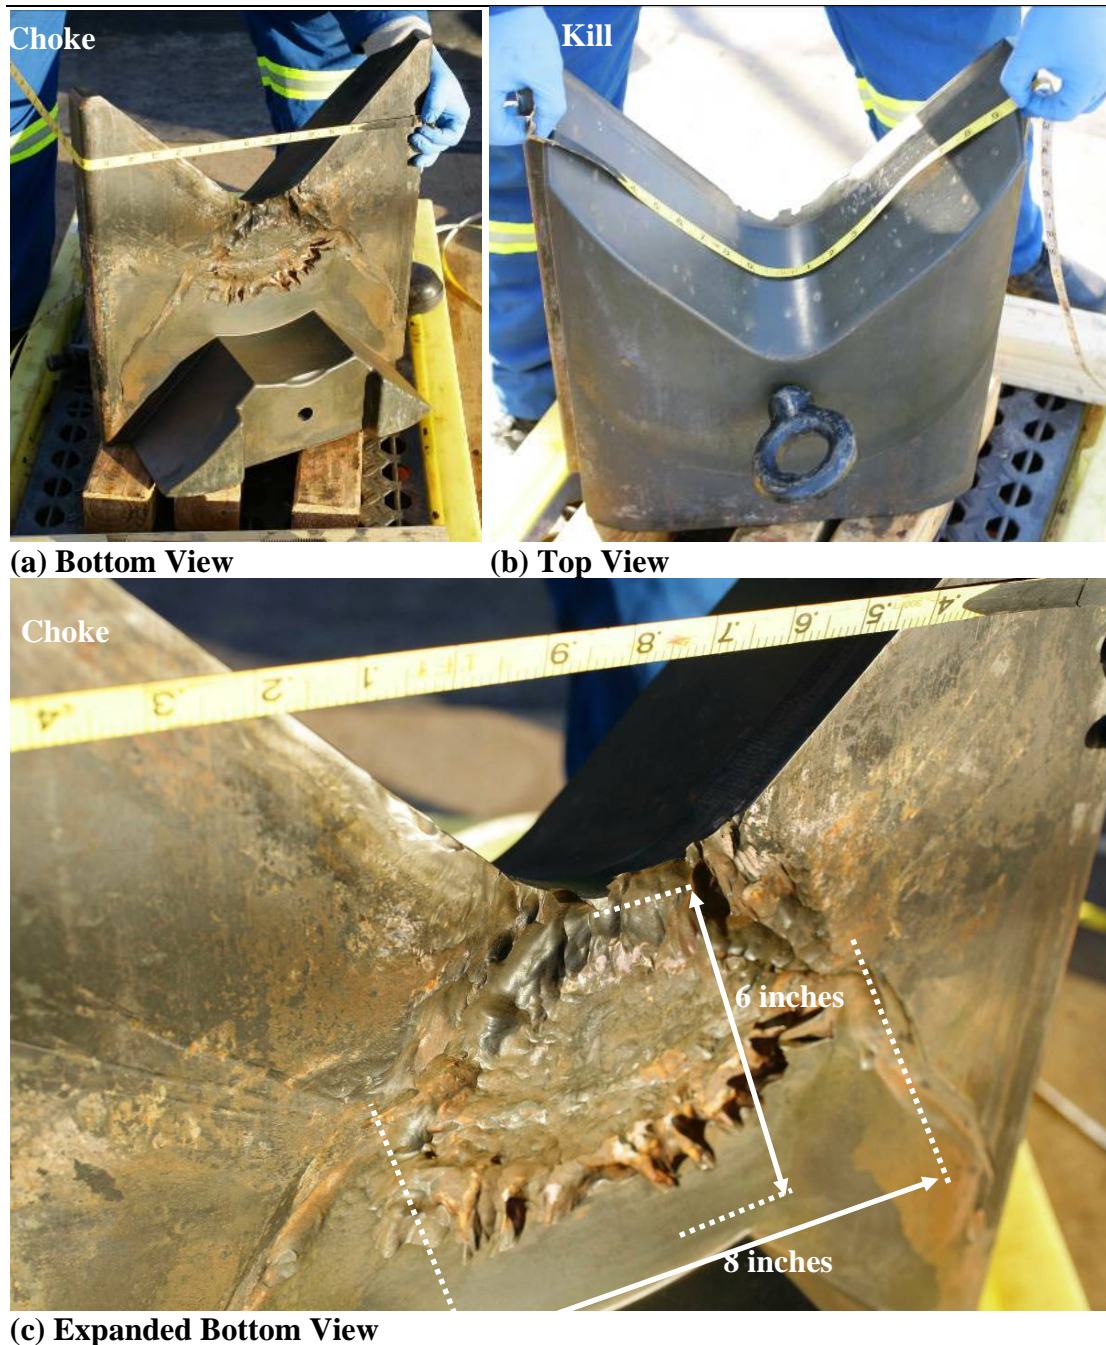
Figure 15 Port Side (Upper) CSR Following Cleaning

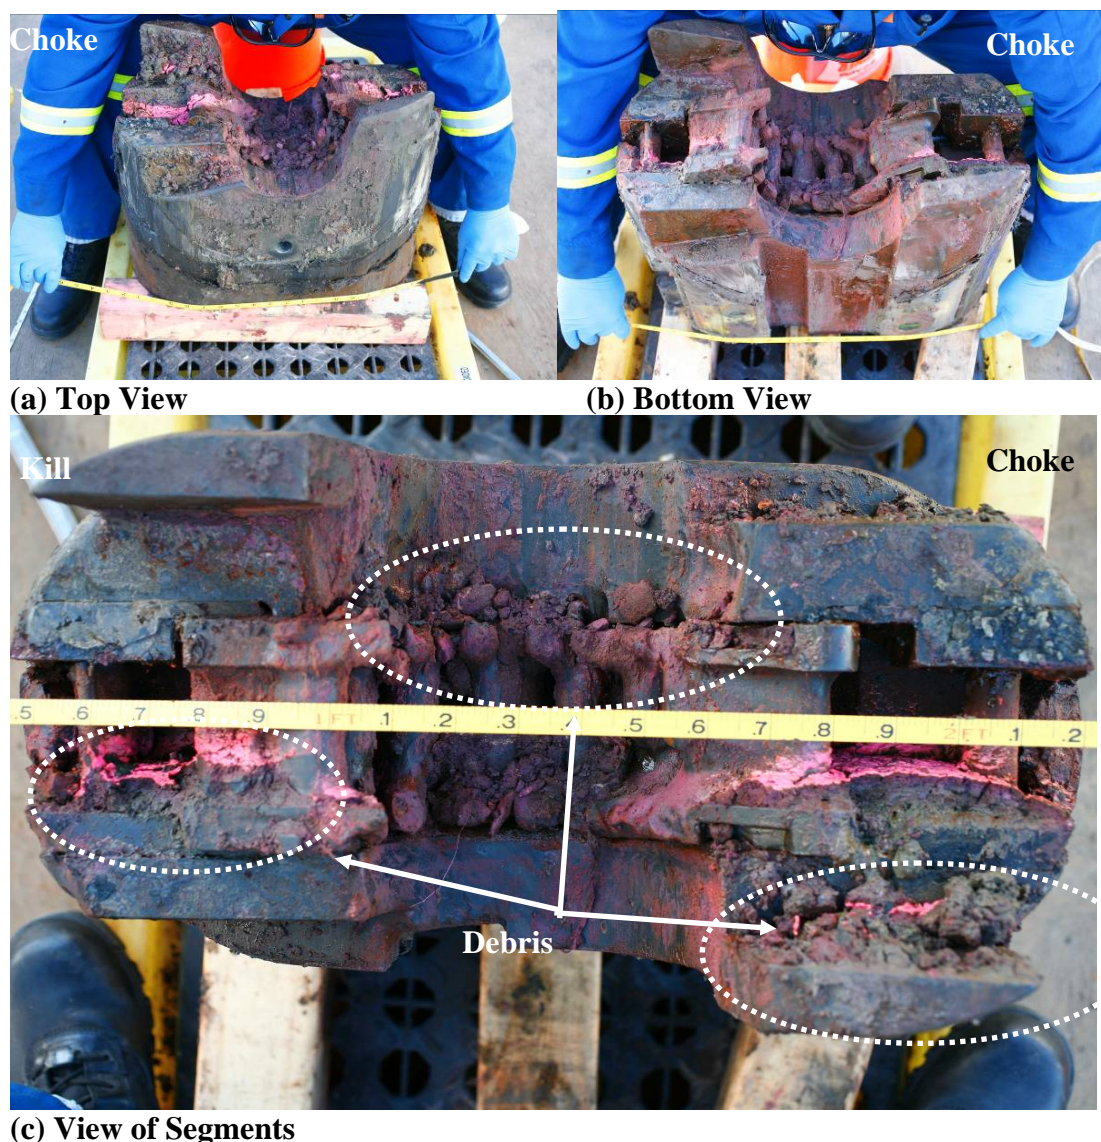
Figure 16 Starboard Side Upper VBR in the As-Recovered Condition

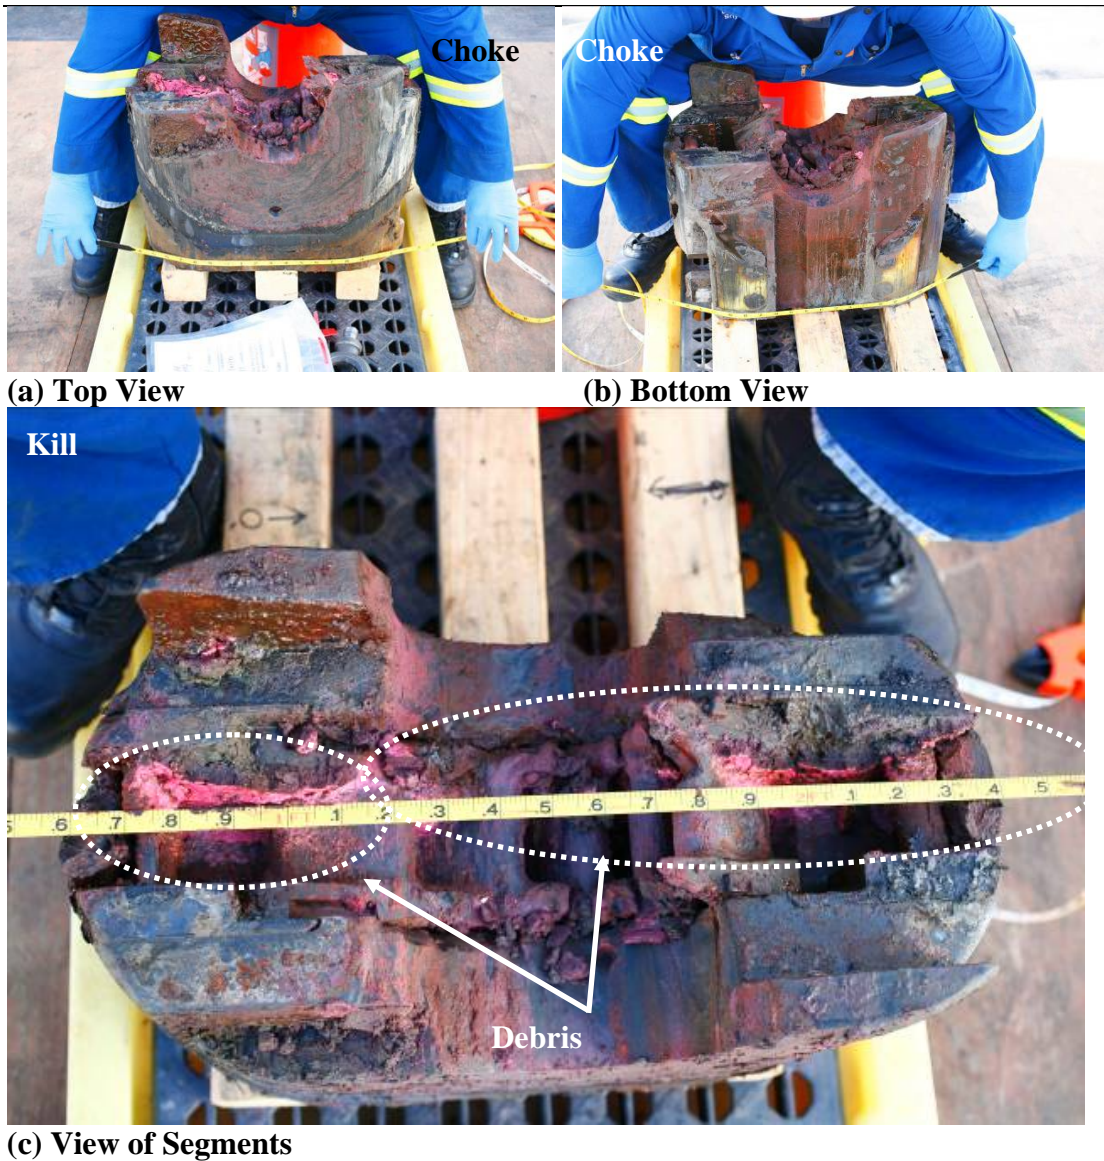
Figure 17 Port Side Upper VBR in the As Recovered Condition

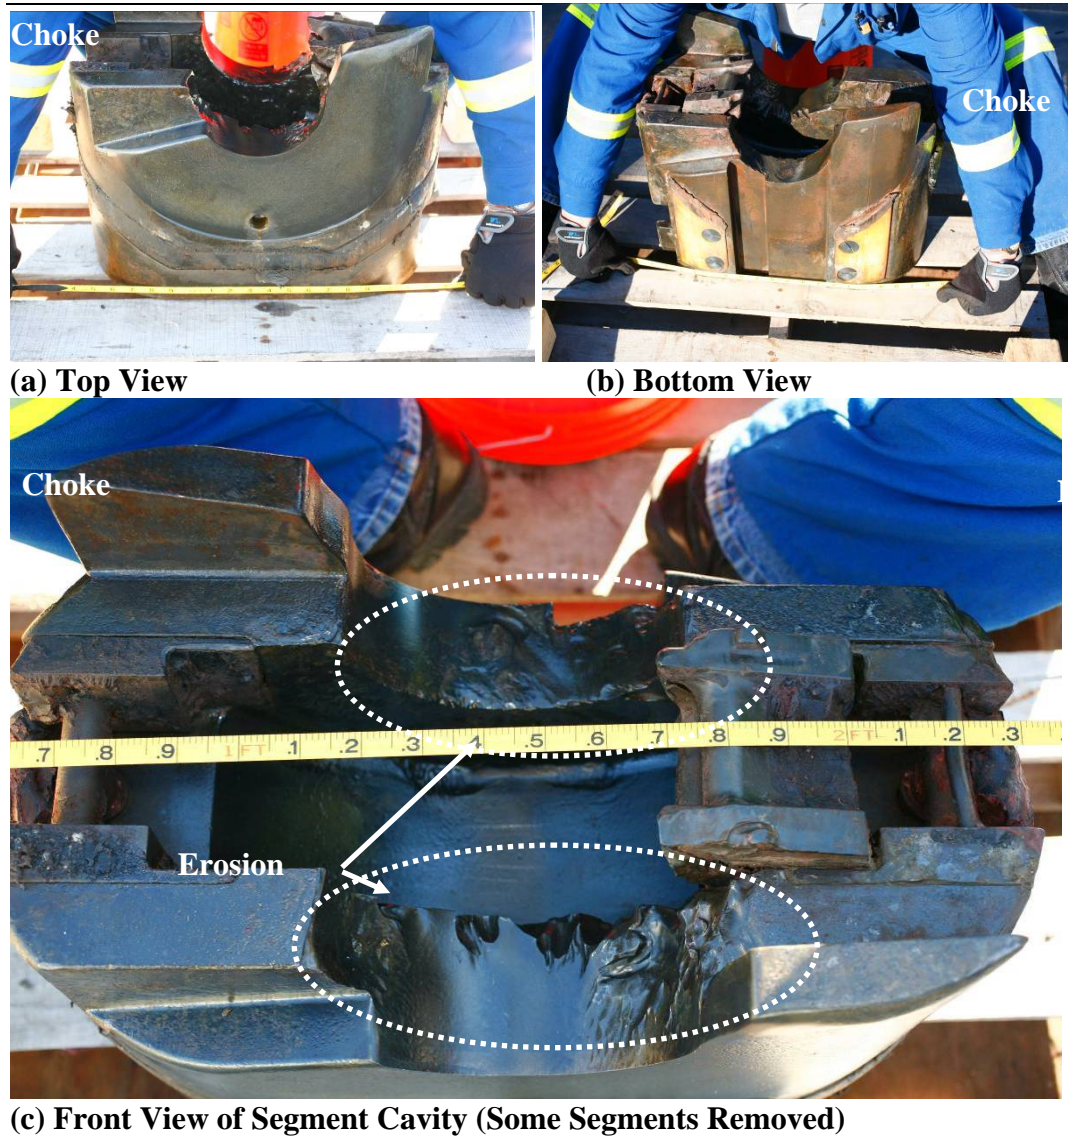
Figure 18 Starboard Side Upper VBR Following Cleaning (Segments Removed)

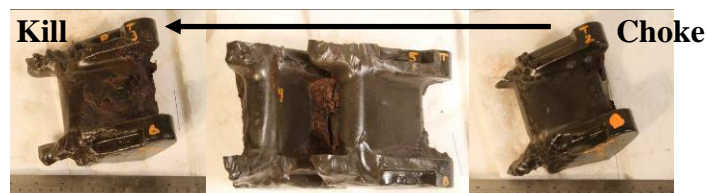
Figure 21 Port Segments from Upper VBRs Following Cleaning. (Segment 1 Remained in Ram)

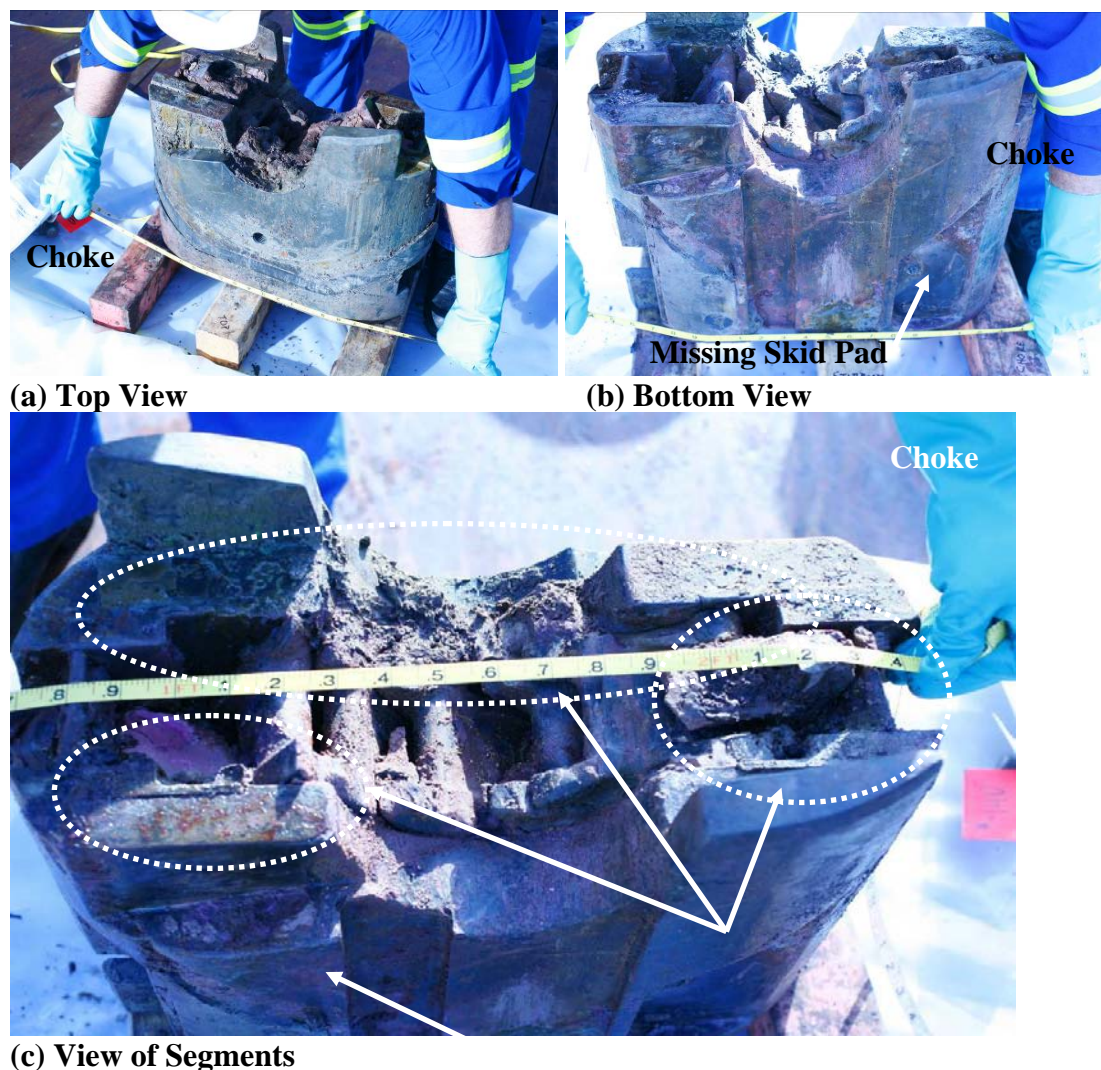
Figure 22 Starboard Side Middle VBR As-Recovered Condition

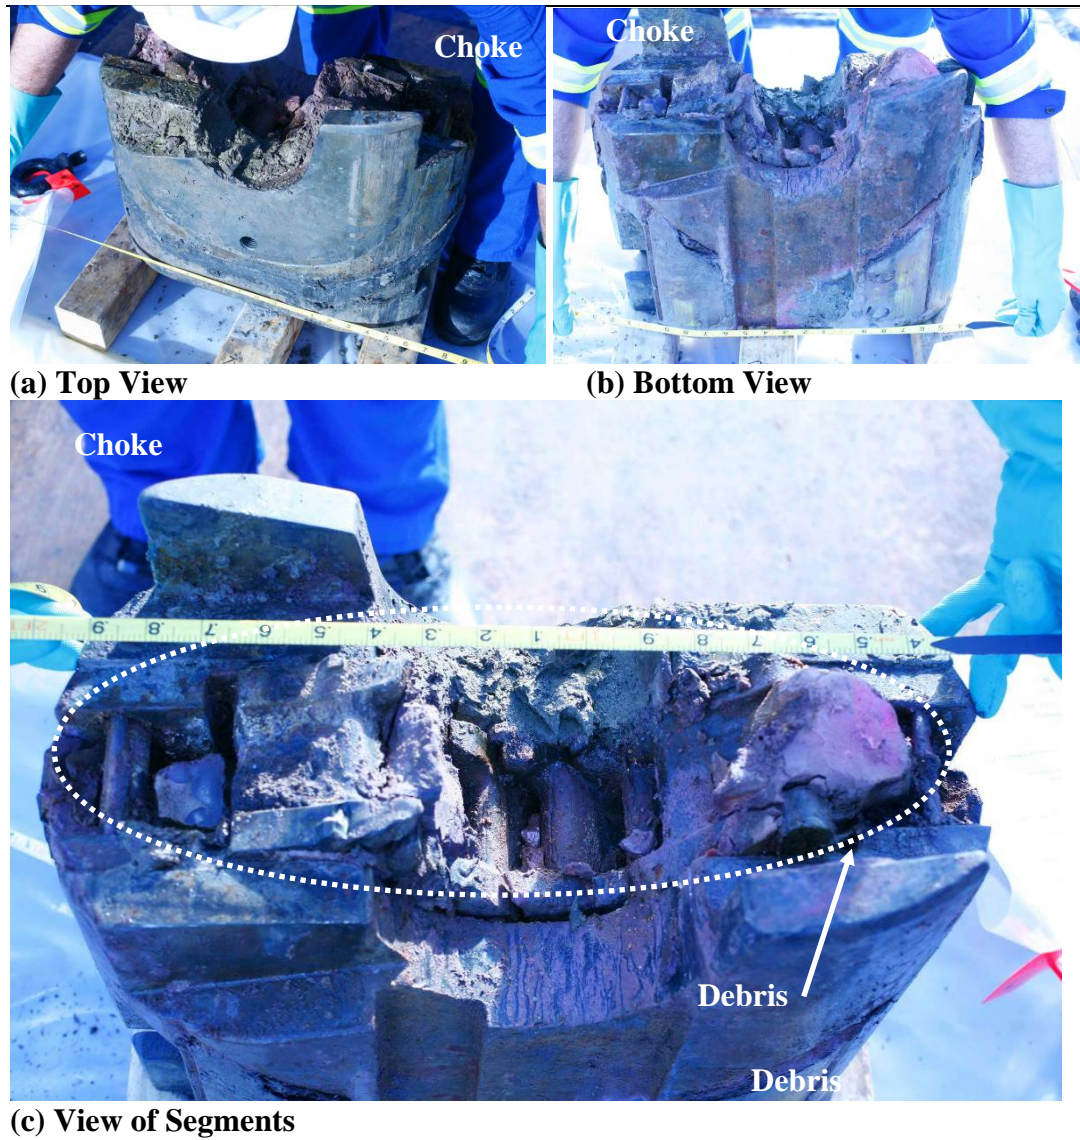
Figure 23 Port Side Middle VBR As-Recovered Condition

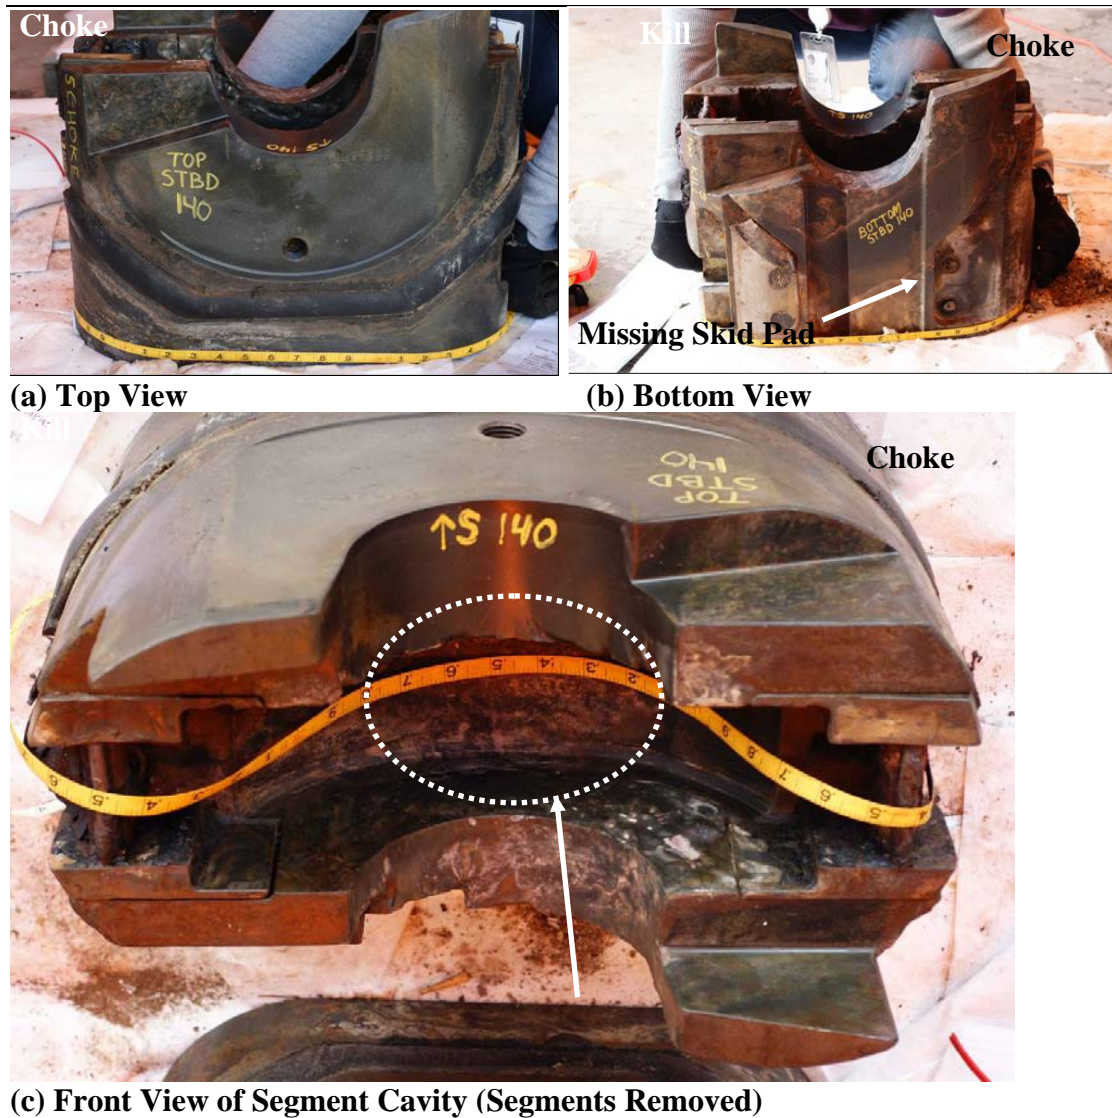
Figure 24 Starboard Side Middle VBR Following Cleaning

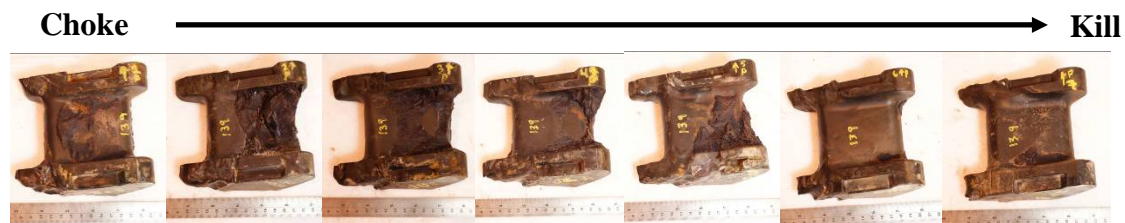
Figure 27 Port Segments from the Upper VBRs Following Cleaning

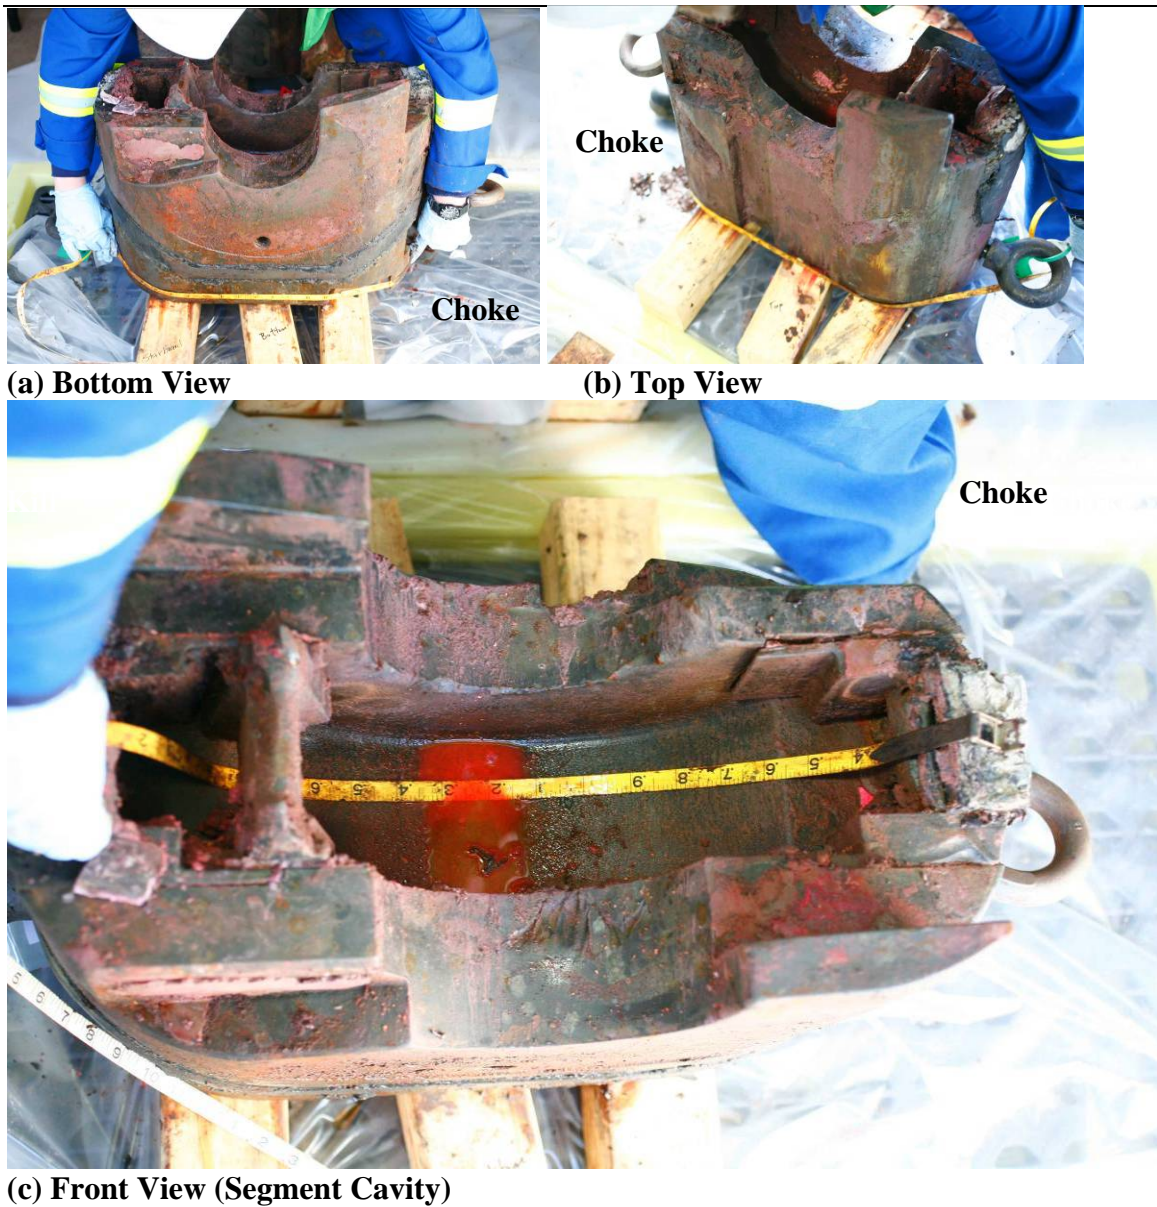
Figure 28 Starboard Side Lower VBR in the As-Recovered Condition

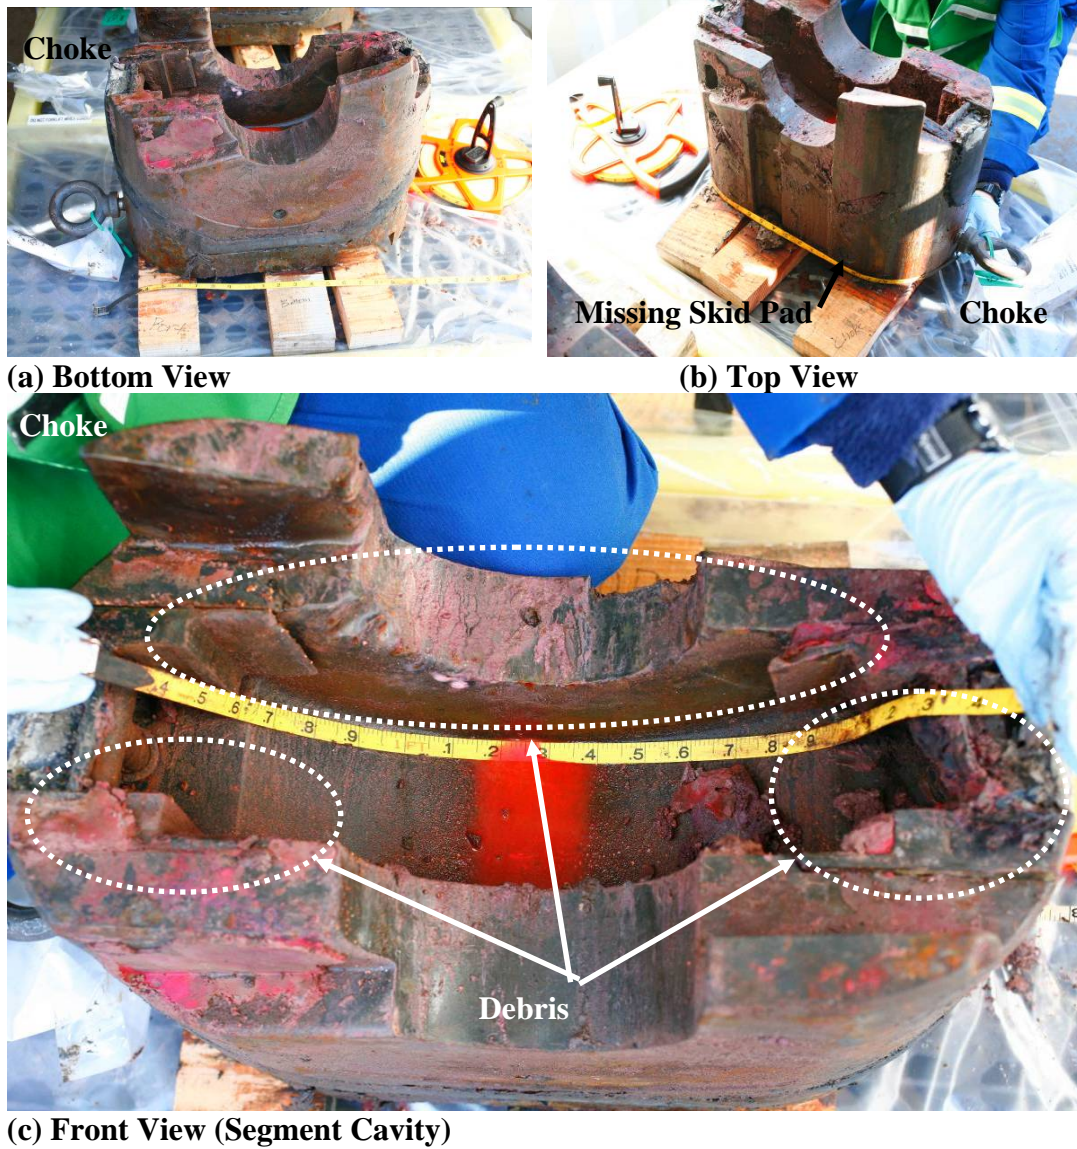
Figure 29 Port Side Lower VBR in the As-Recovered Condition

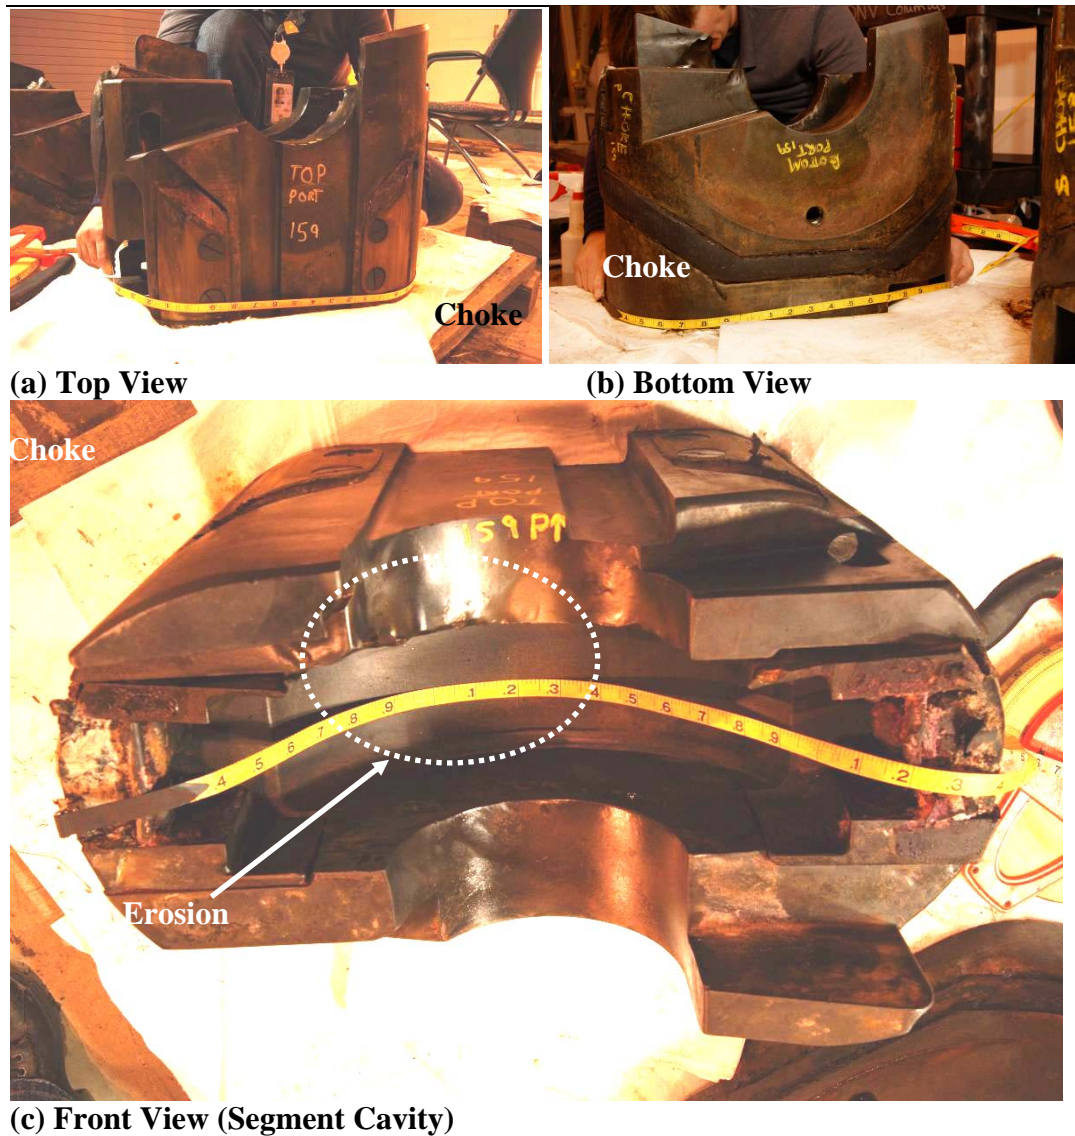
Figure 32 Port Side Lower VBR Following Cleaning

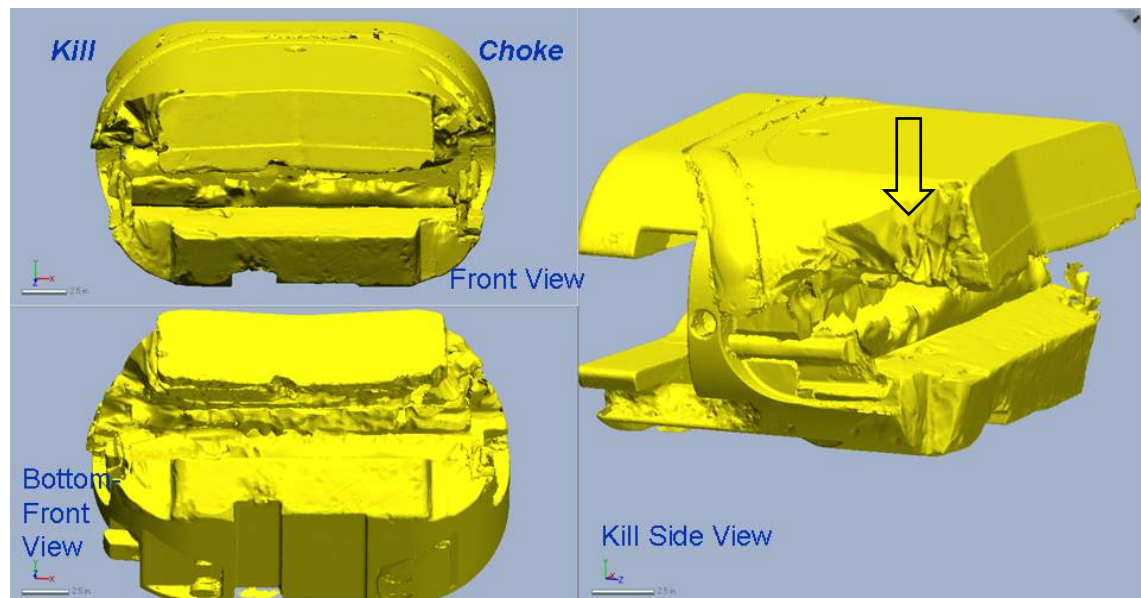
(a) Laser Scans of Upper BSR Block
