DET NORSKE VERITAS

Final Report
for
**UNITED STATES DEPARTMENT
OF THE INTERIOR**

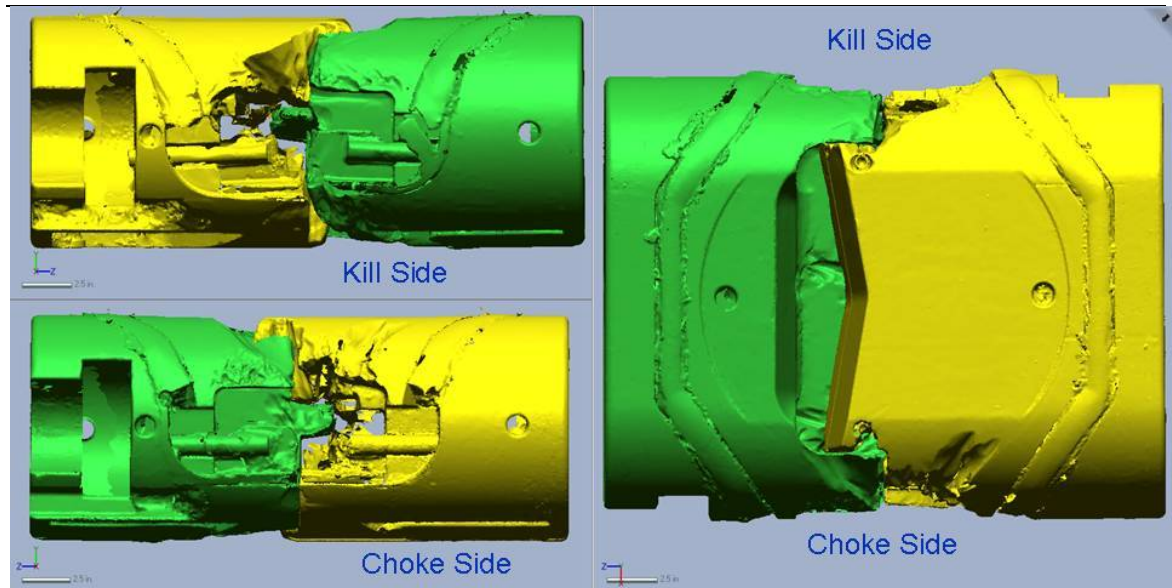
Figure 35 shows the upper and lower BSR blocks in the fully closed position. Based on the visual examination performed on site following recovery, the upper and lower BSR blocks exhibited metal-to-metal contact in multiple locations. As previously noted, the elastomer on the side packers and rear seals was missing allowing the metal-to-metal contact observed.

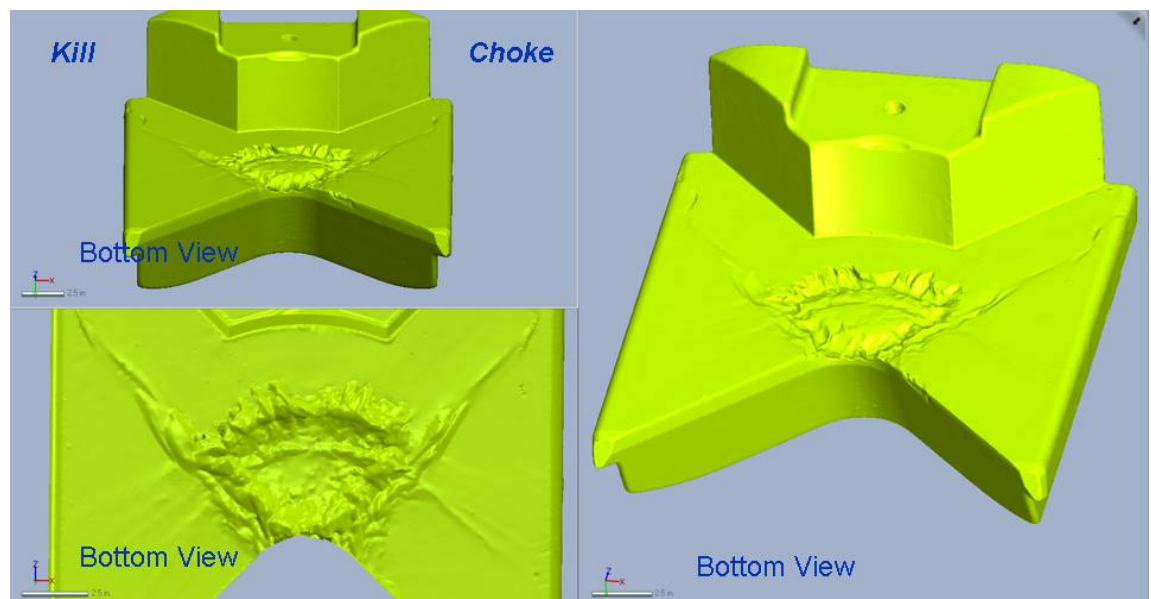
Figure 37 Three-Dimensional Laser Scan of Port-Side (Upper) CSR

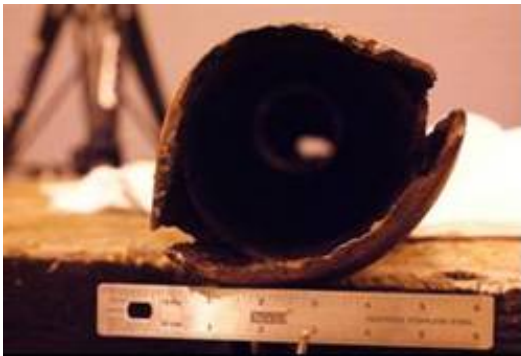
Figure 40 to Figure 54 show the individual drill pipe segments removed from the BOP, LMRP, and Riser. Figure 39 and Figure 40 show drill pipe segment 148 that was recovered from between the CSR and the Lower VBR. The top end exhibited a sheared surface representative of a CSR cut. The bottom end had significant erosion. The erosion is the most likely explanation for the separation of this segment from the rest of the drill pipe downhole. Significant erosion was also observed at areas where the segments of the Upper and Middle VBRs contact the drill pipe.

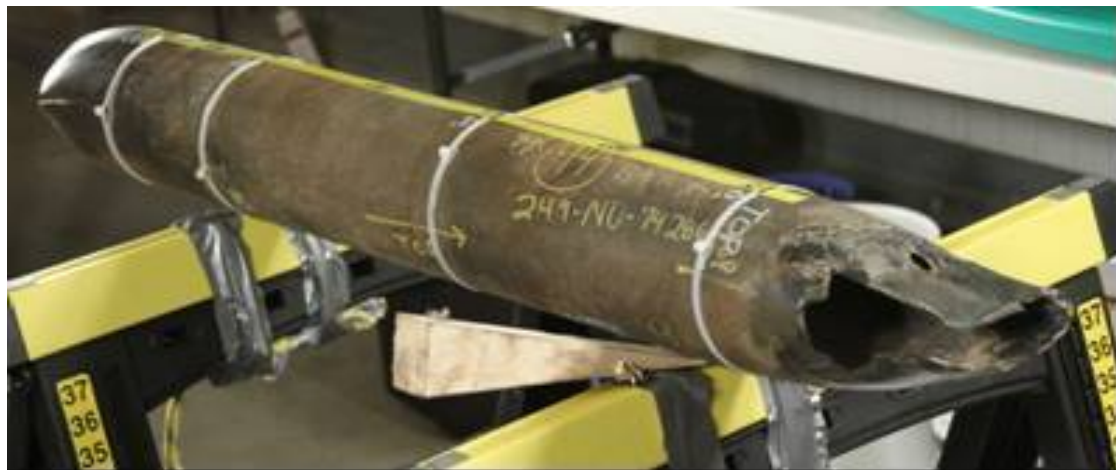
(a) Drill Pipe Segment 94

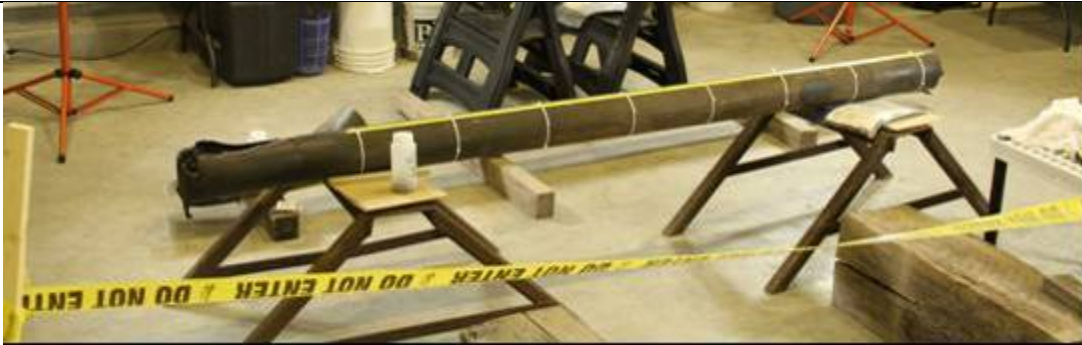
(a) Drill Pipe Segment 83

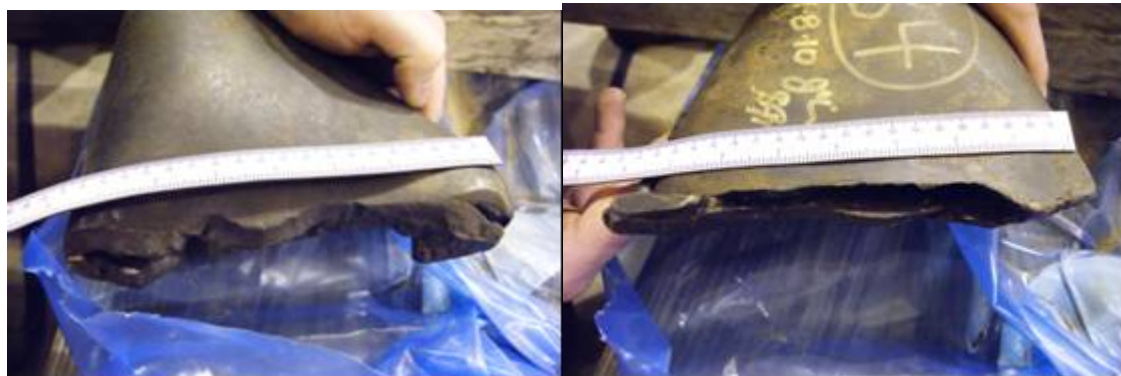
Figure 45 and Figure 46 show drill pipe segment 84 that was recovered from the top of the Upper Annular. Drill Pipe 84 had a saw cut on the bottom end (approximately 80% of circumference with the remaining exhibiting a fractured surface) and a shear cut on the top end.

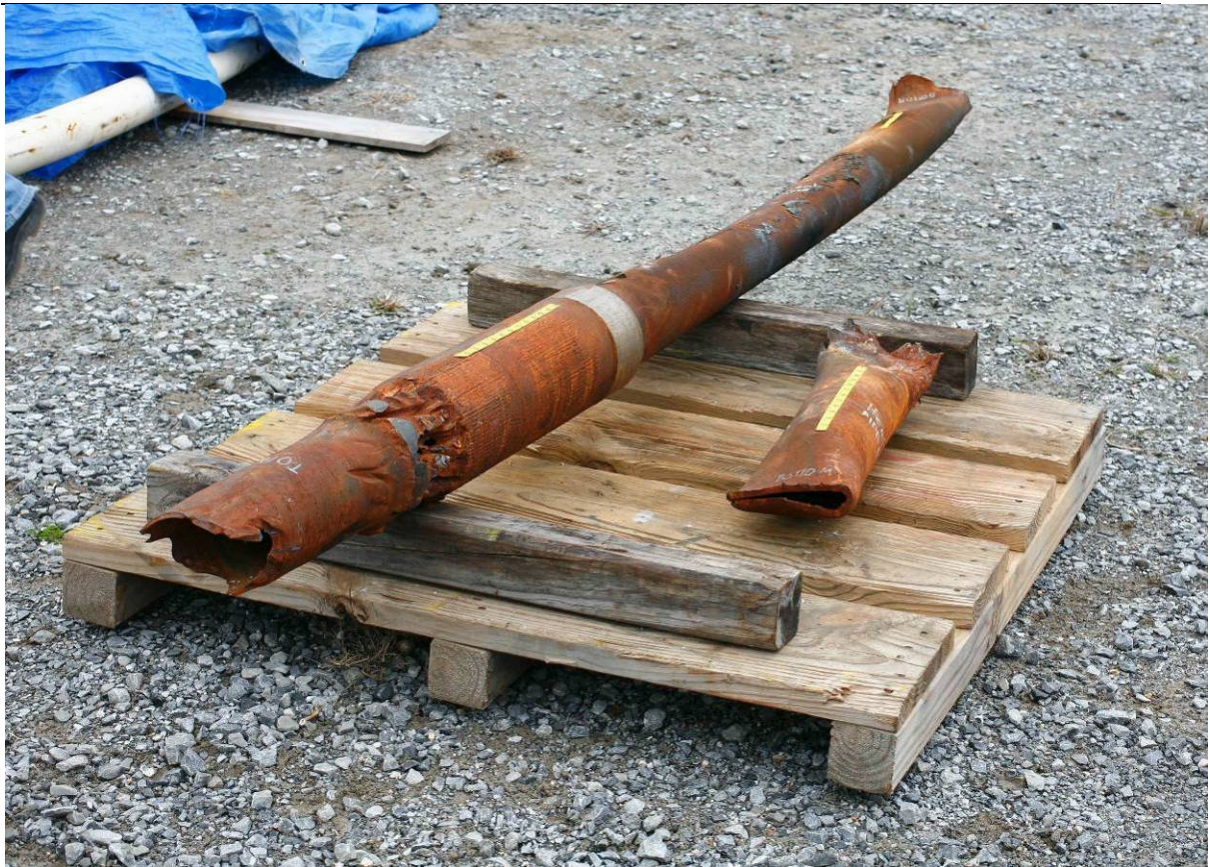
(a) Drill Pipe Segments 1-B-1 and 1-B-2

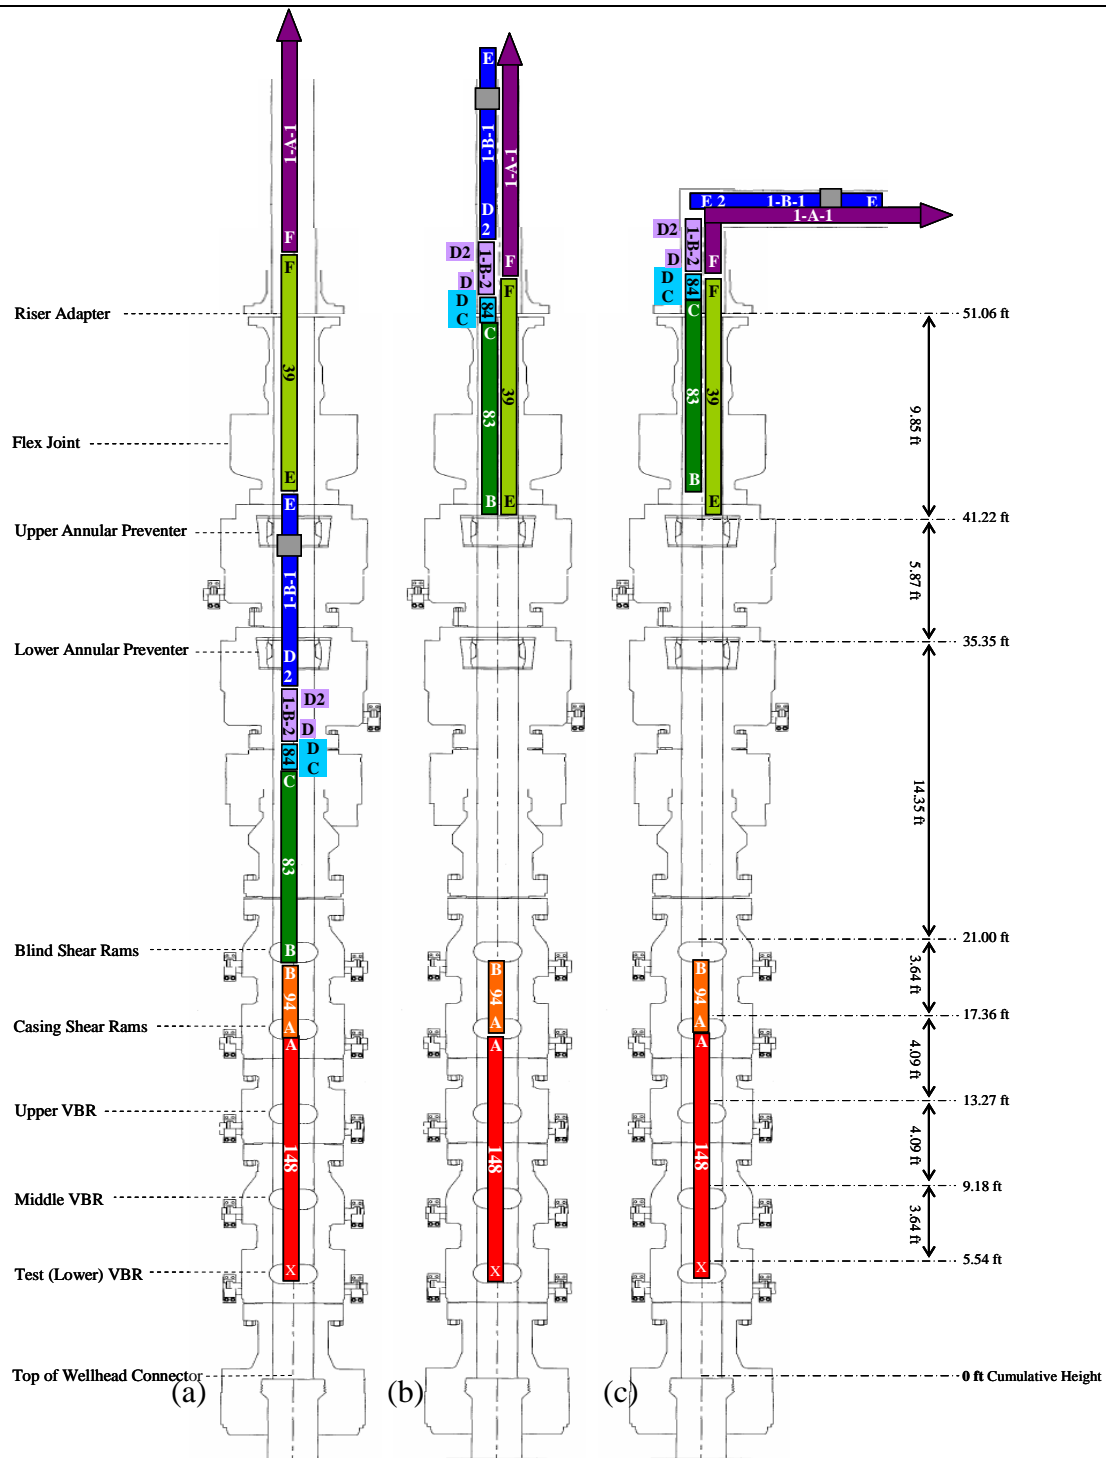
Figure 55 Schematic Diagram of Sequence of Drill Pipe Segment Movement

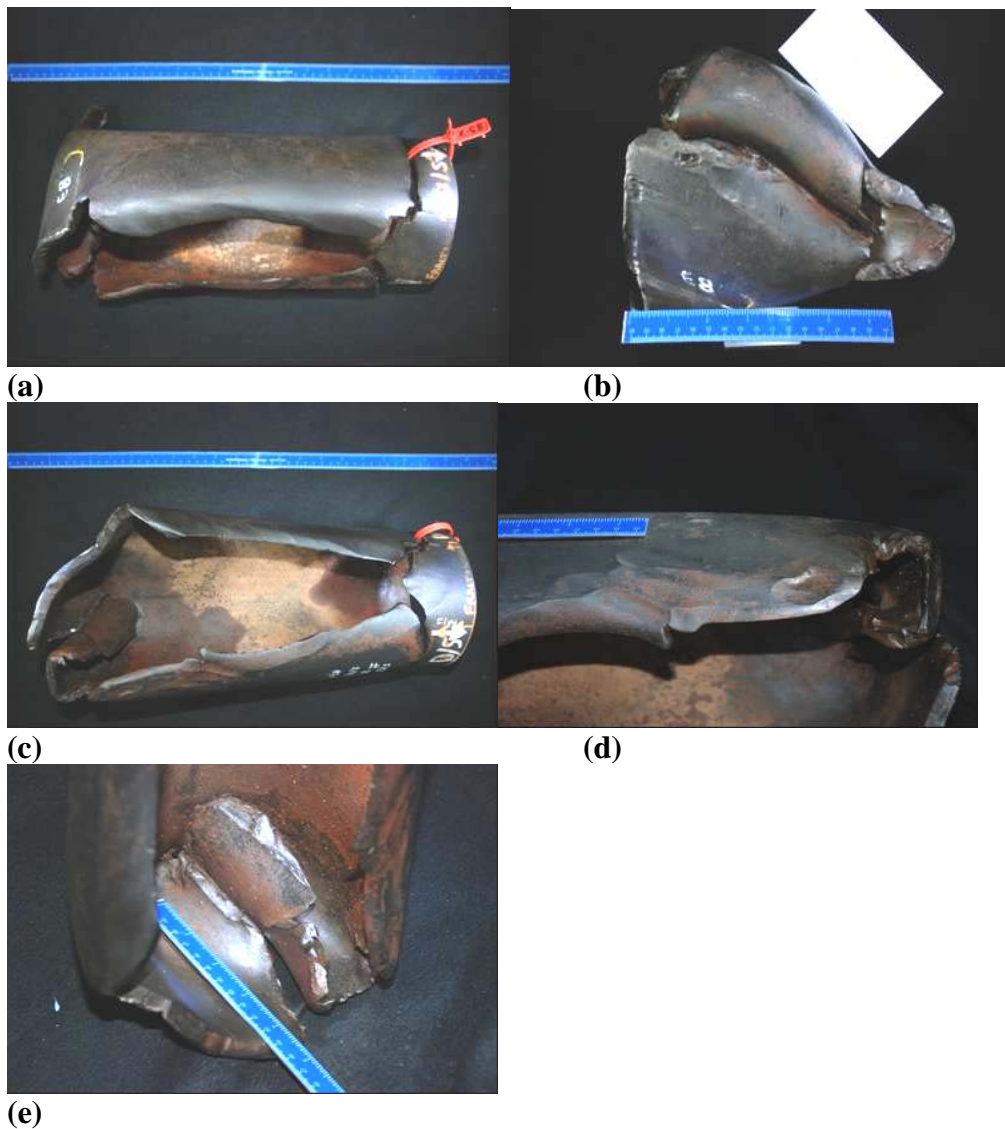
Figure 58 Photographs of 83-B

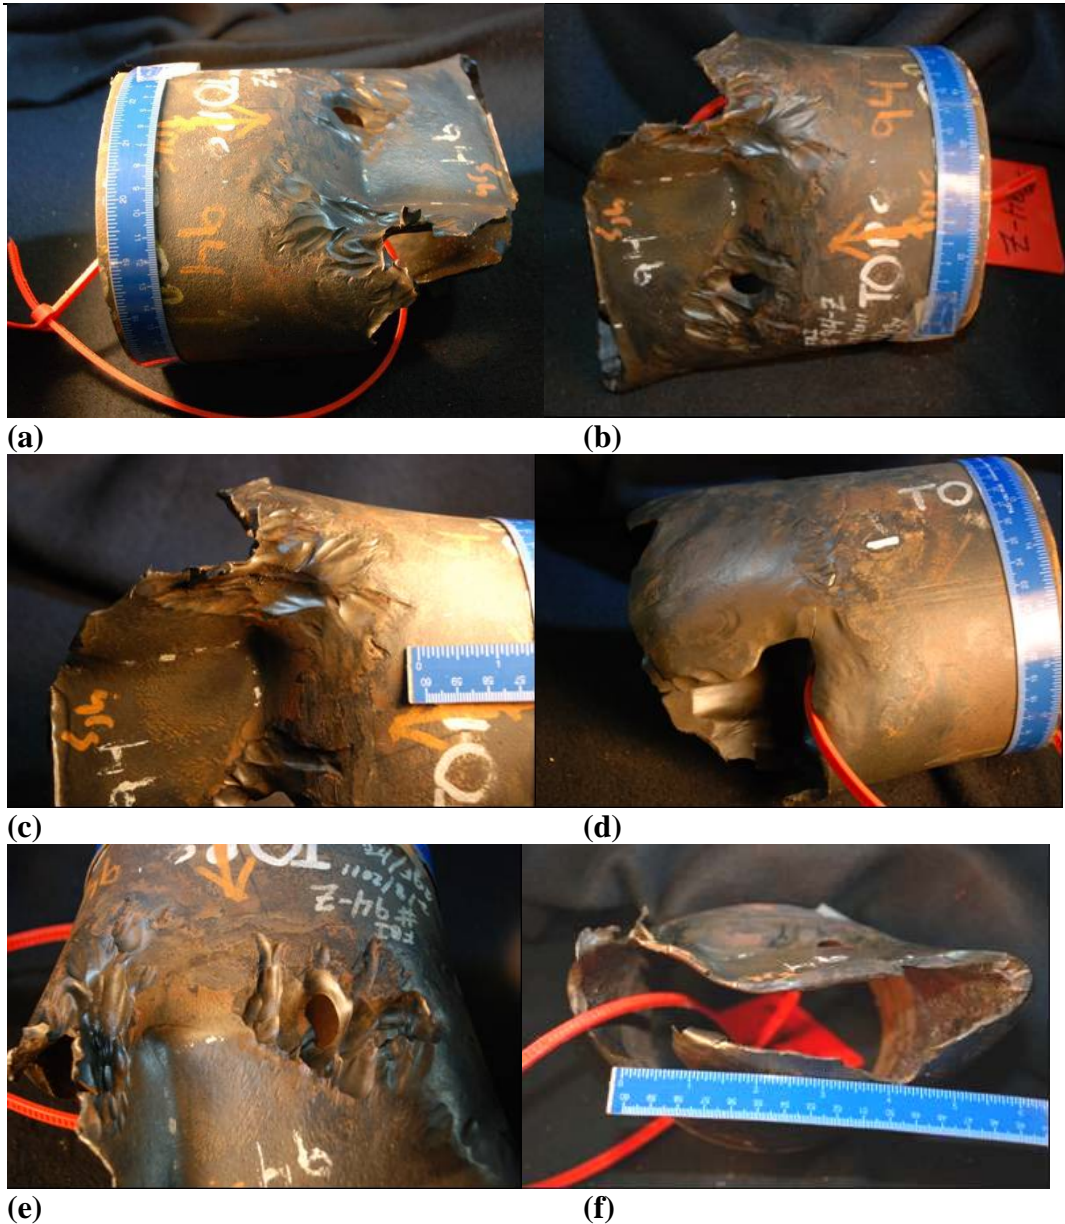
Figure 59 Photographs of 94-B

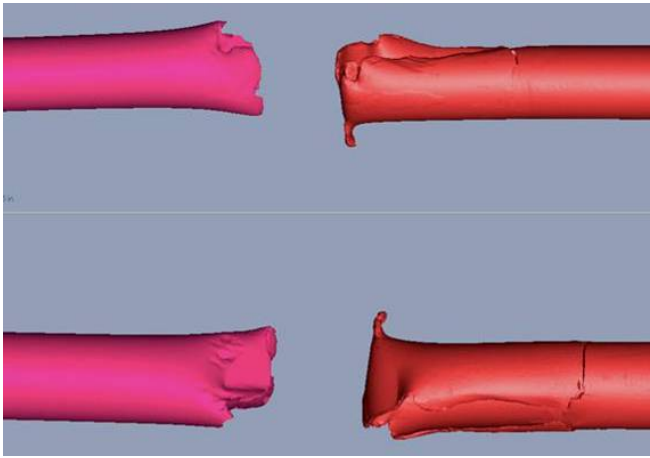
Figure 60 Laser Scans of 94-B and 83-B

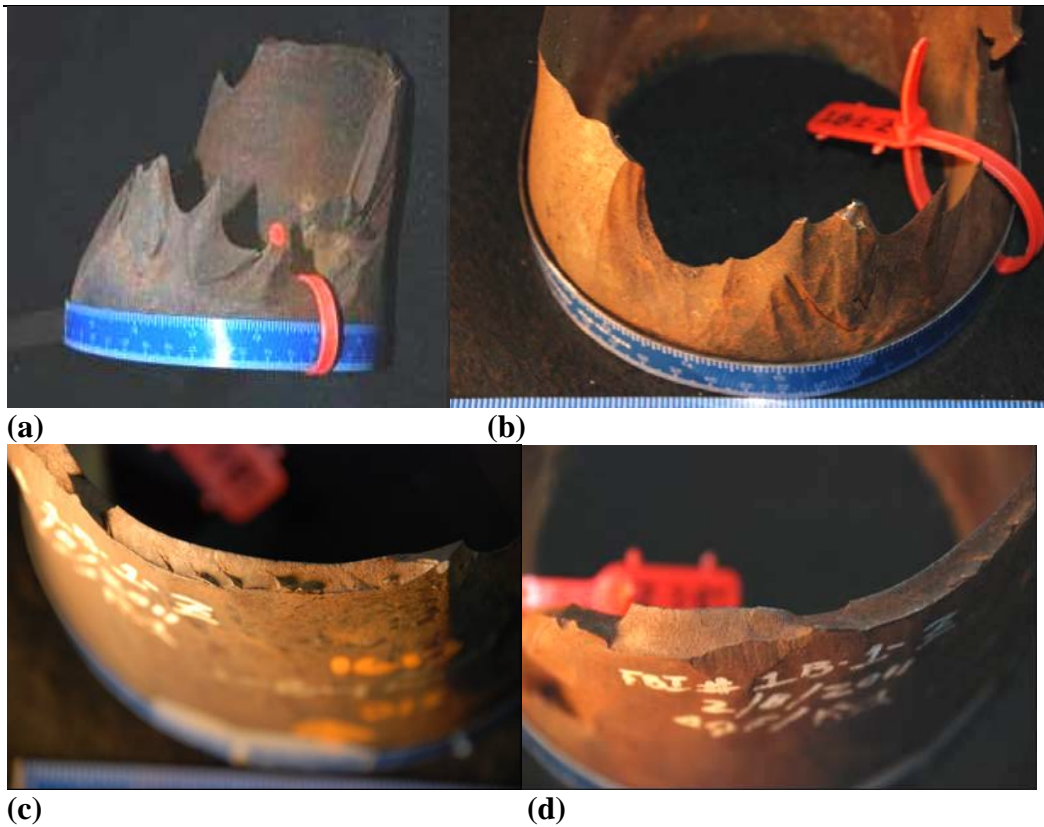
Figure 65 Photographs of 1-B-1-E

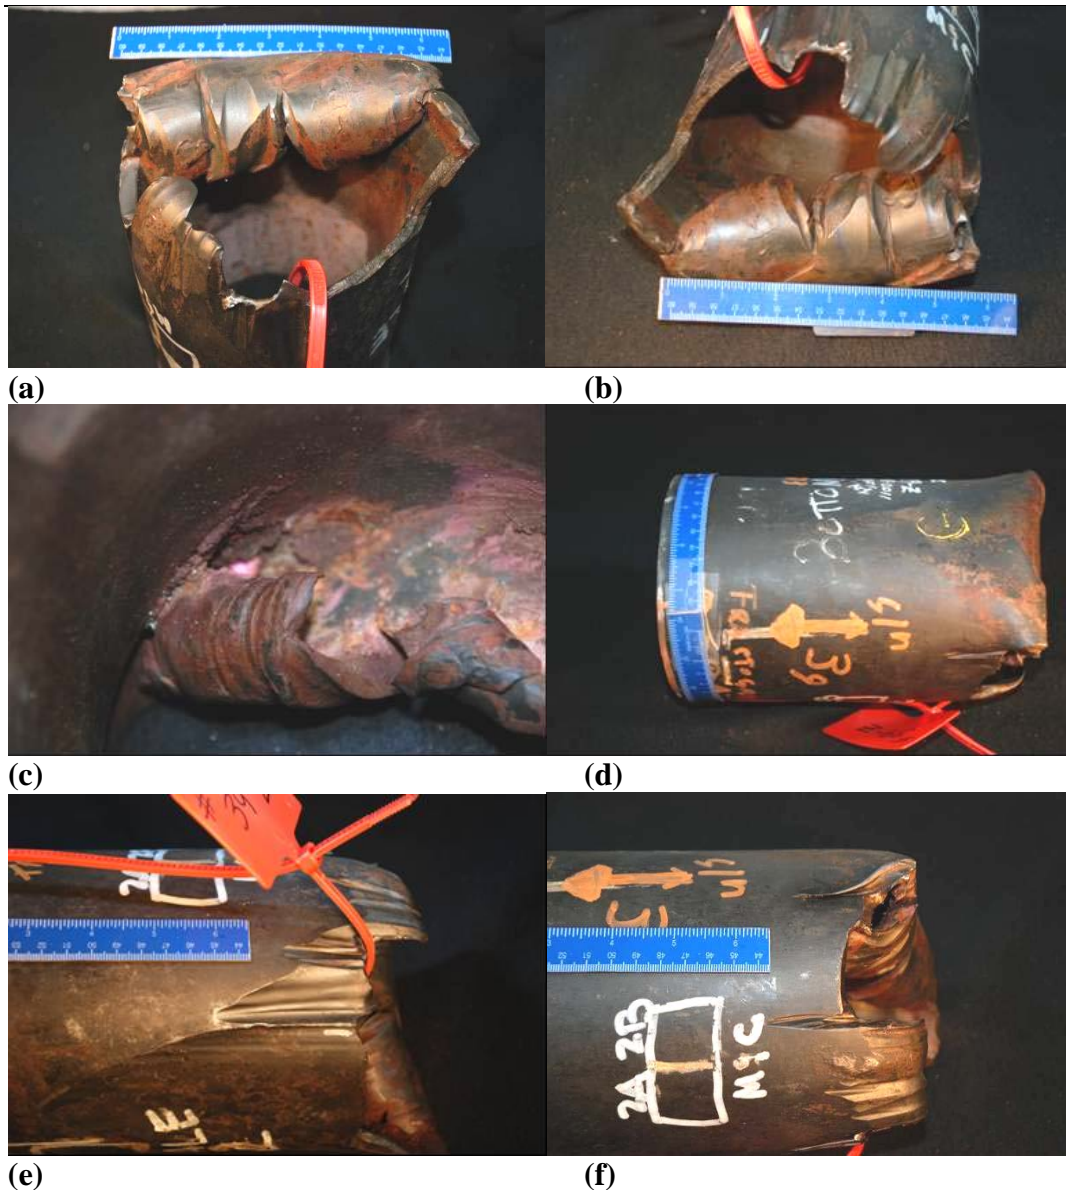
Figure 66 Photographs of 39-E

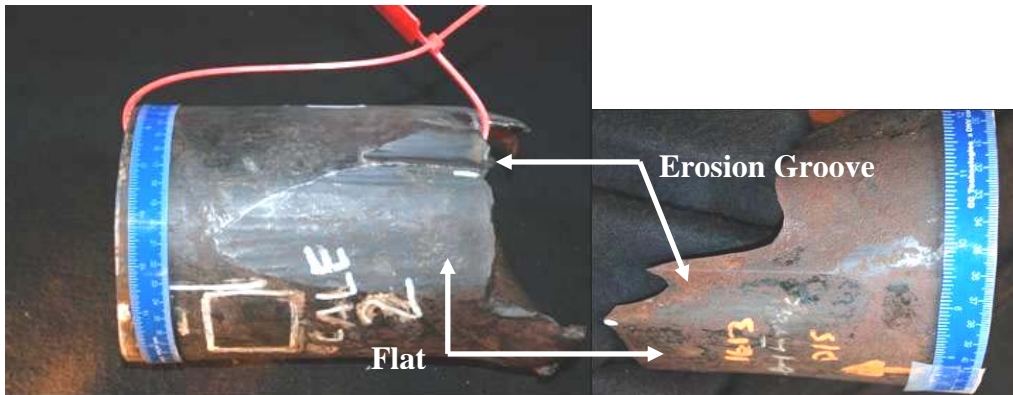
Figure 67 Photograph showing 1-B-1-E and 39-E

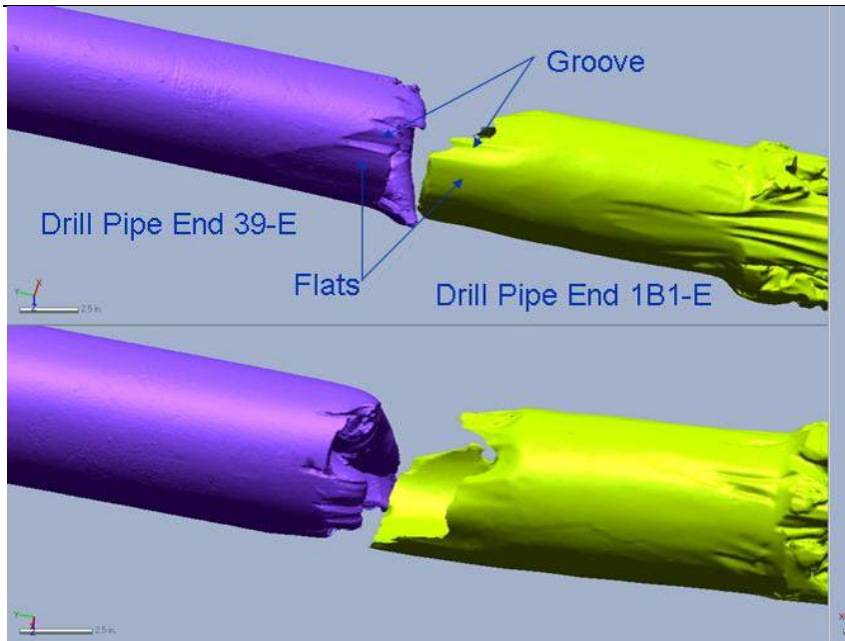
Figure 68 Laser Scans of 1-B-1-E and 39-E

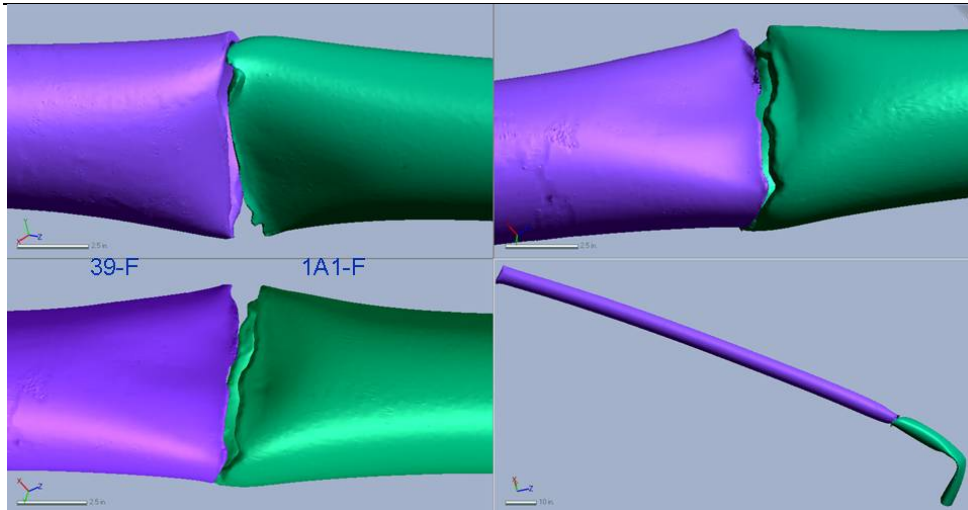
Figure 70 Laser Scans of 39-F and 1-A-1-F

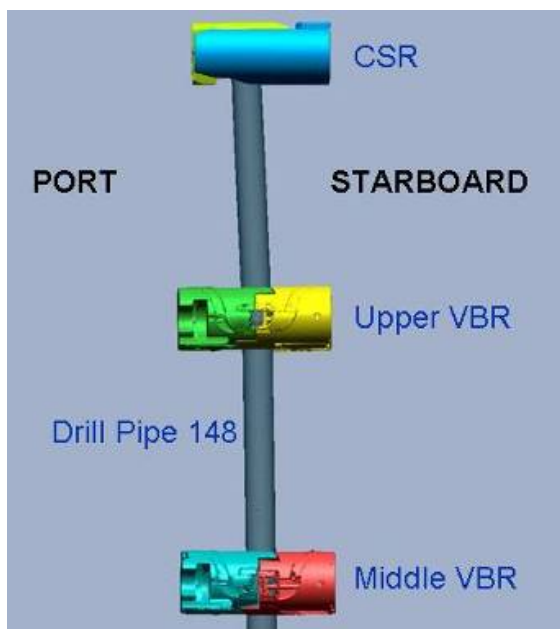
Figure 71 Laser Scans of Drill Pipe Segment 148 passing through the Upper and Middle VBRs

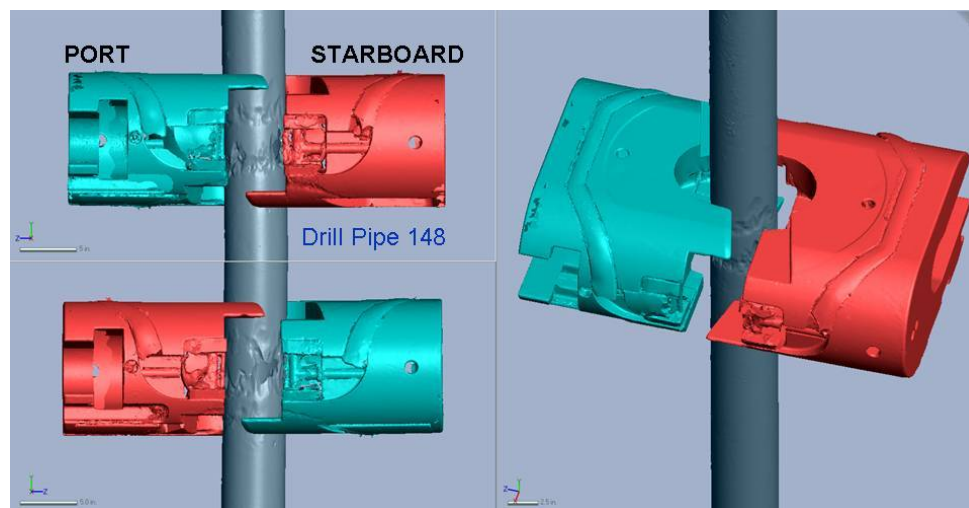
Figure 73 Laser Scan of the Middle VBR matched to Drill Pipe Segment 148

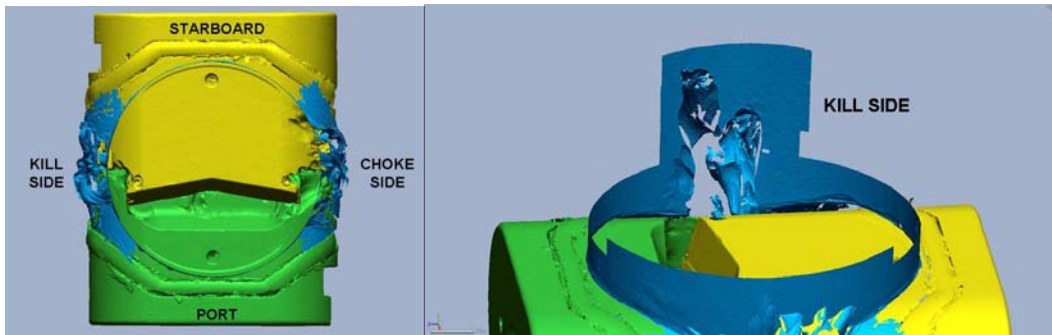
Figure 74 Laser Scan Showing Overhead View of BSR and Wellbore

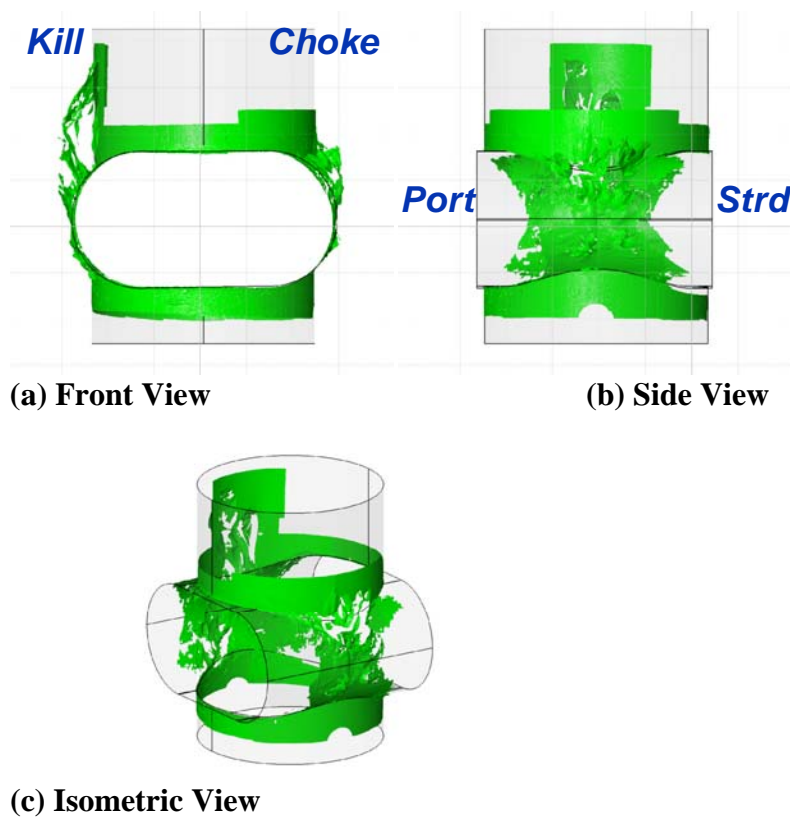
Figure 75 Laser Scan of Wellbore Damage

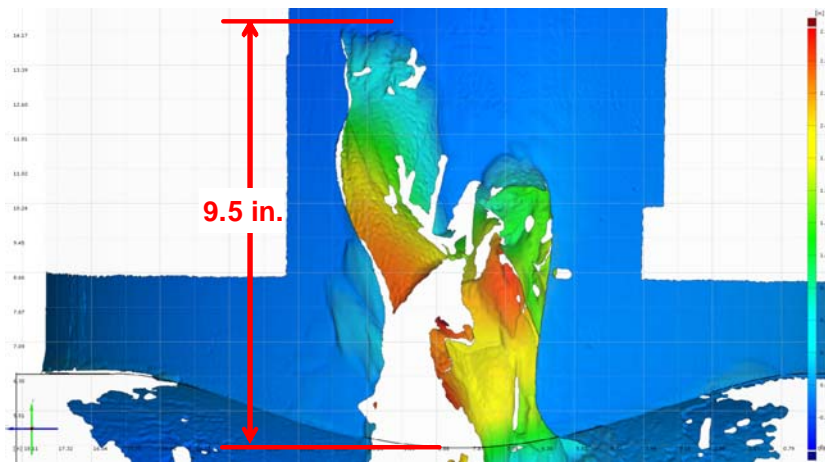
Figure 76 Laser Scan Deviation Plot of the Wellbore on the Kill Side of the BSR

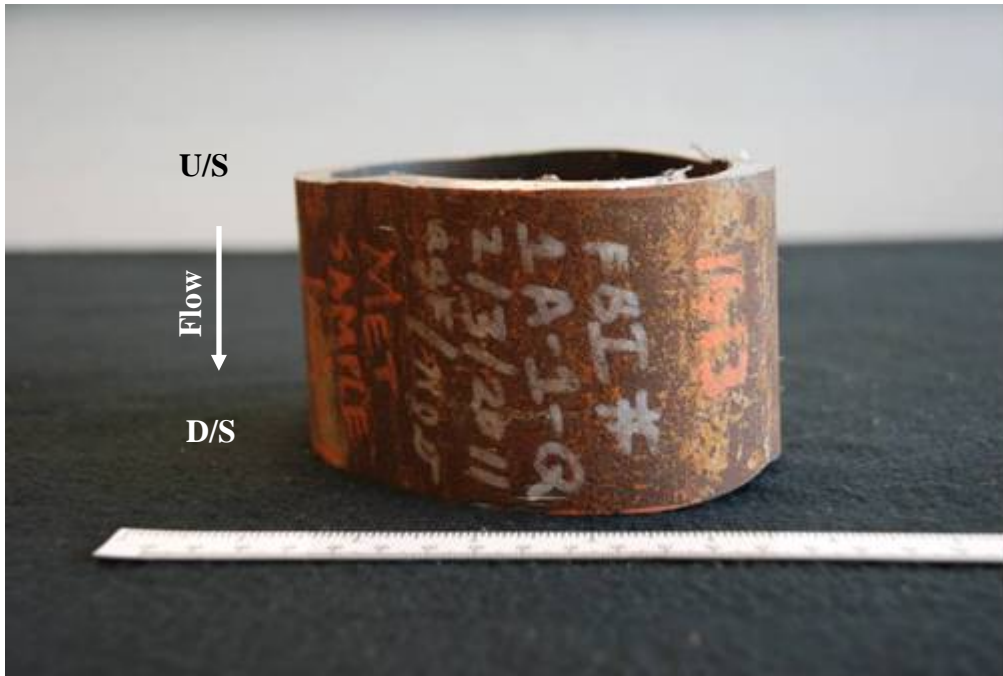
Figure 82 Photograph of 1-A-1-Q

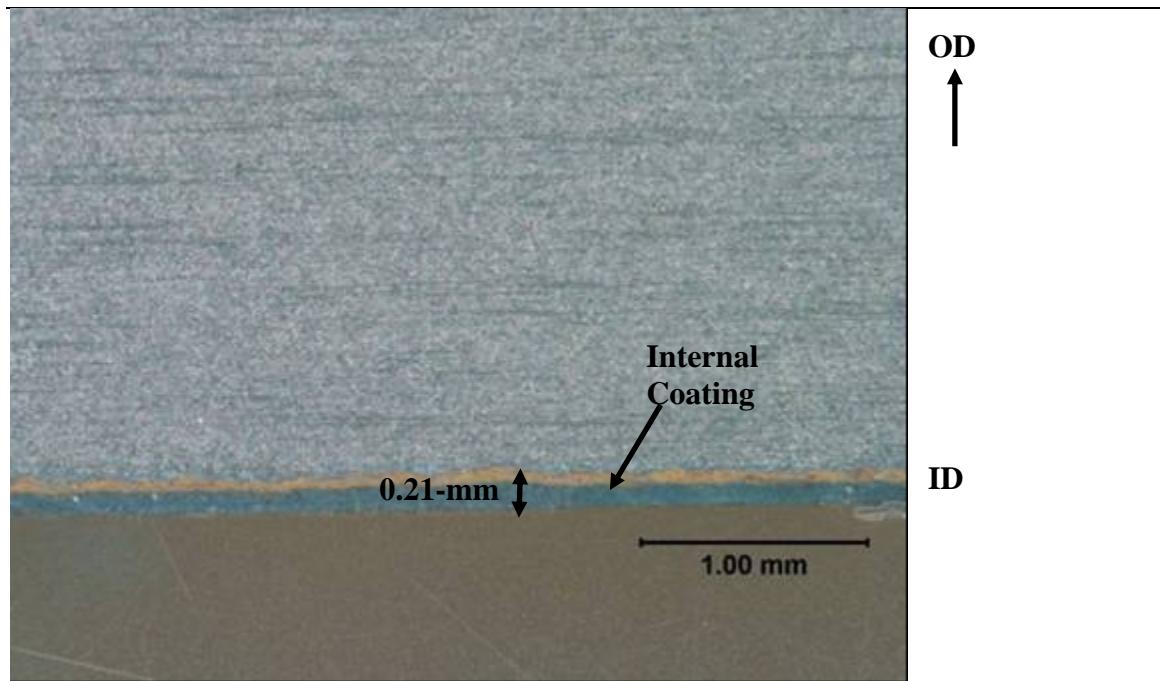
Figure 93 Stereo Light Photograph of Longitudinal Cross-Section of 39-Q

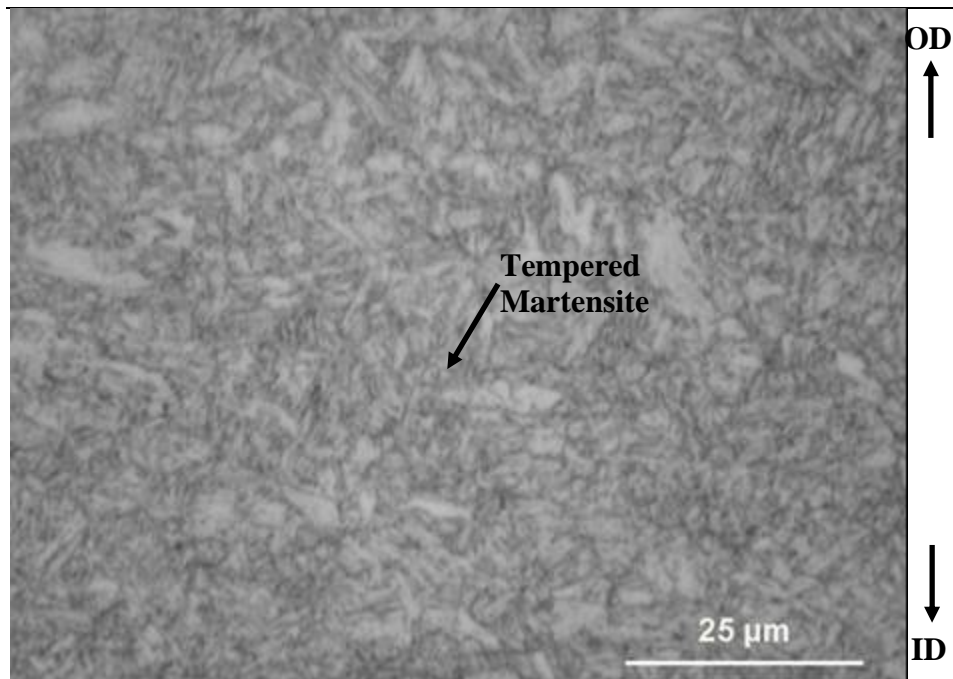
Figure 94 Light Photomicrograph Showing the Typical Microstructure of the Pipe Steel in the Longitudinal Orientation for 39-Q

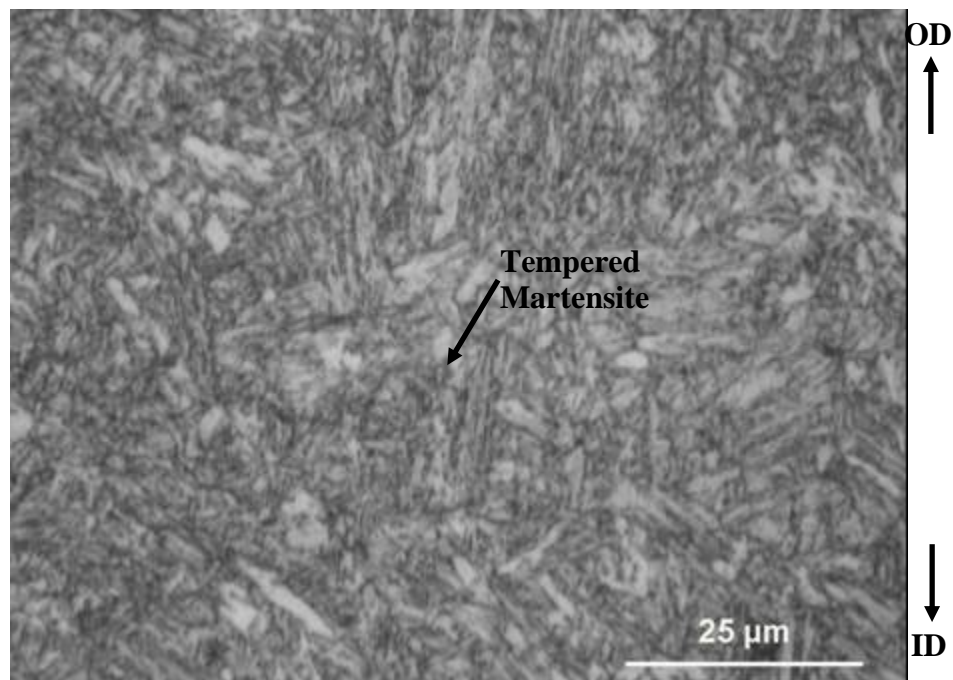
Figure 95 Light Photomicrograph Showing the Typical Microstructure of the Pipe Steel in the Transverse Orientation for 39-Q

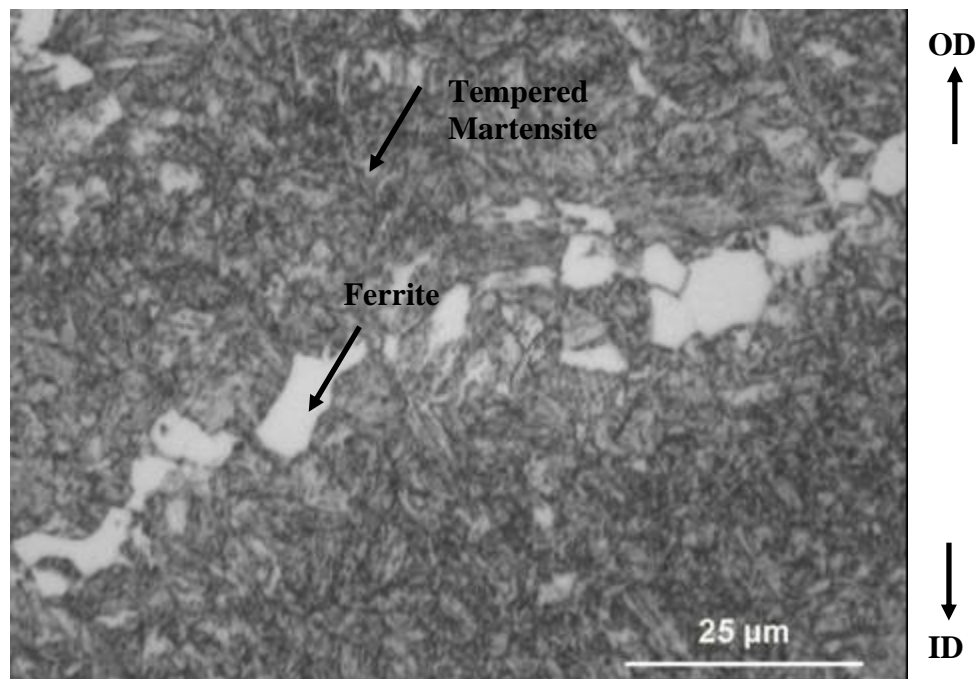
Figure 96 Light Photomicrograph Showing the Typical Microstructure of the Pipe Steel in the Transverse Orientation for 1-B-1-Q

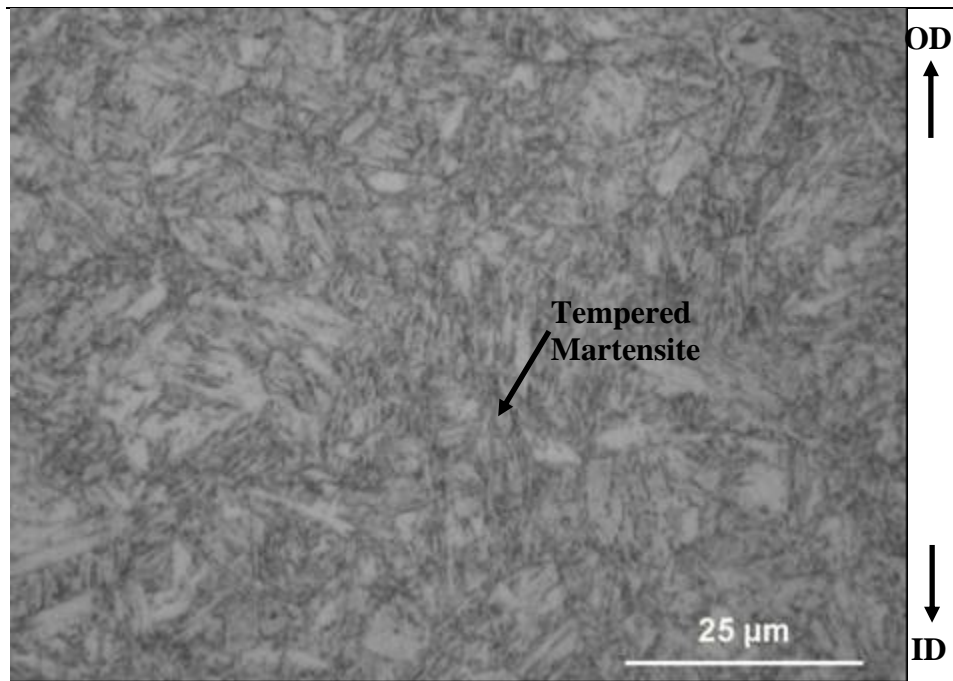
Figure 97 Light Photomicrograph Showing the Typical Microstructure of the Pipe Steel in the Longitudinal Orientation for 83-Q

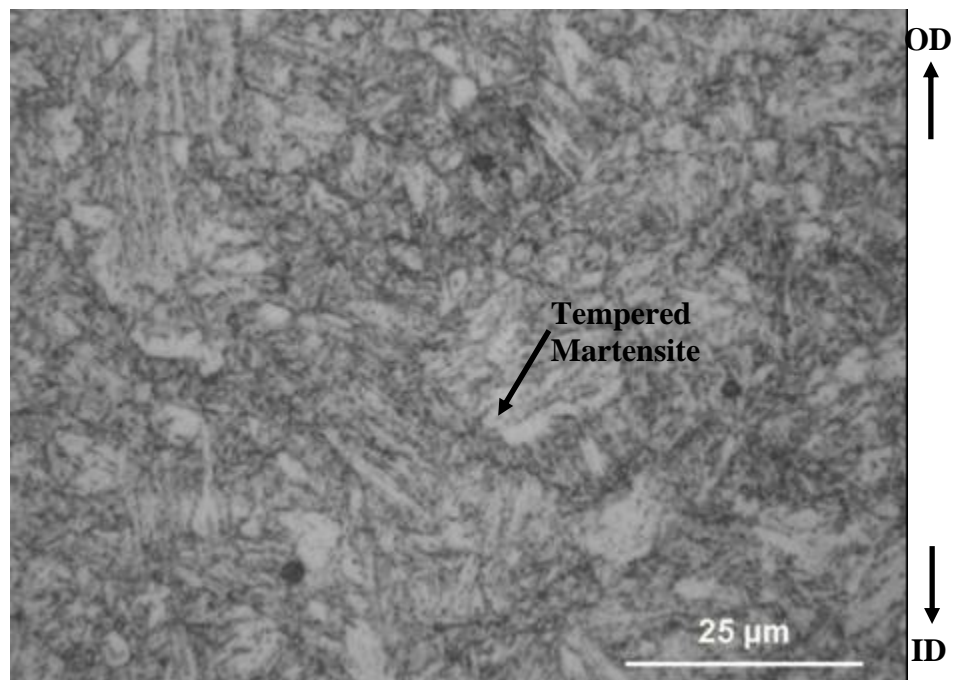
Figure 98 Light Photomicrograph Showing the Typical Microstructure of the Pipe Steel in the Transverse Orientation for 83-Q

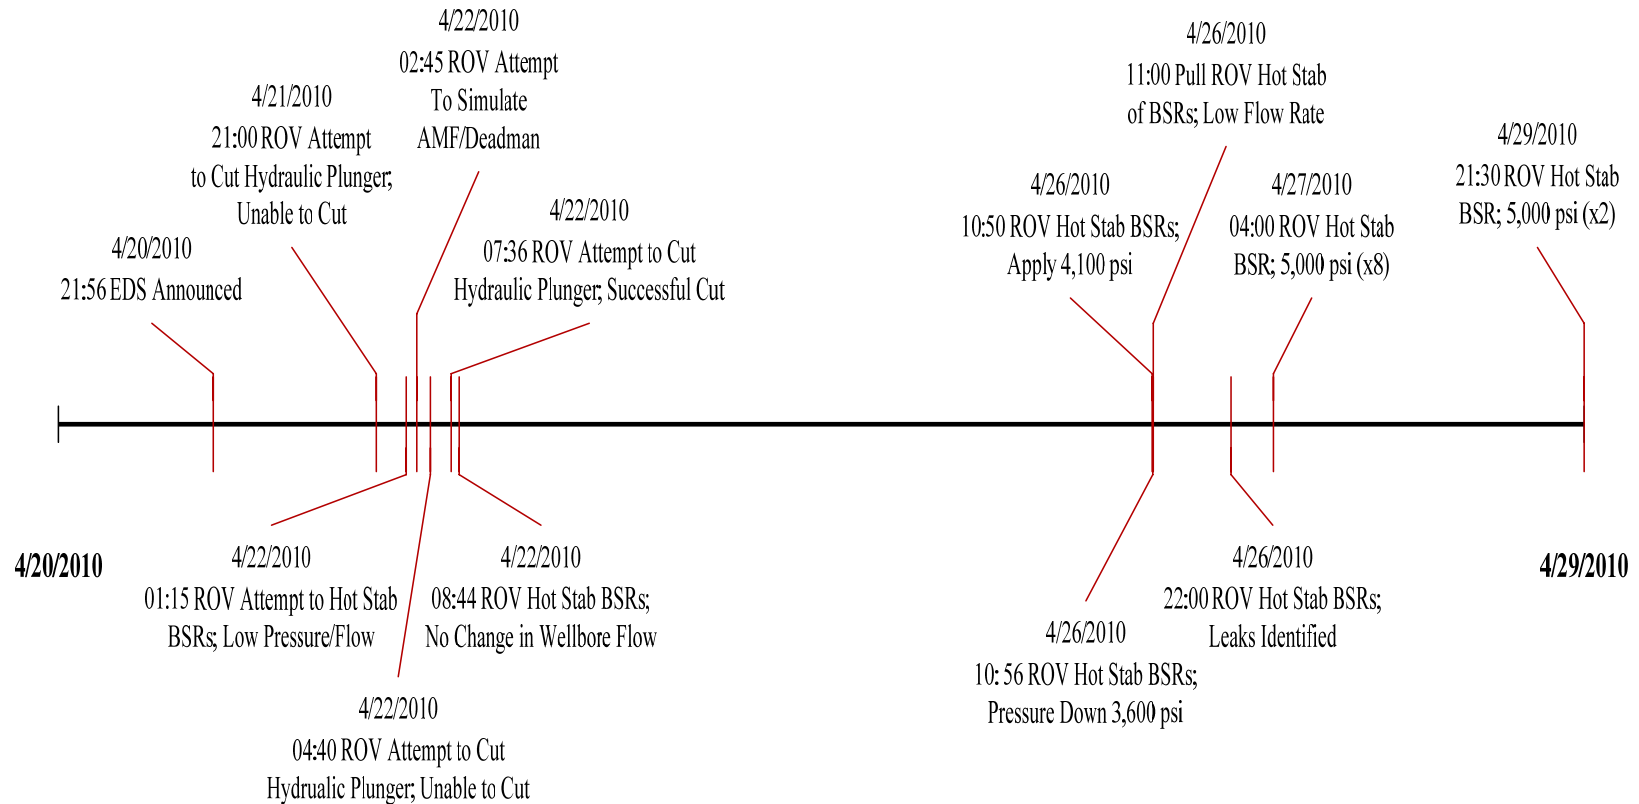
Figure 106 Illustration of the Events Pertaining to BSRs - April 20, 2010 to April 29, 2010

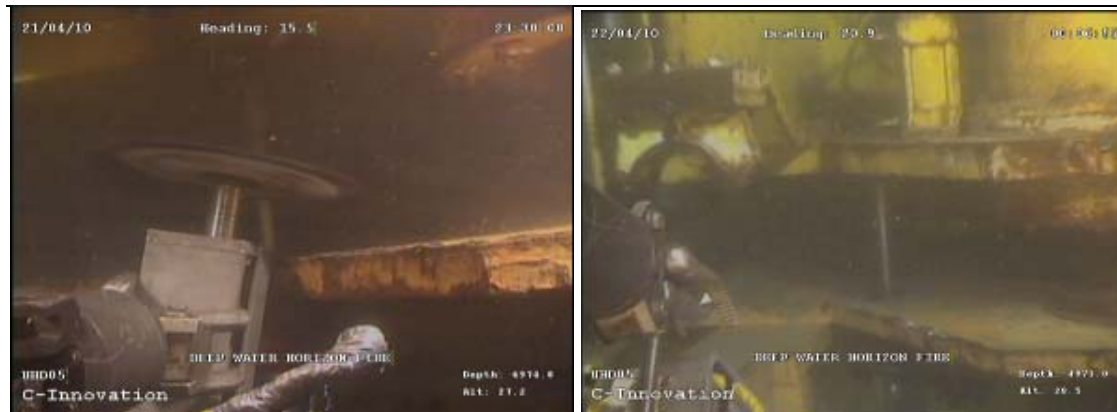
Figure 109 ROV C-Innovation video footage of the failed attempt to cut the Autoshear hydraulic plunger at 23:30 on April 21, 2010

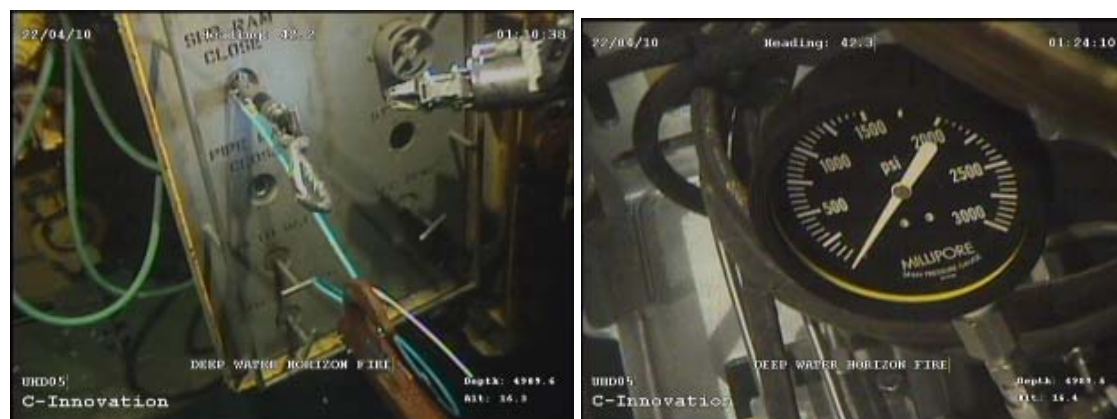
Figure 110 ROV C-Innovation video footage of the failed attempt to raise pressure during hot stab of the blind shear ram at 01:15 on April 22, 2010

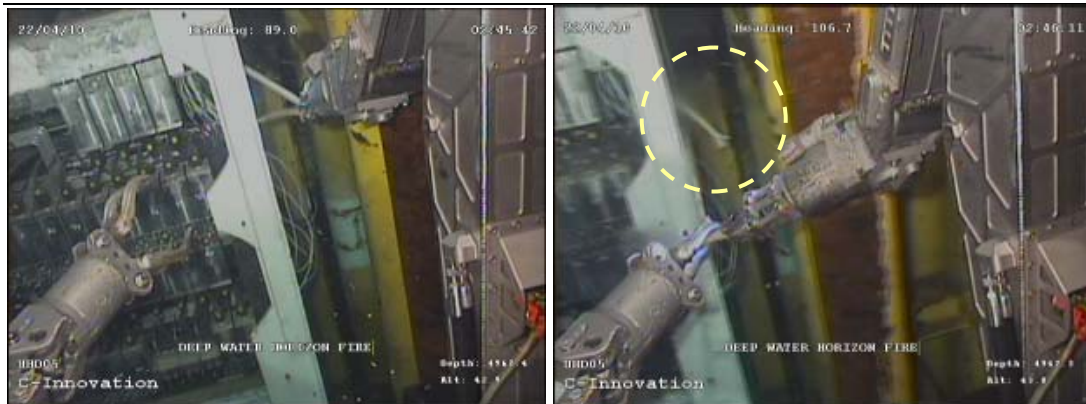
Figure 111 ROV C-Innovation video footage of the successful attempt to sever the PBOF cables 02:45 on April 22, 2010. The severed cable is highlighted with a yellow dashed circle.

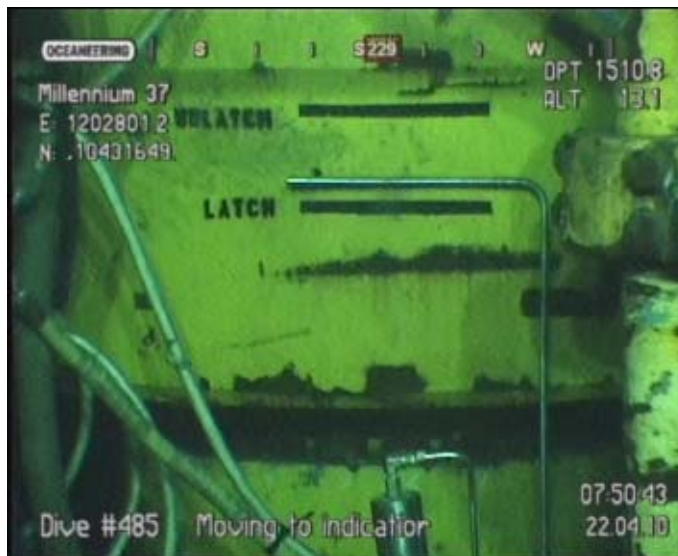
Figure 114 ROV Millennium 37 video footage of the LMRP “LATCH/UNLATCH” indicator shortly after cutting of the Autoshear hydraulic plunger at 07:30 on April 22, 2010

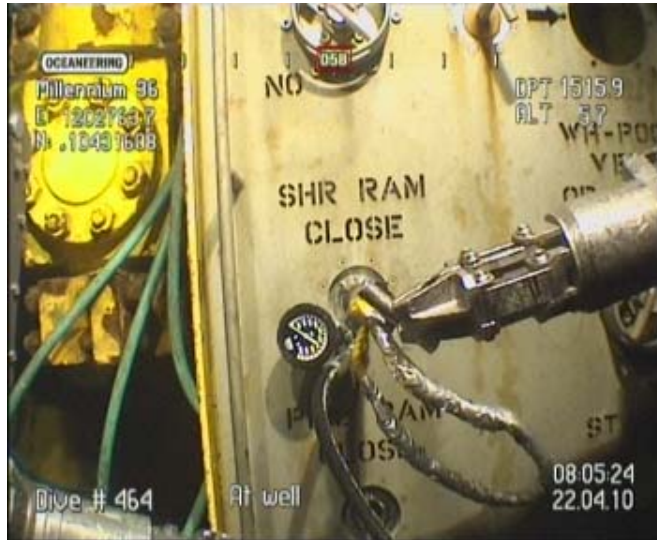
Figure 115 ROV Millennium 36 video footage of the failed attempt to raise pressure during hot stab of the blind shear ram at 08:00 on April 22, 2010
