DET NORSKE VERITAS

Final Report
for
**UNITED STATES DEPARTMENT
OF THE INTERIOR**

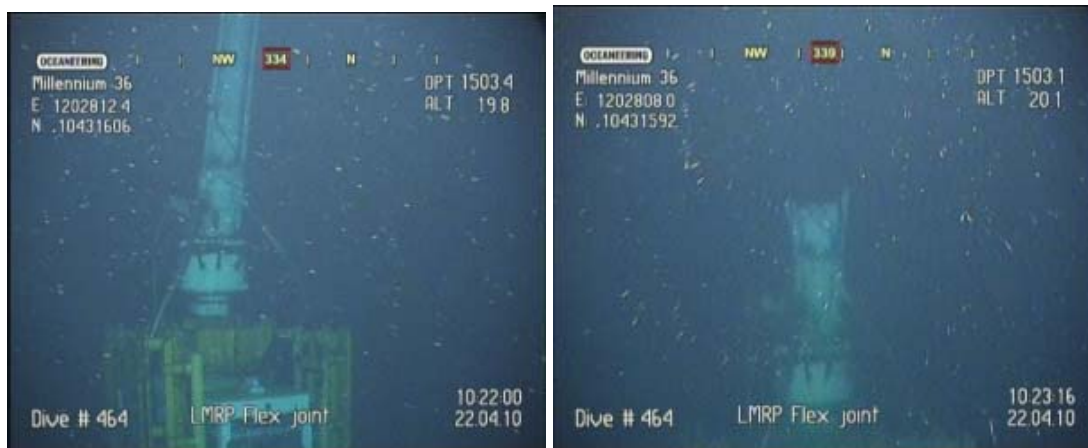
Figure 116 ROV Millennium 36 video footage of the LMRP Flex Joint before and after the kinking of the riser at 10:22 on April 22, 2010

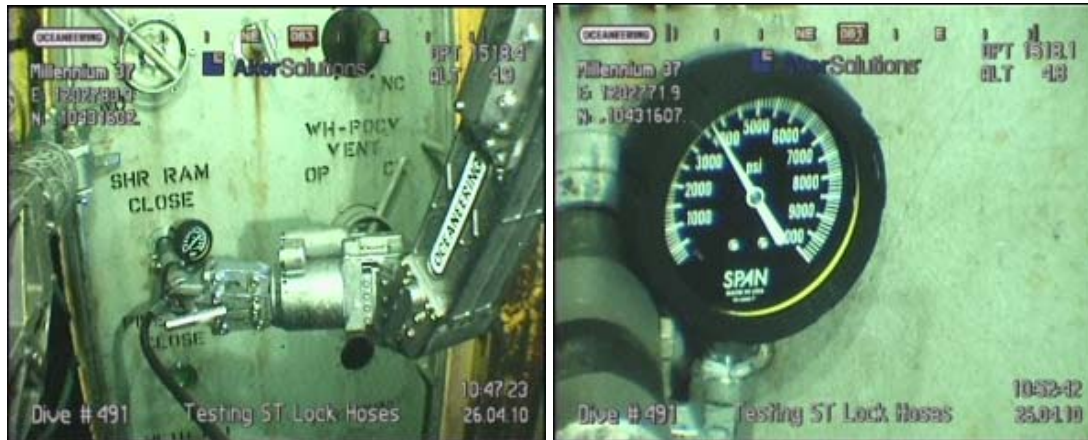
Figure 117 ROV Millennium 37 video footage of a successful attempt to raise pressure during the hot stab of the blind shear ram at 10:45 on April 26, 2010

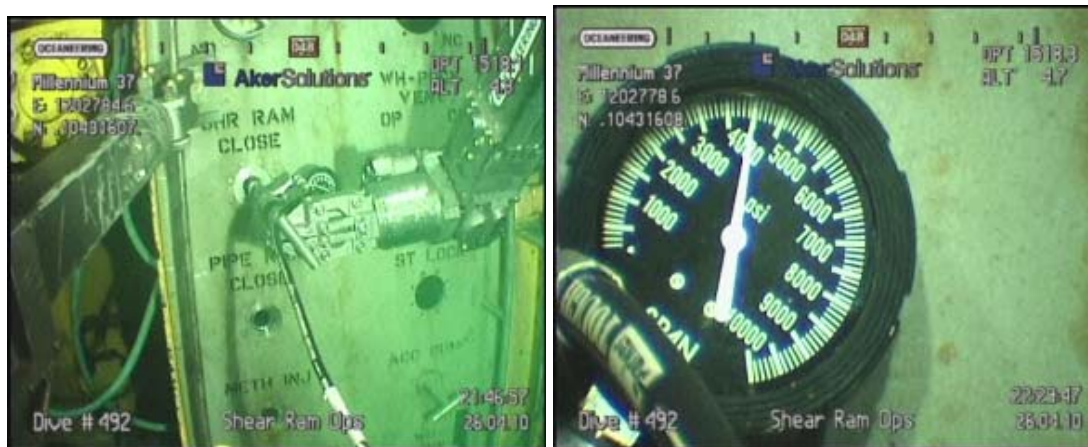
Figure 118 ROV Millennium 37 video footage of a successful attempt to raise pressure during the hot stab of the blind shear ram at 21:45 on April 26, 2010

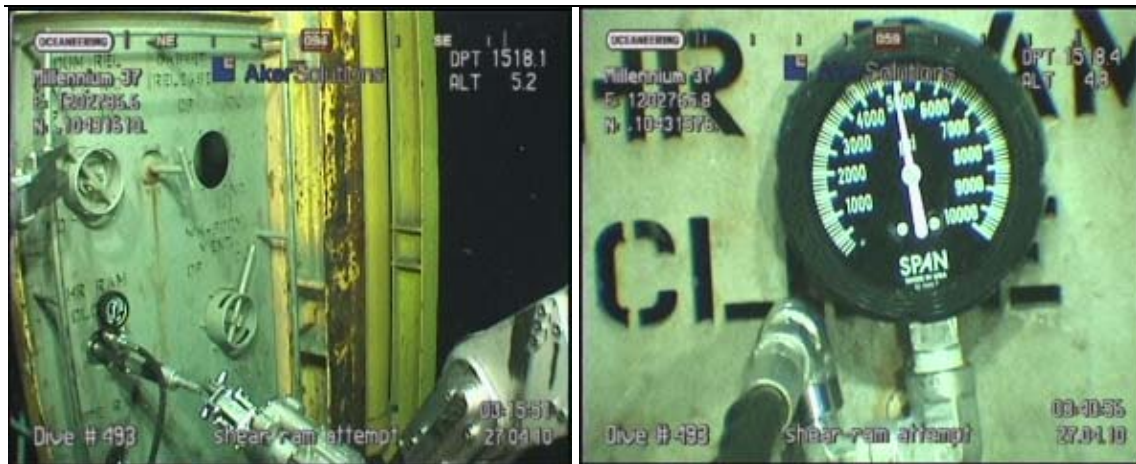
Figure 119 ROV Millennium 37 video footage of a successful attempt to maintain pressure during hot stab of the blind shear ram at 3:15 on April 27, 2010

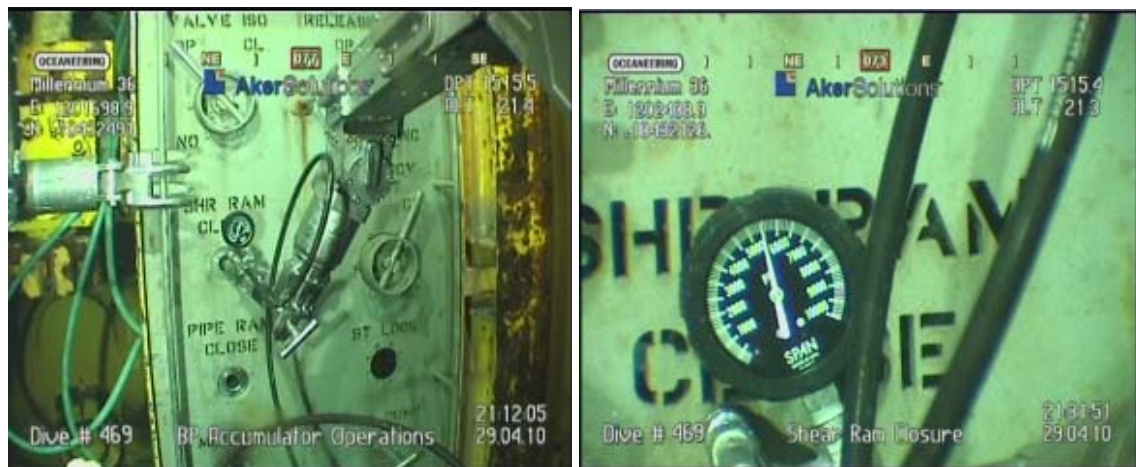
Figure 120 ROV Millennium 36 video footage of a successful attempt to maintain pressure during the hot stab of the blind shear ram at 21:30 on April 29, 2010

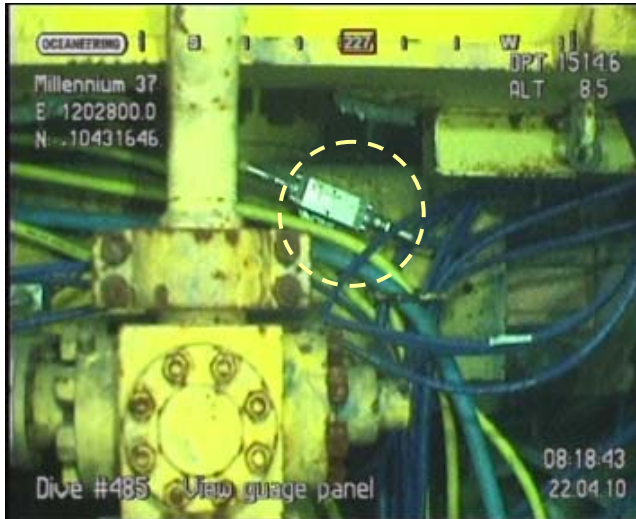
Figure 121 ROV Millennium 37 video footage of an inspection of a fitting on the blind shear ram at 08:15 on April 22, 2010

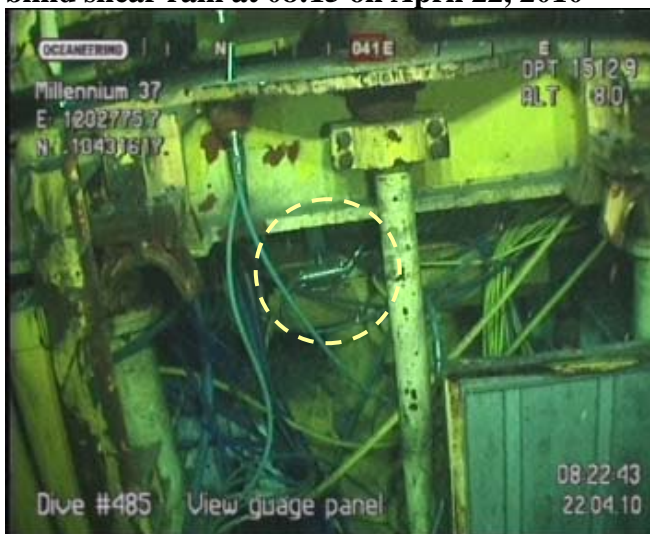
Figure 122 ROV Millennium 37 video footage of a repair to a fitting on the blind shear ram at 08:20 on April 22, 2010

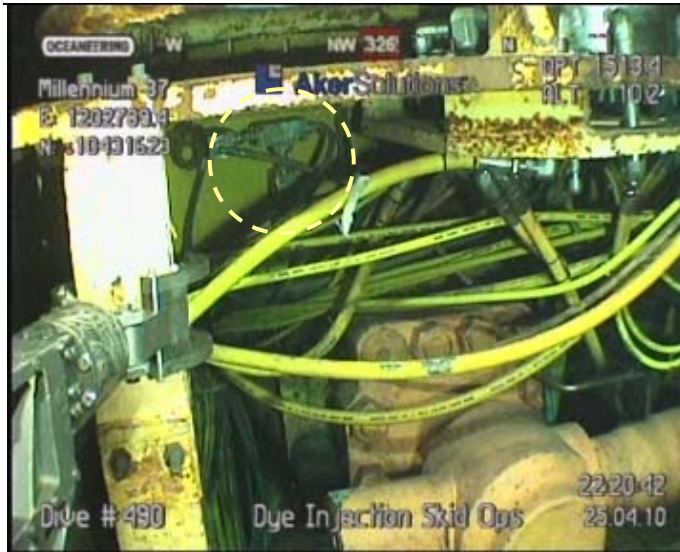
Figure 123 ROV Millennium 37 video footage of an inspection of the ST lock shuttle valve on the blind shear ram at 22:20 on April 25, 2010

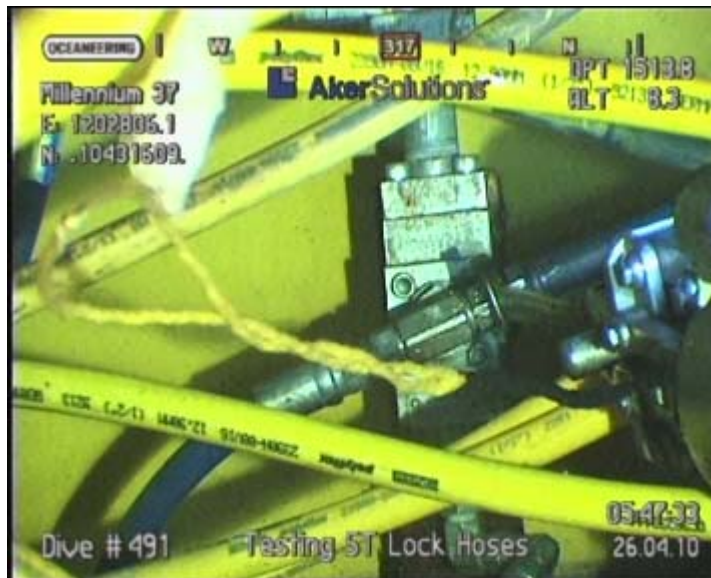
Figure 124 ROV Millennium 37 video footage of a repair of the ST lock shuttle valve on the blind shear ram at 5:45 on April 26, 2010

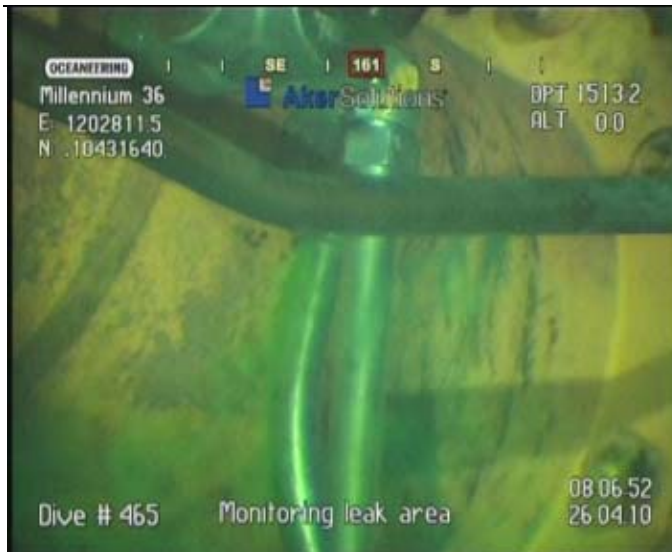
Figure 125 ROV Millennium 36 video footage of a leak in the fittings behind the right side ST Lock on the blind shear rams

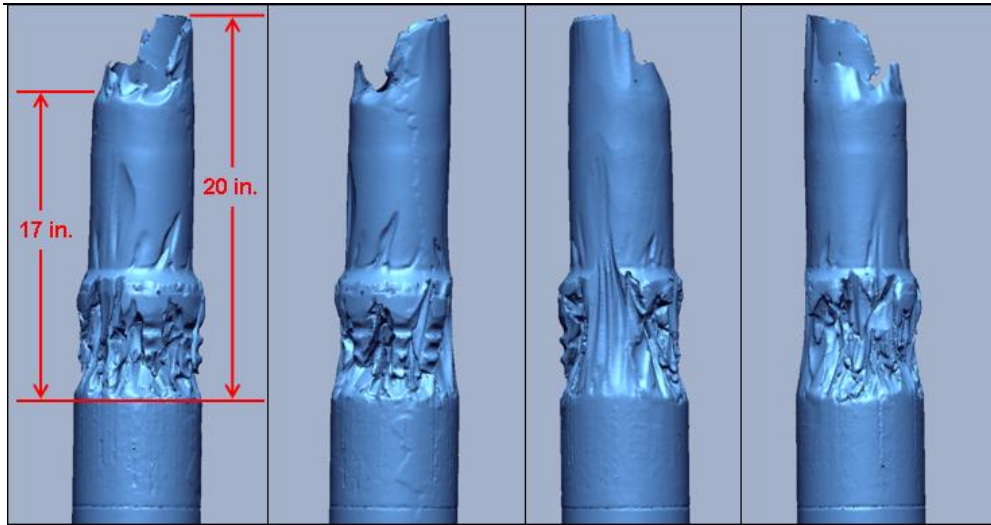
Figure 126 Laser Scan of Drill Pipe Segment 1-B-1 (Top End)

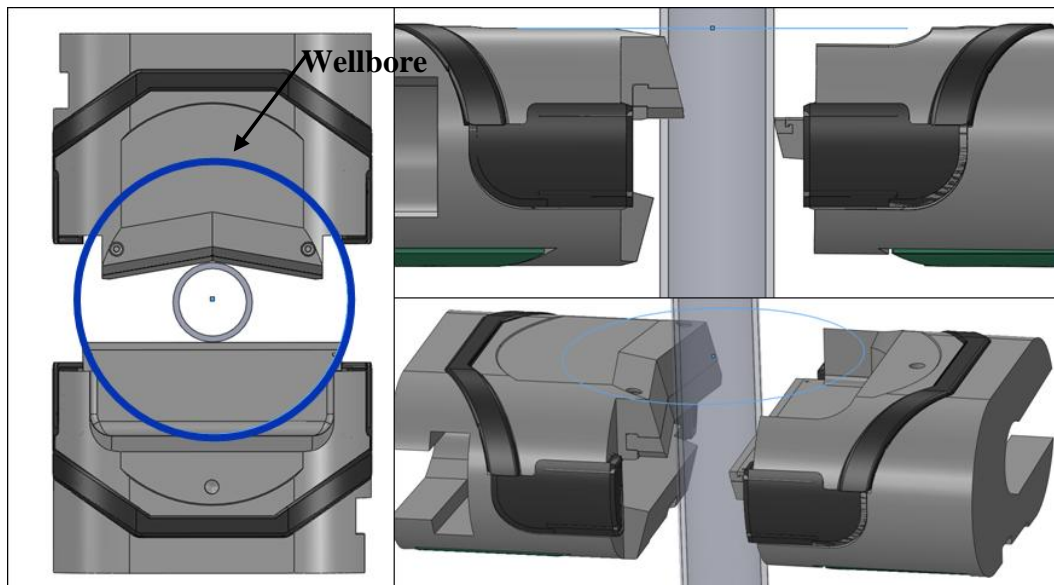
Figure 132 BSR Configuration

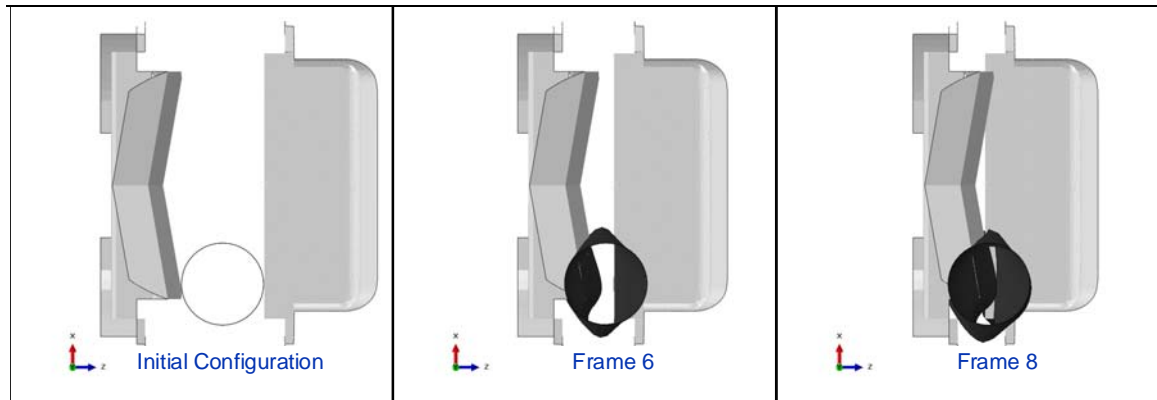
Figure 141 Top View Showing Deformation of Drill Pipe Outside of Shearing Blade Surfaces

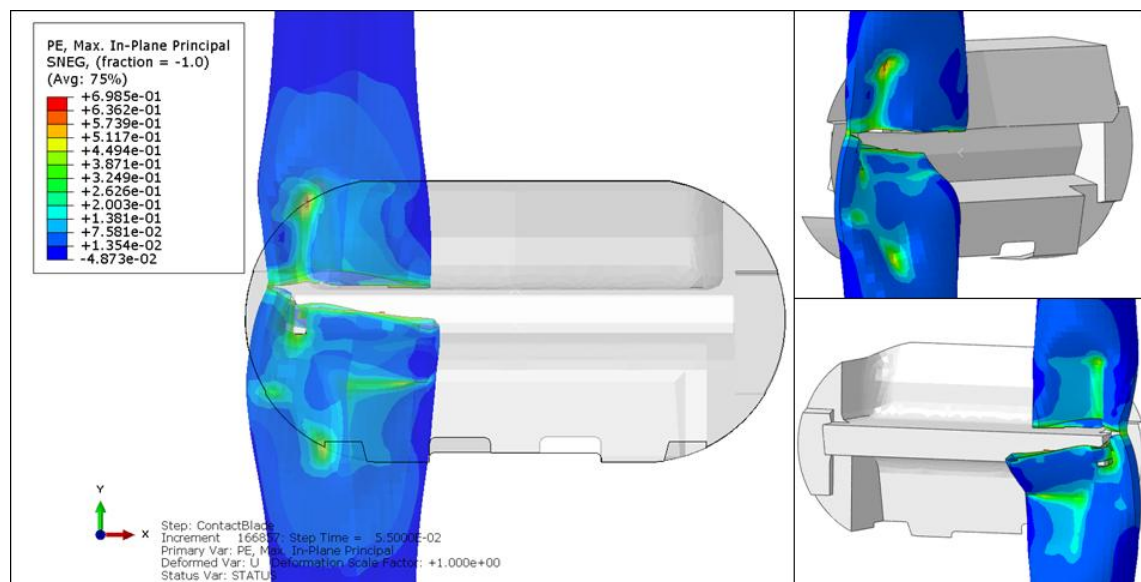
Figure 142 Final Deformed Configuration of Shear Cut Showing Strain Concentration at Inner Bend

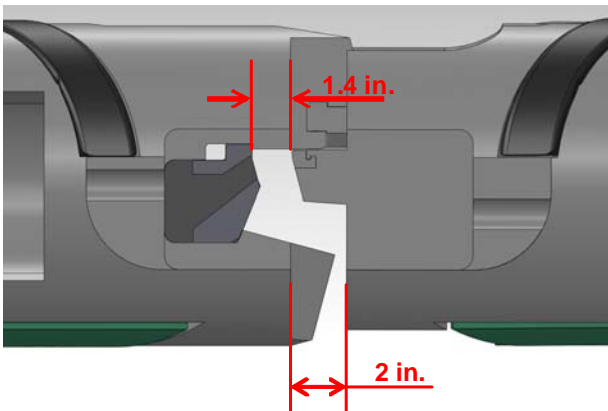
Figure 148 BSR CAD Models - 2 Inch Standoff Between Blocks

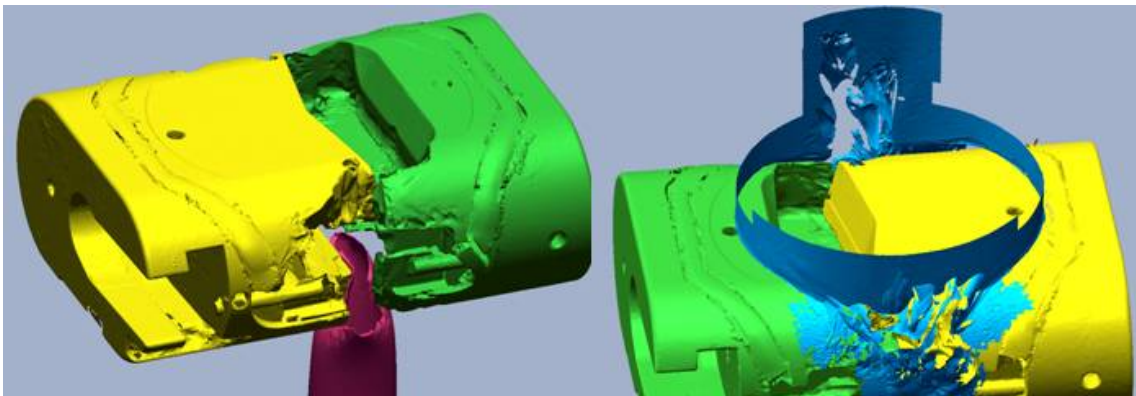
Note the image on the left is viewed from the kill side, while the image on the right is facing the kill side of the wellbore.
