Final Report
for
UNITED STATES DEPARTMENT
OF THE INTERIOR

FORENSIC EXAMINATION OF DEEPWATER
HORIZON BLOWOUT PREVENTER

VOLUME II APPENDICES

Report No. EP030842
20 March 2011

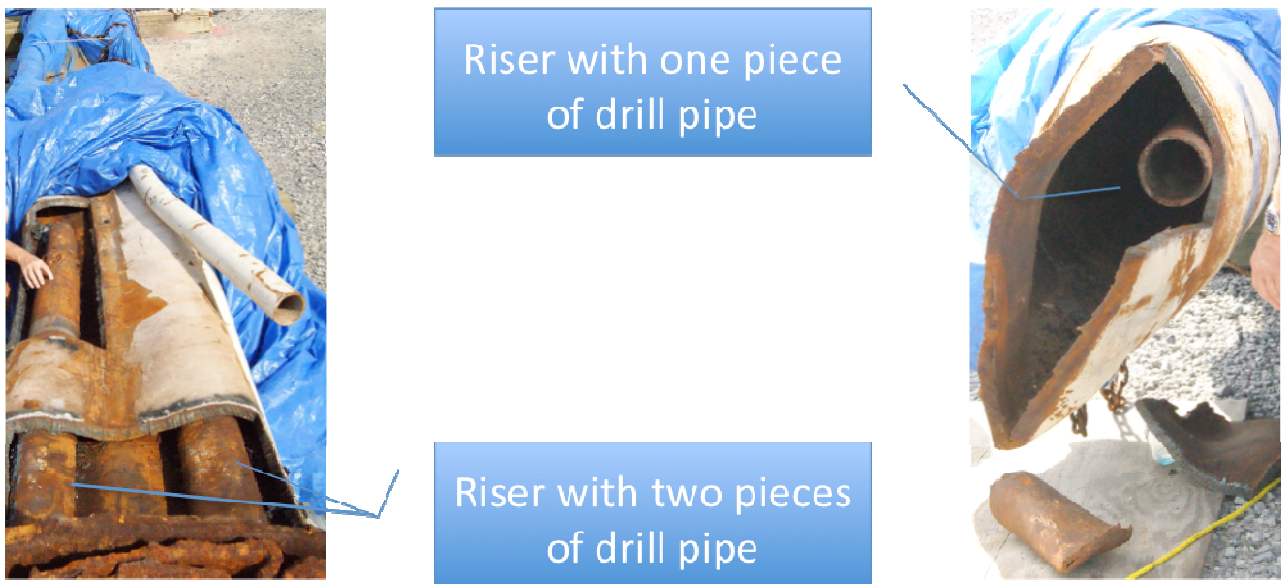
Figure 1 - Photograph of Riser showing two pieces of drill pipe at downstream end of riser and only one piece of drill pipe at upstream end of riser.

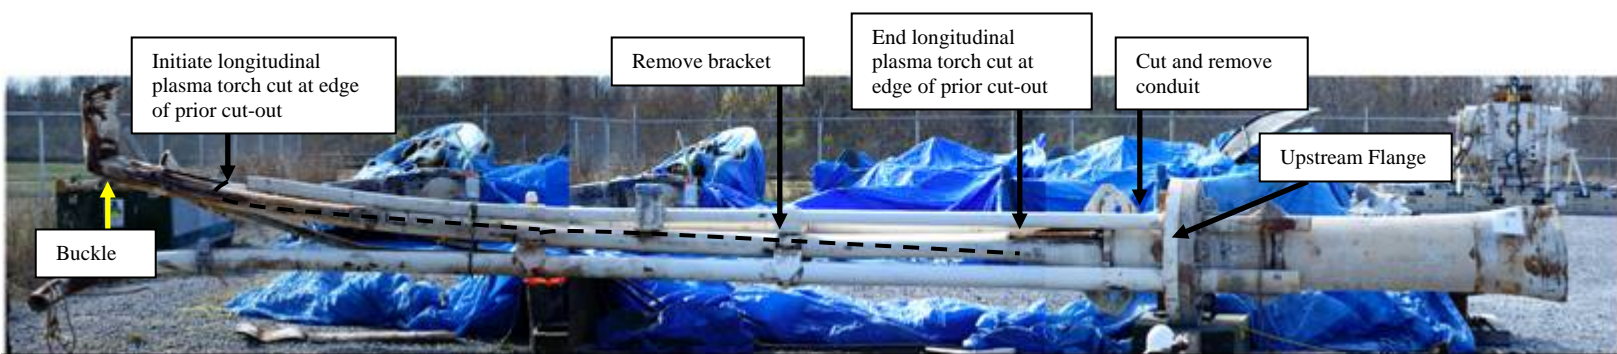
Figure 2 – Longitudinal cut on the edge of the riser.

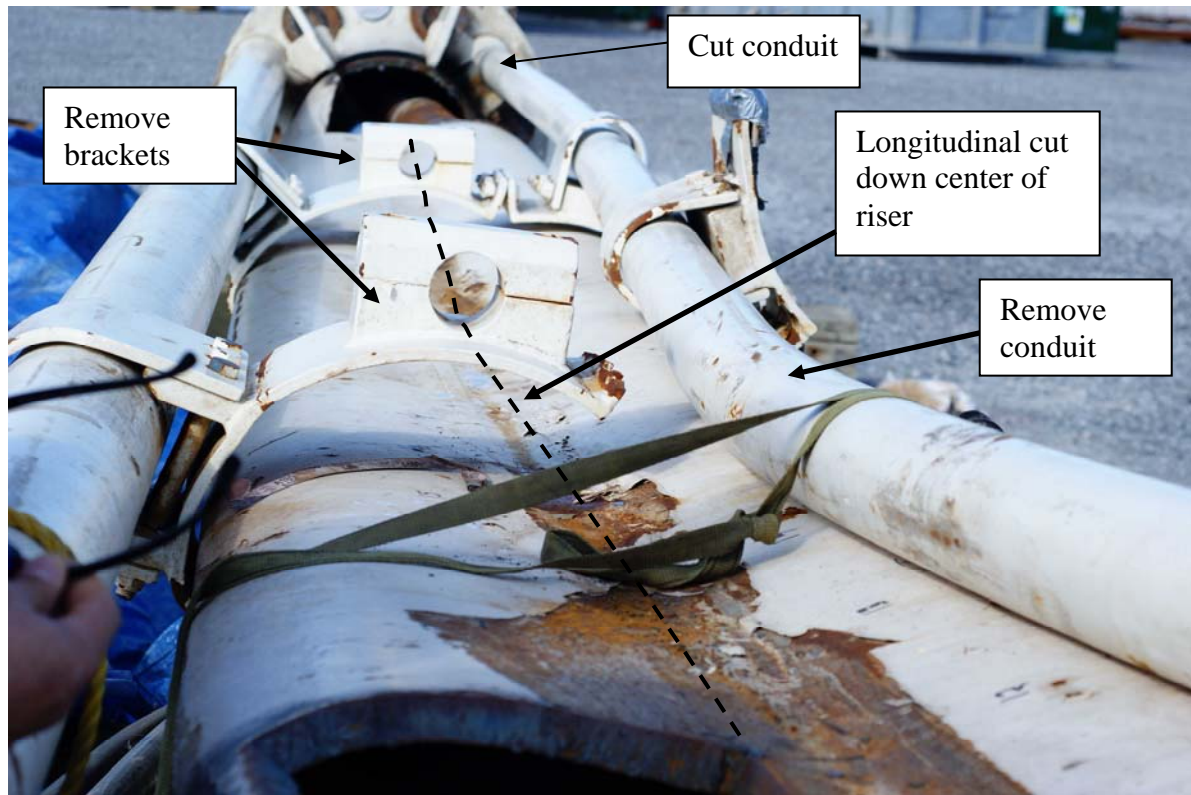
Figure 3 – Longitudinal cut down center of riser.

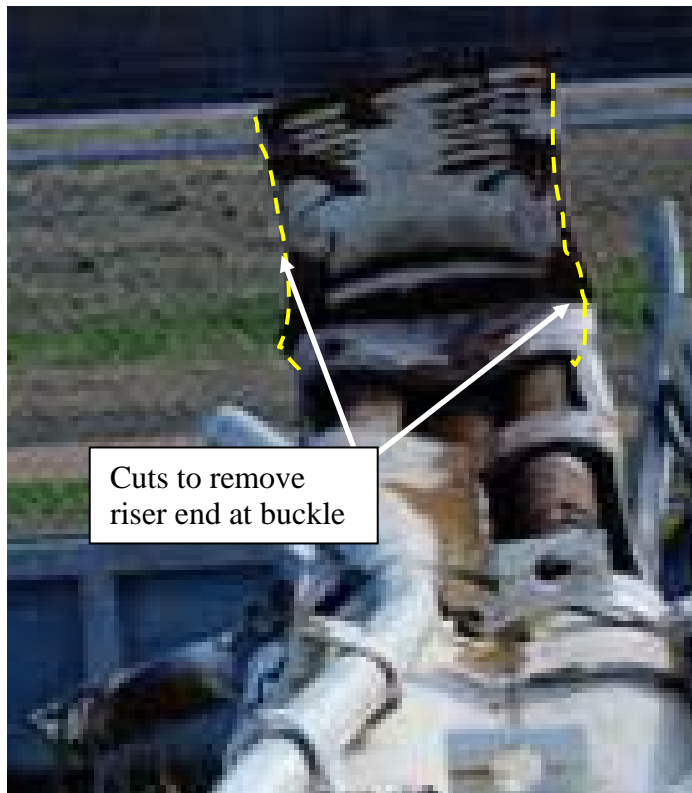
Figure 4 – Cuts to remove riser from ends of drill pipe at 90° bend.

8. Cut the riser at the 90° buckle and downstream to remove the top (as positioned in the evidence yard) of the riser (see Figure 4).
9. Remove the short piece of drill pipe from the buckle portion of the riser.

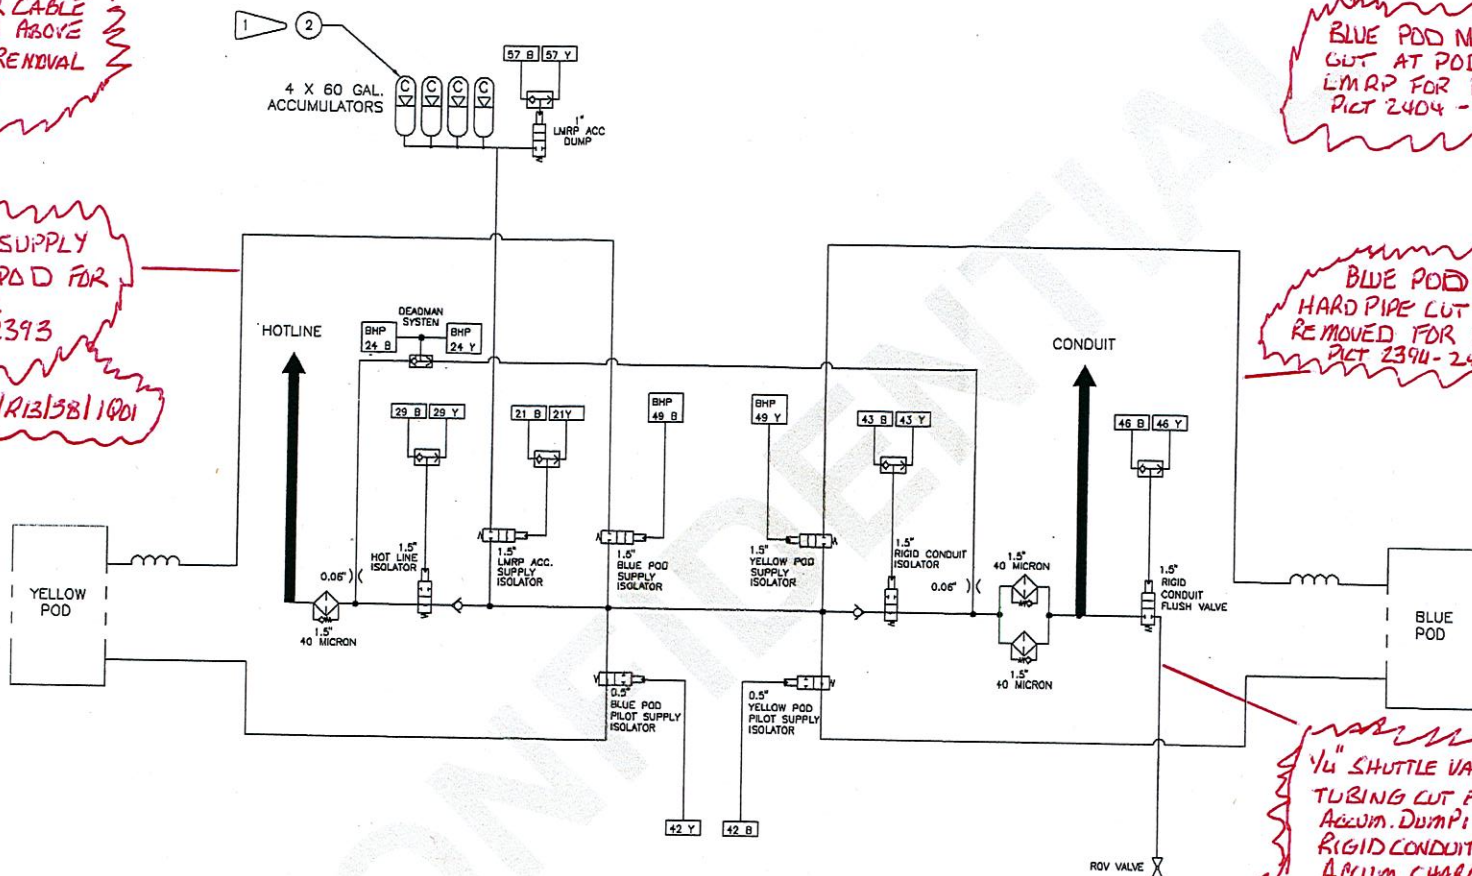
BLUE POD SUPPLY
HARD PIPE CUT AND HOSE
REMOVED FOR POD REMOVAL
PICT 2394-2400

1/4" SHUTTLE VALVE ARRANGEMENT
TUBING CUT FROM DEADMAN
ACCUM. DUMP; RIGID CONDUIT FLUSH;
RIGID CONDUIT ISOLATOR, LMRP
ACCUM. CHARGE FOR ROV
INTERVENTION R & B FALCON
PICT 2508-2516 "DEEPWATER HORIZON"

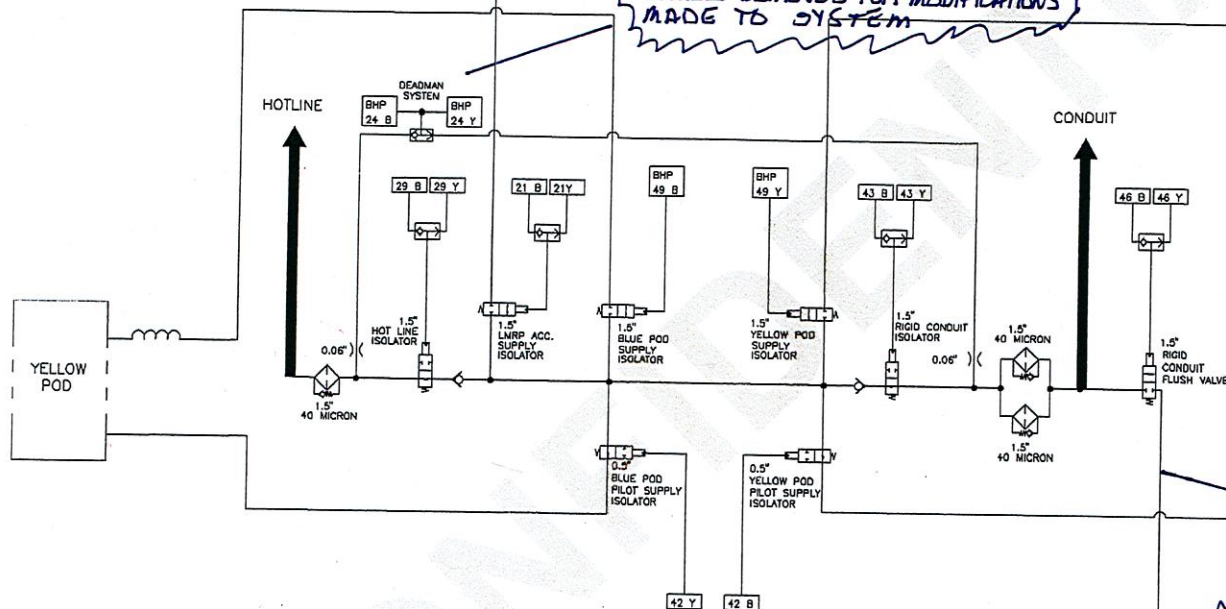
ORIGINAL DEADMAN
PANEL REMOVED FOR MODIFICATIONS
MADE TO SYSTEM

BLUE POD MUX CABLE CUT AT POD
AND ABOVE LMRP FOR POD REMOVAL
ATA ARMOR TERMINATION ASSY.
ADDED. PICT 2404-2417

YU SHUTTLE VALVE ARRANGEMENT
TUBING CUT FROM DEADMAN.
ACCUM. DUMP. RIGID CONDUIT FLUSH.
RIGID CONDUIT ISOLATOR. LMRP
ACCUM. CHARGE

PICT 2508-2516 MODIFICATION
R & B FALCON
"DEEPWATER HORIZON"

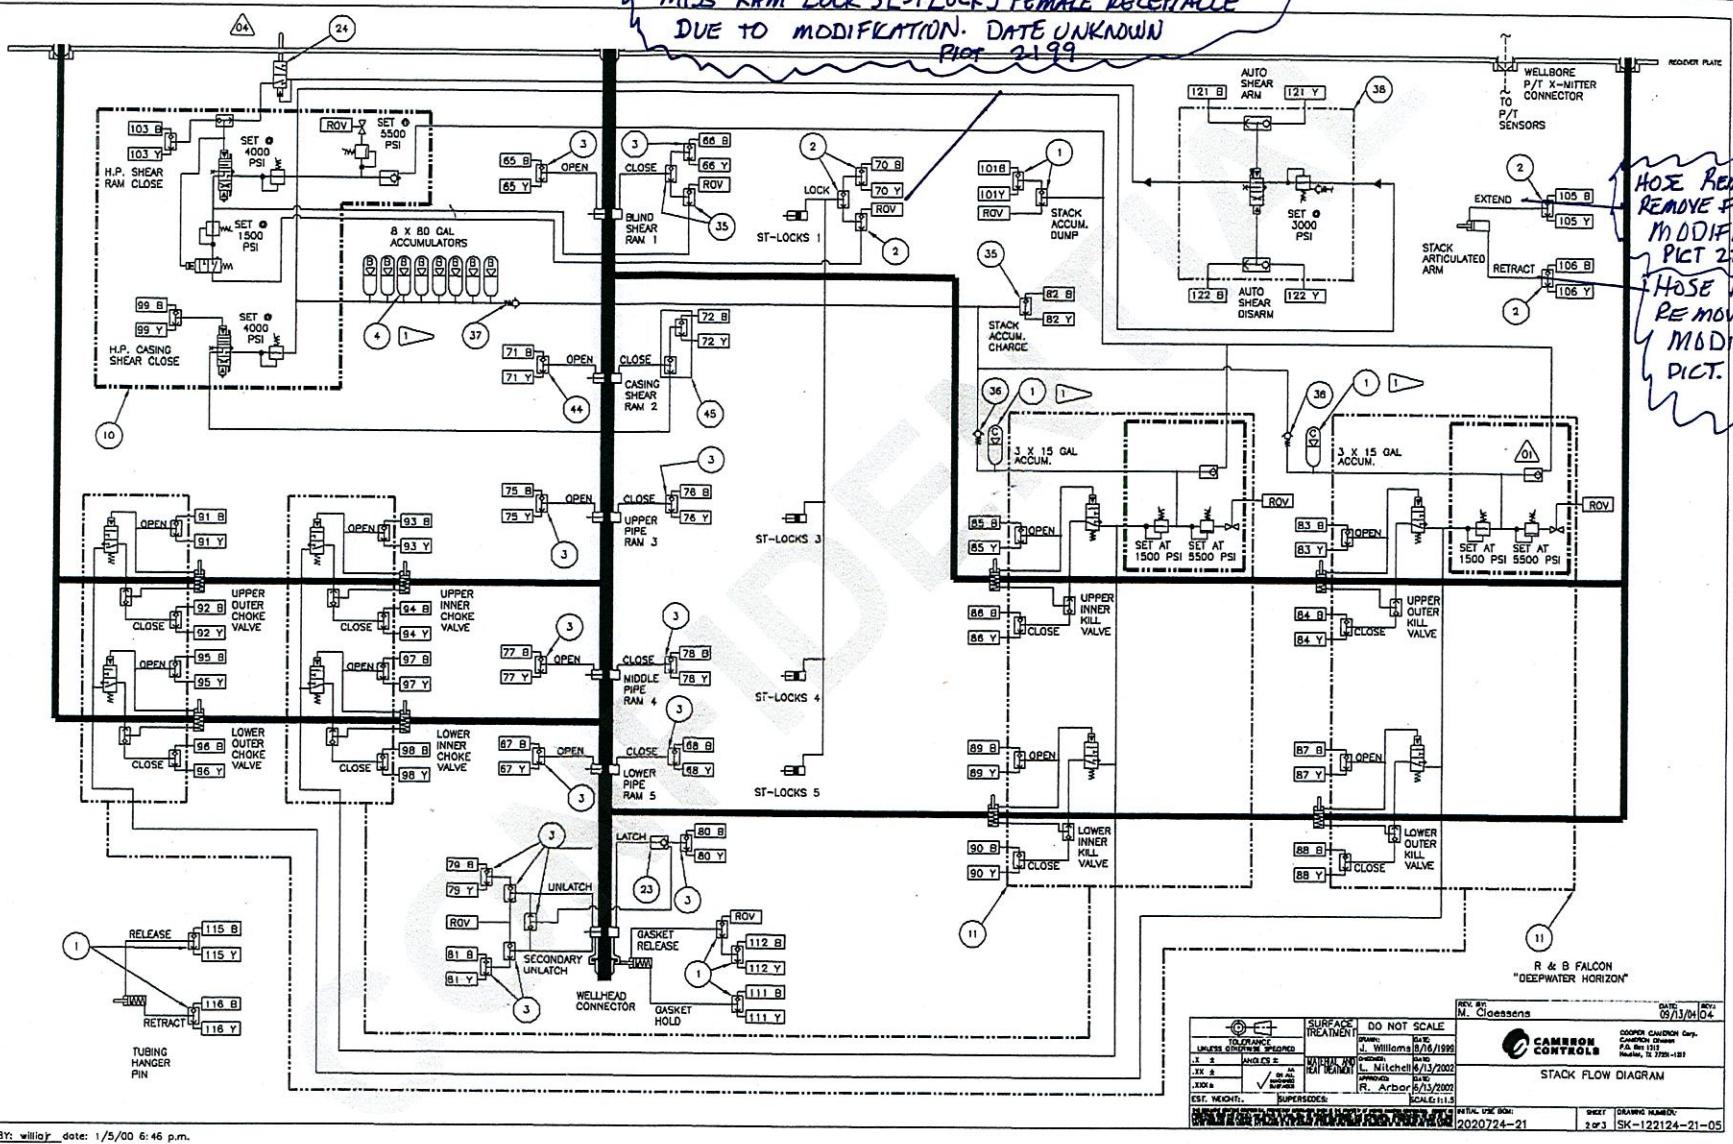
MISS RAM LOCKS (ST-LOCK) FEMALE RECEPTACLE
DUE TO MODIFICATION. DATE UNKNOWN
PICT 2199

HOSE REMOVED TO
REMOVE FUNCTION
MODIFICATION
PICT 2237-2283
HOSE REMOVED TO
REMOVE FUNCTION
MODIFICATION
PICT. 2237-228
