ASSESSMENT OF THE PERFORMANCE OF OFFSHORE SAFETY AND POLLUTION CONTROL DEVICES IN THE AFTERMATH OF HURRICANE ANDREW

United States Department of the Interior

MINERALS MANAGEMENT SERVICE

JOB No : 80295.1
APRIL 1995

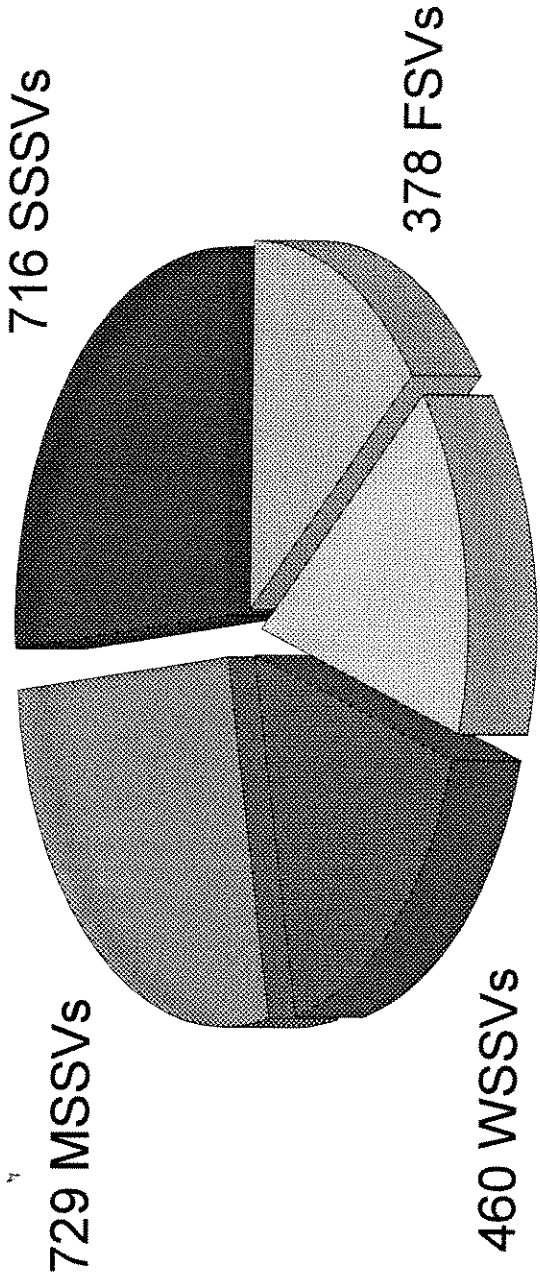
5 - MSSV FAILURES; FAILURE RATE - 0.0005 fph

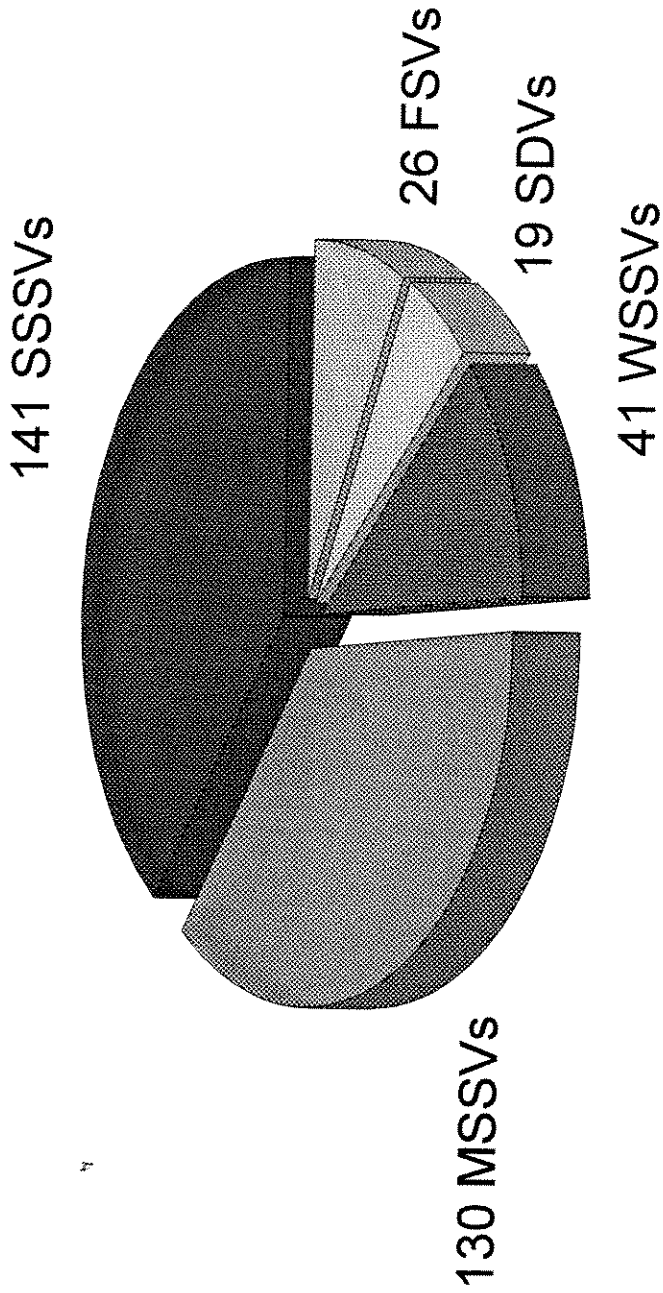
The five (5) MSSV failures were disclosed in the South Timbalier field, an area directly in the path of the eye of Hurricane Andrew. This location reported more valve actuations than any other field location. The results from the survey also revealed more MSSV closures than any other valve, which can possibly contribute to a higher failure rate.

5 - MSSV FAILURES
11 - SSSVs PREVENTED UNCONTROLLED FLOW
