HPHT 17TR8 Test Articles: Post-Test Characterization Following Pressure Burst Testing (Final)

*Examination of F22 Materials Following Plastic Deformation from Controlled
Pressure Testing*

Prepared for the U.S. Department of the Interior, Bureau of Safety and Environmental
Enforcement

April 30, 2018

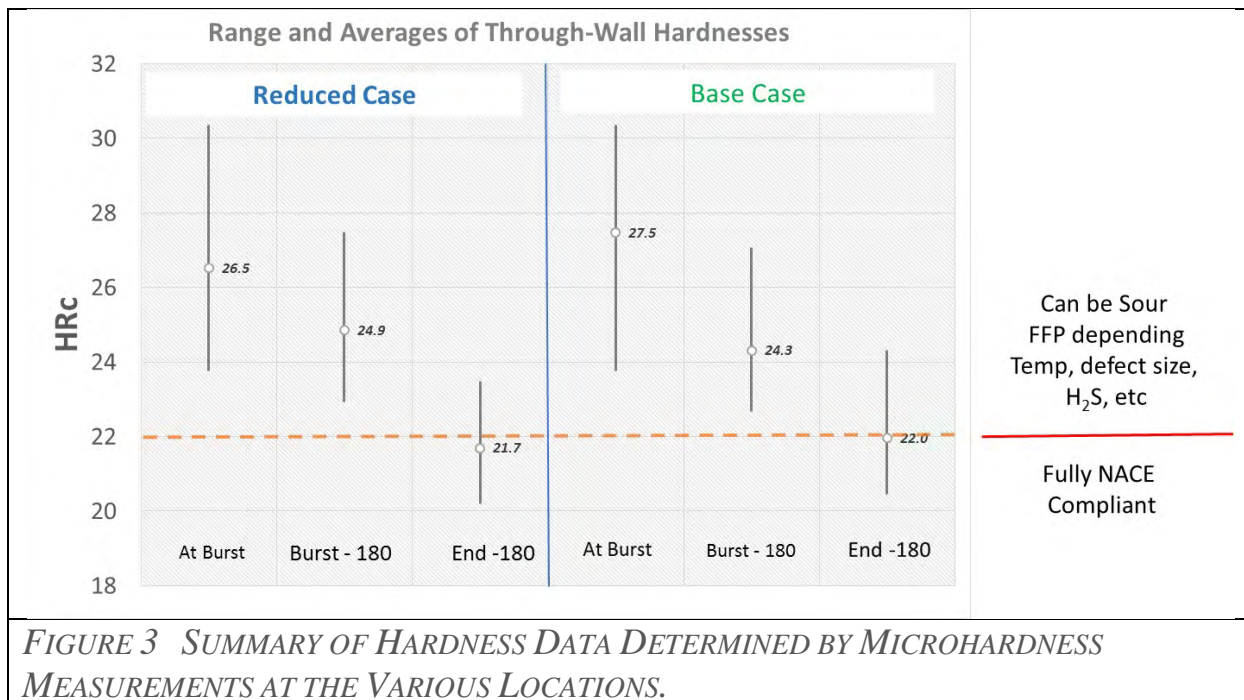
FIGURE 3 SUMMARY OF HARDNESS DATA DETERMINED BY MICROHARDNESS MEASUREMENTS AT THE VARIOUS LOCATIONS.

2. Hardness tests revealed that strain hardening caused higher hardness values at the burst and 180 degrees from burst locations (26.5 -27.5 HRc at burst location and 24.3 to 24.9 HRc at 180° to burst location versus approximately 22.0 HRc pretest).

Figure 3 shows the range and average hardness at the three chosen locations for both samples. The bar represents the range of measurements made at a location; the number associated with each bar is the average value at that location. Note the horizontal, dashed line at HRc = 22.0. Below this hardness level, material is considered fully NACE compliant, as defined by ISO 15156/NACE MR0175. Materials above the line can be used if it can be demonstrated that they are fit-for-purpose (FFP) for specific temperatures, pressures, pH, and H₂S concentrations. As shown in Figure 3, the thick material away from the burst location has hardness values showing complete compliance with ISO 15156/NACE MR0175. Near the burst location, where plastic deformation occurred, hardness can be as high at HRc 30.0.

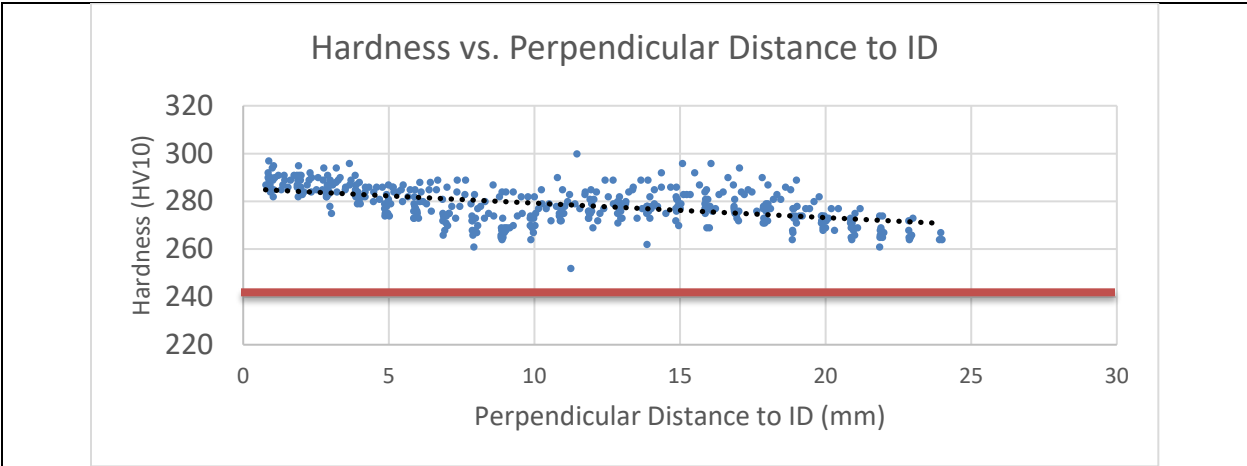
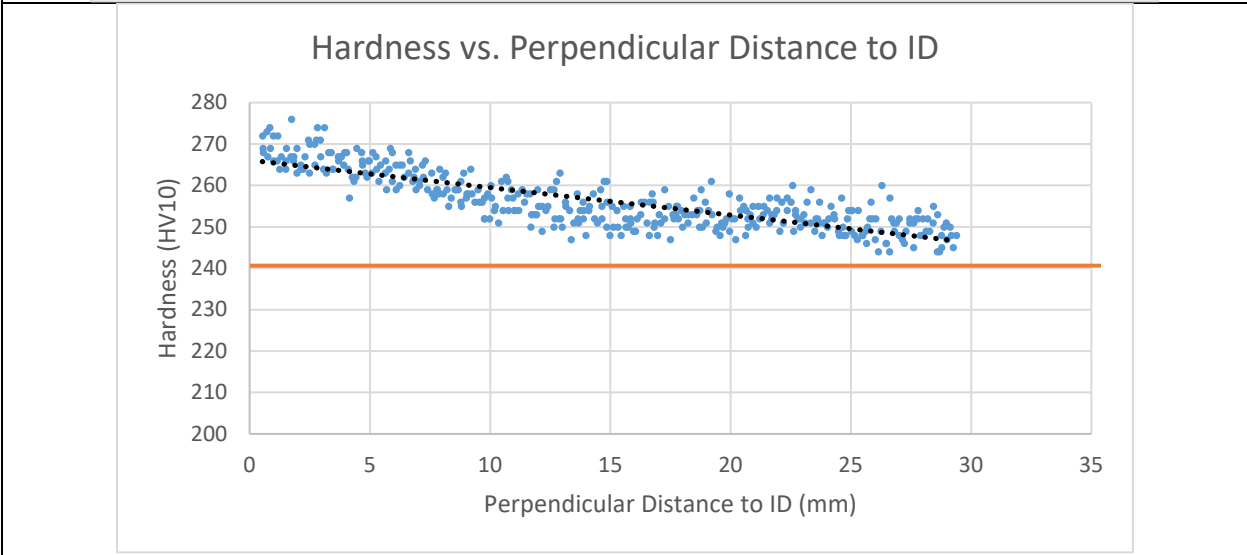
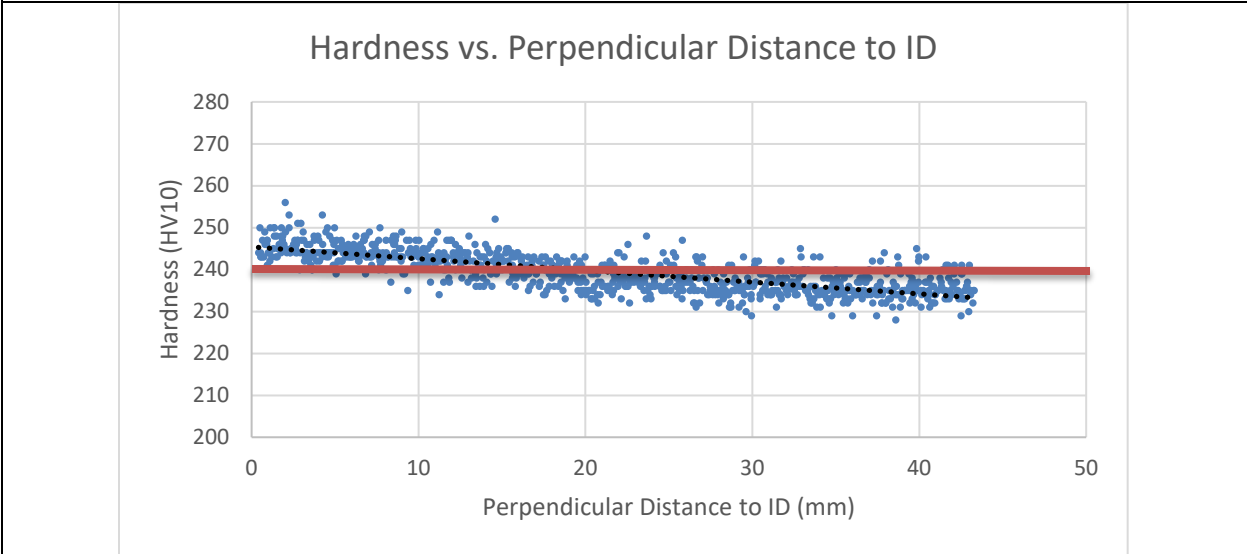
FIGURE 4 MICROHARDNESS MEASUREMENTS FOR ID TO OD OF SURFACE FOR BASE CASE SPECIMEN; TOP AT BURST LOCATION; MIDDLE CIRCUMFERENTIALLY 180 DEGREES FROM BURST; BOTTOM CIRCUMFERENTIALLY 180 DEGREES FROM BURST AT END OF THROAT

Although Figure 3 is a good visual summary of hardness measurements, it does not indicate how hardness varies from the ID to the OD surface of the throat sections. Such an indication is desirable, since fracture mechanics analysis could be employed at defects where the material is harder than HRC 22. Figures 4 and 5 show the variation of hardness across the wall thickness from the ID to the OD. These two figures show hardness values in Hv units. An HRC of 22 corresponds to an Hv value of 240 and is shown as a horizontal red line in each plot.

Close examination of Figures 4 and 5 reveals that only the ends of the throat regions (i.e., region C of Figure 2) have material values softer than Hv 240. It should be remembered, though, that the other two material regions are plastically deformed and would not be expected to deform in actual service conditions. For the throat end locations, the value of Hv 240 is fairly deep into the wall thickness. For the base case, it is 20 mm from the ID surface; for the reduced case, values greater than 240 are found completely through the wall.

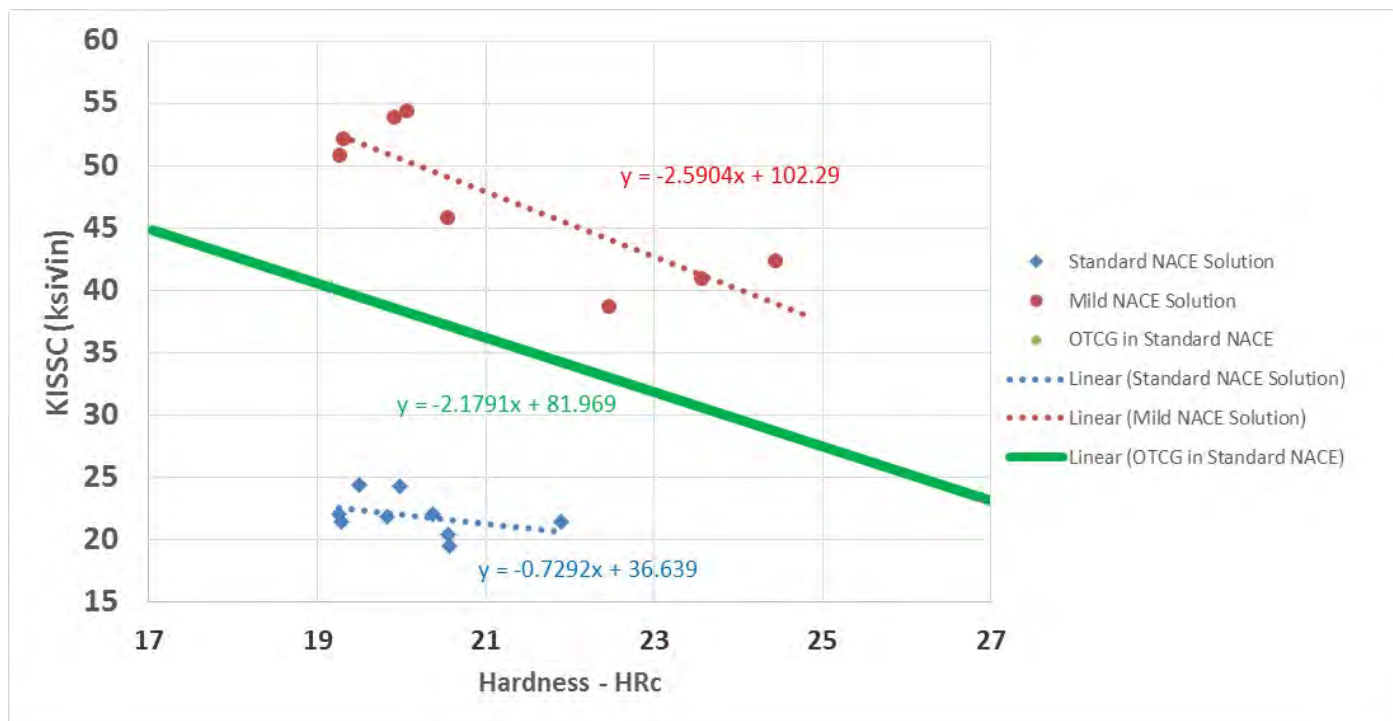
FIGURE 8 PLOT OF NACE METHOD D RESULTS FOR F22 FORGING MATERIAL AND COMPARED TO WROUGHT OCTG STEEL

The heavy, solid green line in Figure 8 is the same as the line labelled “industry” in Figure 6. This heavy, solid line shows a lower bound in SSC performance for sour grades of OCTG. As noted in the legend of Figure 8, environmental conditions were the same for the OCTG materials and for the F22 materials in the standard test solution. Also plotted in Figure 8 are the data for the F22 forging material tested under mild conditions. Two observations from Figure 8 are quite apparent:

1. The SSC performance of F22 material is greatly improved if the standard environment (i.e., 100% H₂S with initial pH of 2.7) is substituted with the mild environment (i.e., 7% H₂S with initial pH of 4.0).
2. The forged F22 material performed poorly (i.e., lower KISSC values- range of 20-25 ksi√in) in the standard environment compared to the OCTG materials (OCTG standard NACE minimum range is 33-40 ksi√in). The forged F22 and wrought OCTG materials had the same general microstructure (i.e., quenched and tempered martensite) and were tested at some of the same hardnesses (i.e., HRC values > 22.0).

The first of these observations is not surprising. One would expect a material to have better cracking resistance in less severe conditions. The second observation requires a little more explanation.

Containing less carbon than a typical C90, the F22 is processed at a lower tempering temperature. The F22 also has higher amounts of Cr, S, and Ni. Since OCTG chemistries are optimized for enhanced SSC resistance, chemistry and processing variations for the F22 result in poorer SSC resistance in the same environment and under the same loading conditions.

This report recommends that standard NACE tests should be performed to determine the sulfide stress cracking performance of the forging material and test results compared to published data on wrought steel products used for casing in sour wells.

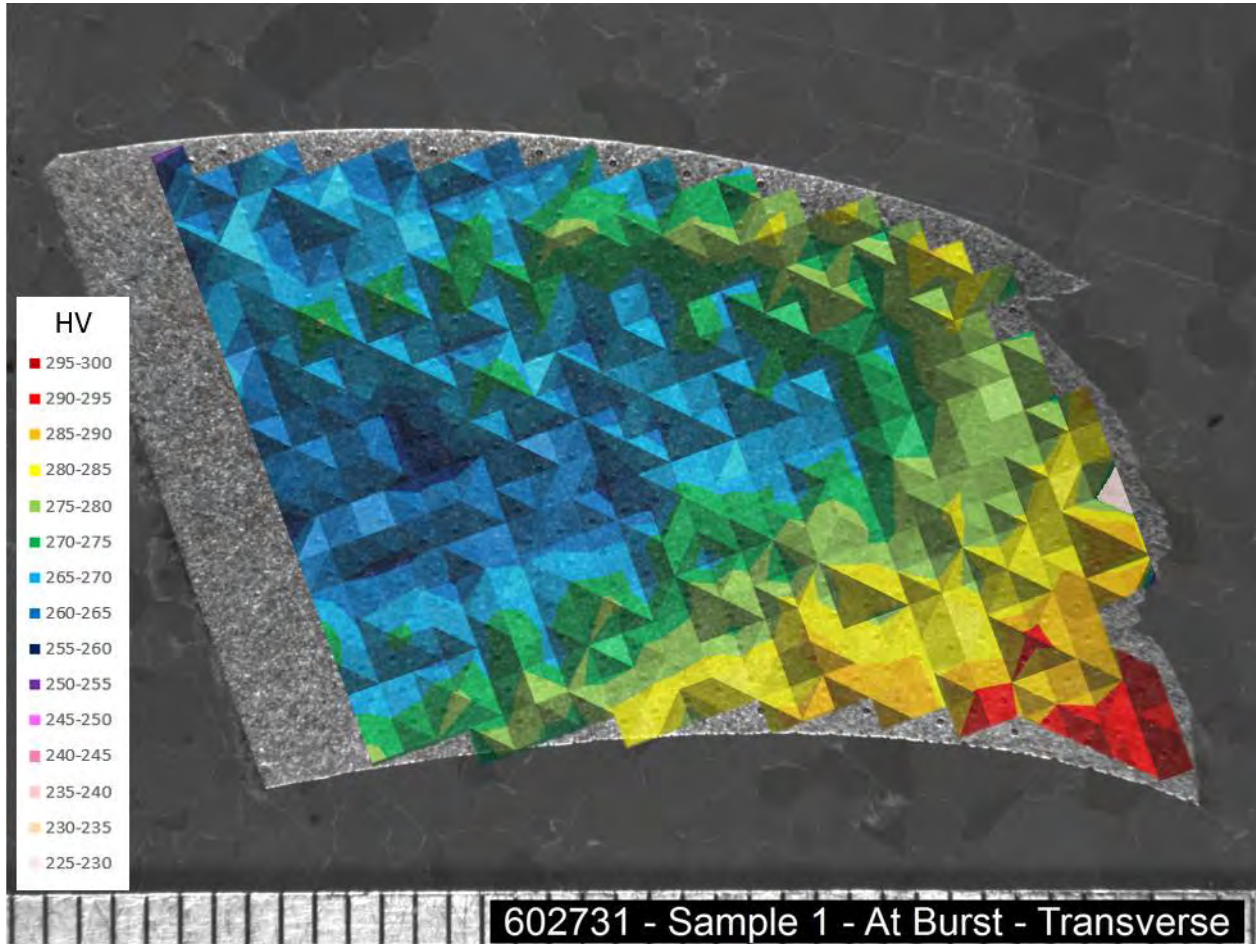
| Vickers Hardness Comparison - Sample 1 | | | | | |
|--|---|---|---|---|---|
| AtBurst | *252 | 300 | 48 | 272 | *Hardness value of 229 resulted as an invalid indent, excluded from data; next lowest is 252. High hardness near ID and fracture. High hardness at fracture is due to strain hardening. |

Figure 57: Sample 1 – Hardness Map of At Burst - Transverse Area (scale in mm)

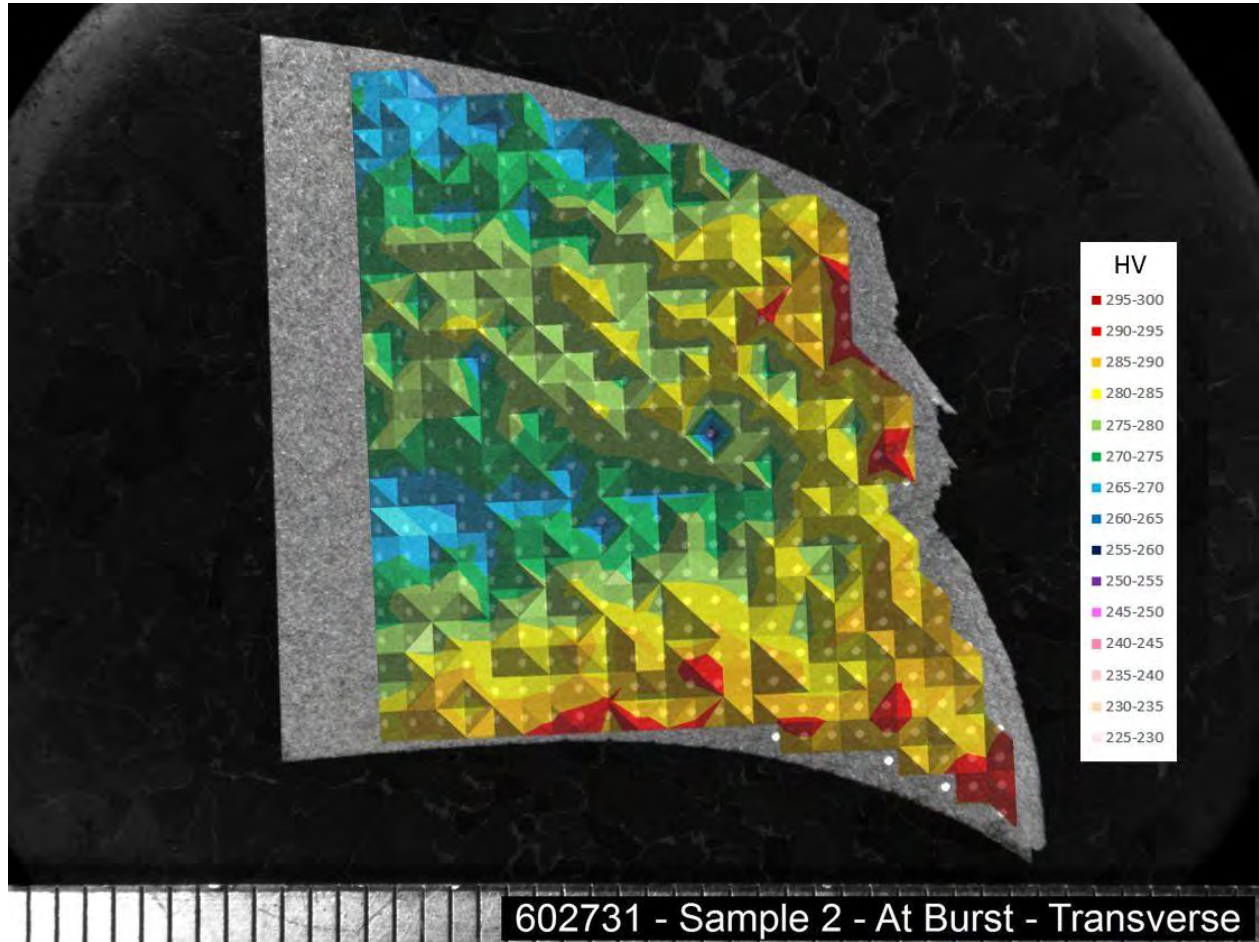
| Vickers Hardness Comparison - Sample 2 | | | | | |
|--|---|---|---|---|---|
| AtBurst | 252 | 300 | 48 | 279 | High hardness near ID and at fracture. High hardness at fracture is due to strain hardening. |

Figure 60: Sample 2 – Hardness Map of At Burst - Transverse Area (scale in mm)

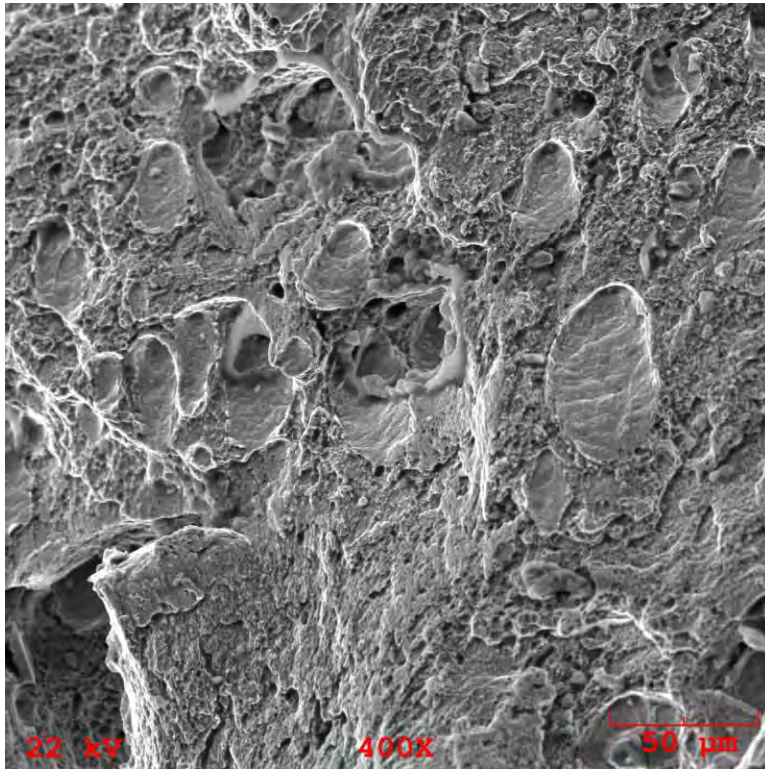
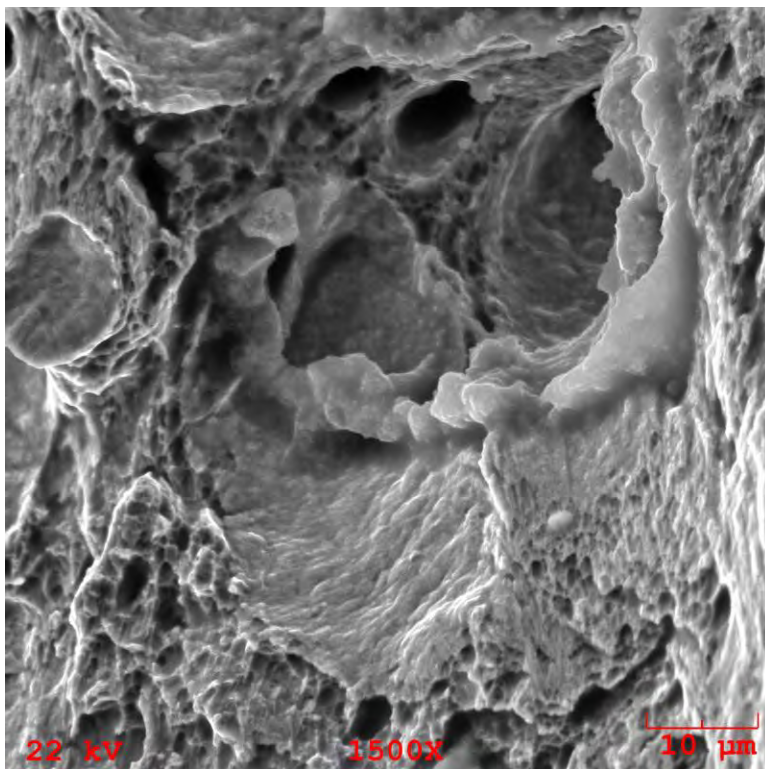
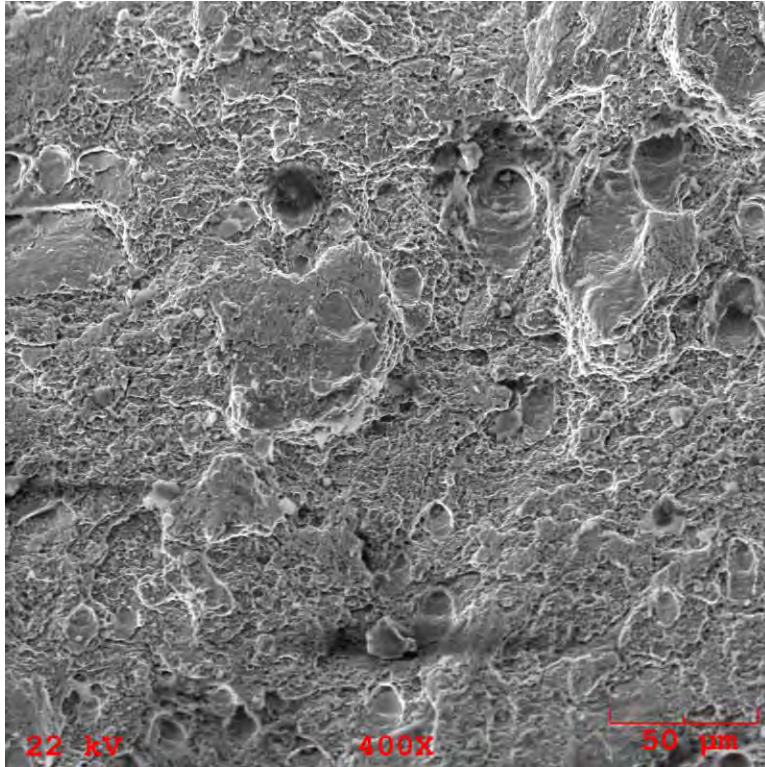
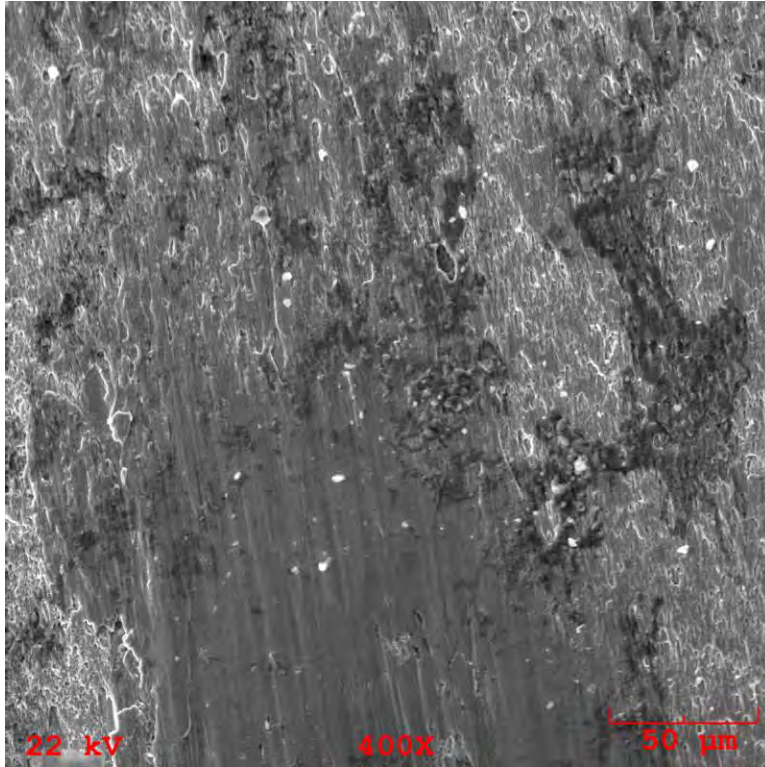
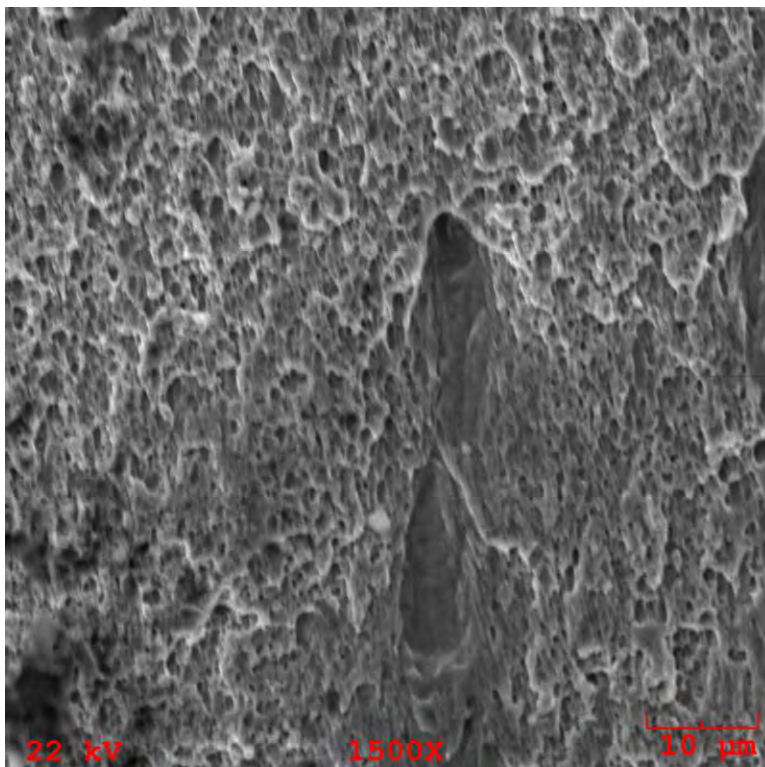
The SEM examination for both samples revealed numerous cuplike depressions consistent with dimple rupture. Elongated dimples were observed near the OD and ID. No evidence of machining or material defects were found during the SEM examination.
