SAFETY ALERT

Safety Alert No. 364
August 13, 2019

Improper Riser Tension Leads to Subsea BOP Falling Off Wellhead Mandrel and Failure of Riser Adapter

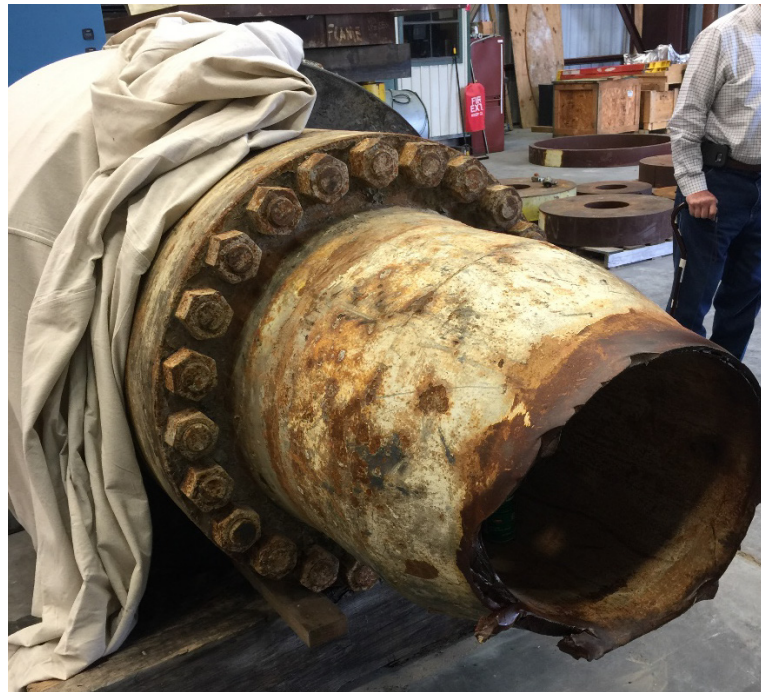
Failed Riser Adapter

On January 14, 2019, a subsea blowout preventer was being disconnected from a wellhead mandrel when the BOP rolled over due to excessive weight applied at (i.e., not enough tension on) the riser adapter and BOP stack prior to disconnecting the BOP. The weight of the riser overloaded the riser adapter, causing bending, which led to the adapter parting from the riser. The failure resulted in the disconnected BOP falling to the seafloor. Prior to the incident, the well was secured with multiple plugs; thus, no pollution occurred.

After the riser tension was adjusted, the underwater Remotely Operated Vehicle inserted the flying lead into the hydraulic stab on the BOP ROV panel and unlocked the primary connector from the wellhead. The BOP shifted to a 45-degree tilt. The resulting tilt put undue bending stresses on the tapered joint above the BOP, and it completely failed some hours later. The BOP came to rest on the seafloor after the joint failure. An independent third-party review concluded the riser adapter failed due to reduced top tension while unlatching the wellhead connector.

- Develop a comprehensive procedure for unlatching a subsea BOP. The procedure should incorporate all the necessary calculations to determine the appropriate tension settings for all unlatching scenarios. Base the procedure specifics on actual conditions including, but not limited to, weight of the BOP, water depth, weight of the drilling riser in seawater, weight of riser fluid, and all other pertinent factors.

- Unlatching procedures for BOPs should make reference to riser analysis in the body of the program and provide a hold point for review and verification of riser tension being set to the recommended setting point prior to landing the BOP and unlatching the BOP.
