SAFETY ALERT

Safety Alert No. 423

August 11, 2021

BSEE Inspector Nearly Falls Through Unsecure Grating

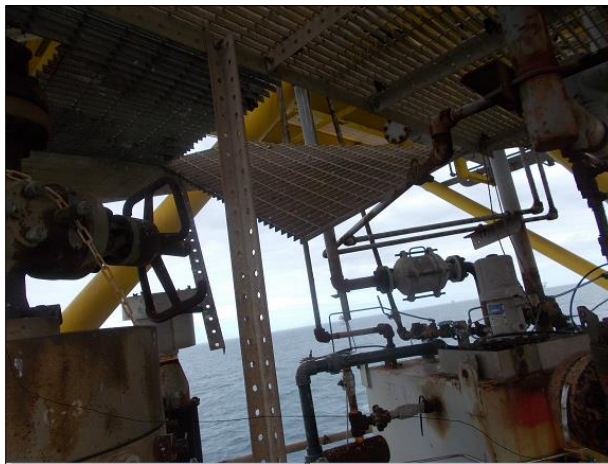
View of the loose grating from below the well bay deck.

- Pre-punched galvanized angle with bolted and/or clipped connectors were used for the construction of the permanent deck and support columns, which is not typical and not recommended.
- Due to vibration and movement, some of the connecting bolts became loose and some had completely backed out of the connections leaving framing members loose and/or unconnected.

- Install barricades to prevent personnel from entering an unsafe area if deficiencies are identified.
- Remove all wellhead access platforms erected with pre-punched galvanized angle iron from the platform in lieu of attempting salvage repairs.

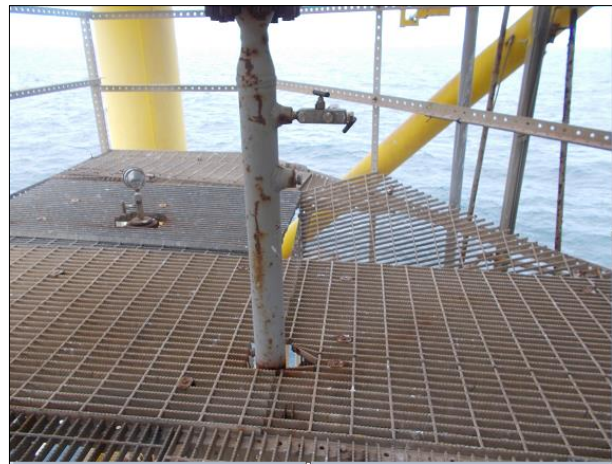
View of the loose grating from the well bay deck.
