# SAFETY ALERT

Safety Alert No. 425

August 16, 2021

## Drawworks Parking Brake Failure

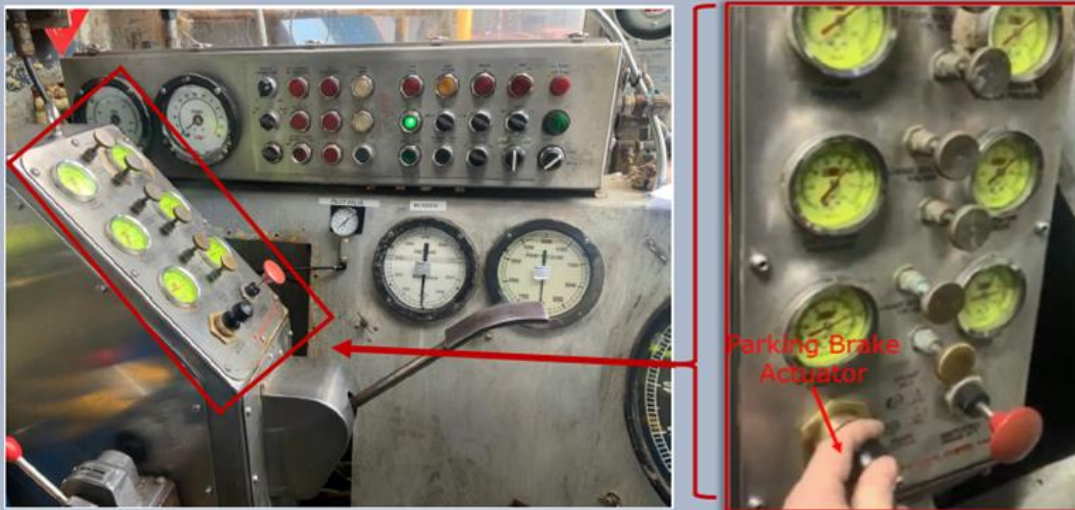
Drawworks parking brake control panel including parking brake actuator knob

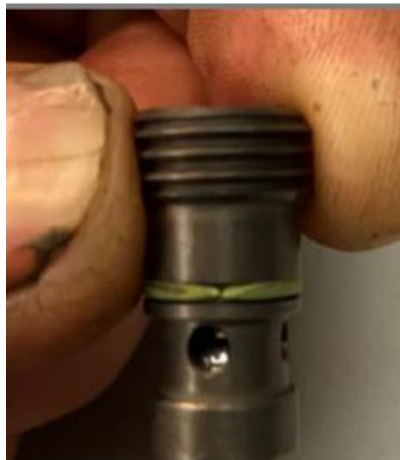
The team was able to simulate the brake failure. The brake would not function as designed with a pilot pressure range of 32-40 psi, when the pilot line should have been zero pressure. The maintenance crew found the following issues: 1). Cut O-ring on a shuttle valve, 2). Internal leaking on the emergency stop piloted valve, 3). Leaking crown-o-matic toggle valve. (See below.)

Shuttle valve cut O-ring

After replacing the faulty components, the team successfully functioned the brakes 93 times and then successfully performed and documented brake endurance testing.

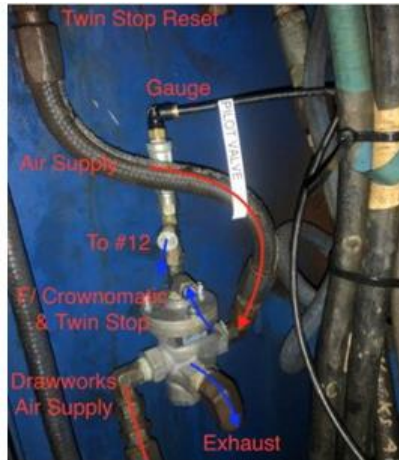
Emergency stop piloted valve

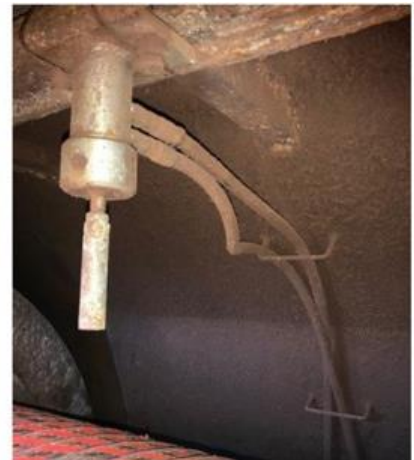
Crown-o-matic toggle valve
