# SAFETY ALERT

Safety Alert No. 428  
February 17, 2022

## Flexible Intermediate Bulk Container (FIBC) Parted Straps Result in Near Misses

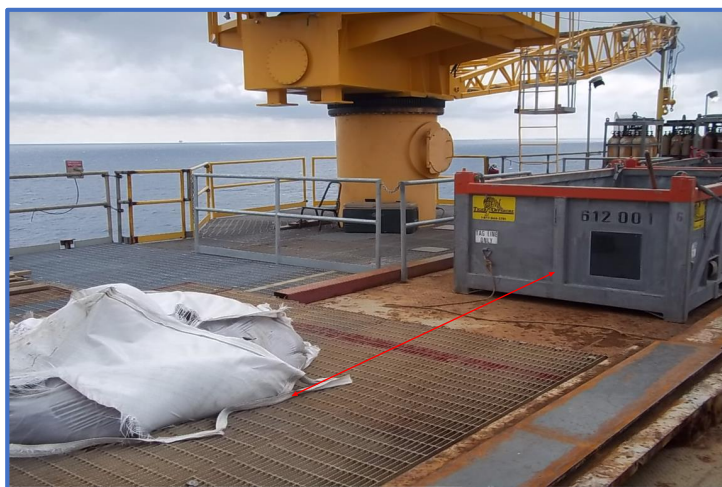
Figure 1. FIBC Load travel Path from the Cargo Basket to the Drop Zone 17 Feet Away

- October 2021: In preparation to trip and lay-out drillpipe, drill floor personnel communicated the need for additional thread protectors. The crane crew rigged up an FIBC containing multiple thread protectors to be transported to the nearby pipe rack area. The crane operator swung the load slightly over the pipe rack when the designated signal person observed the straps breaking and the FIBC ripping apart. Two thread protectors fell out of the FIBC onto the pipe rack six feet below. No crew members were in the drop zone at the time of the incident.

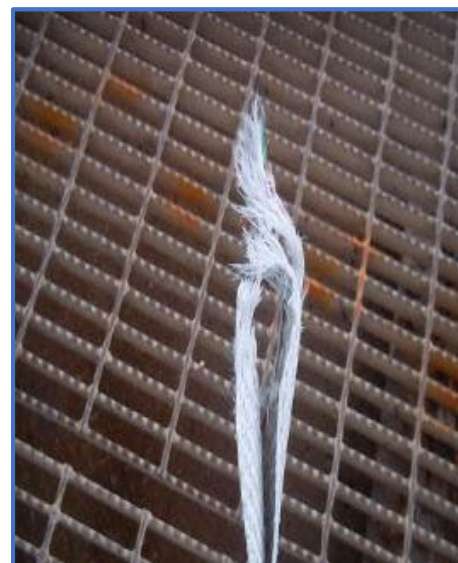
Figure 2. Broken FIBC Strap

- September 2021: An FIBC containing blasting operations material was lifted out of a cargo basket by the platform crane using its pre-manufactured straps. Upon moving the load out and away from the cargo basket, one of the straps failed (Figure 2), transferring the weight of the load to the other strap, which subsequently failed due to exceeding its load capacity. The FIBC dropped 5 feet onto the deck grating below (Figure 1).
- September 2021: While a forklift was lifting an FIBC containing lost circulation material for drilling operations, tension on the FIBC straps caused two of the four straps to part. The FIBC was not dropped from an

elevation as the load never became suspended. However, the accelerated whiplash due to the straps failing resulted in the FIBC spilling a gallon of its dry chemical contents onto the deck. Personnel promptly cleaned up the material in the area.

The primary contributing factor associated with these failures is the prolonged exposure of the FIBCs to inclement weather and other natural elements, resulting in their rapid degradation and subsequent failures. A recurring conclusion from the incident investigations suggested that the FIBCs were saturated with water and had debris on their outer linings due to Hurricane Ida in early September 2021. Additionally, polypropylene is the primary component used to manufacture FIBCs, which is known to deteriorate over time when exposed to ultraviolet light. The lack of adequate storage potentially compromised the original integrity of the FIBCs.

- Confirm the weight limitation of the FIBC before lifting the load.
- Establish a Quality Assurance / Quality Control program to ensure FIBCs are adequately stored before transportation to minimize any adverse effects from weather or ultraviolet light.

- Ensure FIBCs are kept out of the cold weather (< 32 deg F) when not in use. Under a heavy load or unevenly distributed load in below freezing temperatures, the straps can become brittle, which could lead to a loss of the load when lifted.

- Generate an inspection protocol and remove the FIBC from service before lifting if any degradation is observed in the pre-manufactured straps..
- Emphasize during safety meetings before the job that the force applied to each FIBC strap is equally distributed to prevent overloading.

- Update applicable policies and procedures to include alternative lifting methods, such as transferring FIBC material via pre-slung baskets instead of utilizing the pre-manufactured FIBC straps.

- Ensure a 4-point lifting technique is applied to the FIBC straps to maintain the integrity of the load as designed in place of utilizing a single-point lift.
- Confirm the contents in the FIBC are compatible with all FIBC components before offloading to the facility. FIBCs may not be the approved storage device for some materials, as certain products may have an adverse effect on their overall integrity.
