SAFETY ALERT

Safety Alert No. 433

March 16, 2022

Crane Anti-Two Block Weight Pulled into Boom Tip Causing Damages to Auxiliary Cable and Sheave

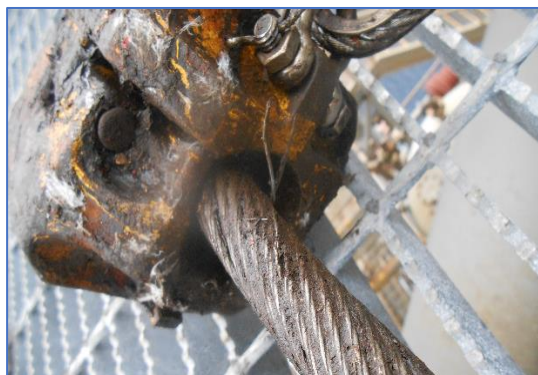
Auxiliary line protruding wire and A2B sensor weight

An investigation by the Operator concluded a protruding broken strand carried the A2B weight on the auxiliary cable and into the boom tip sheave. The Operator reported the A2B alarm was bypassed during both lifting incidents.

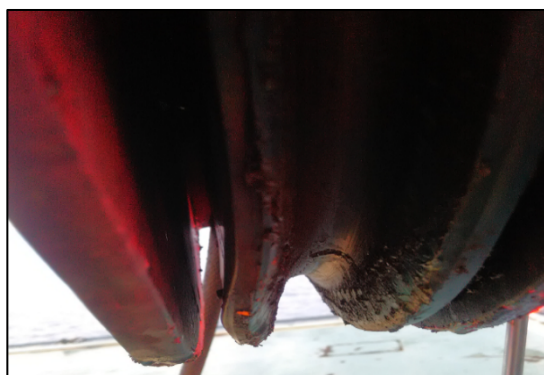
Damaged auxiliary line on drum

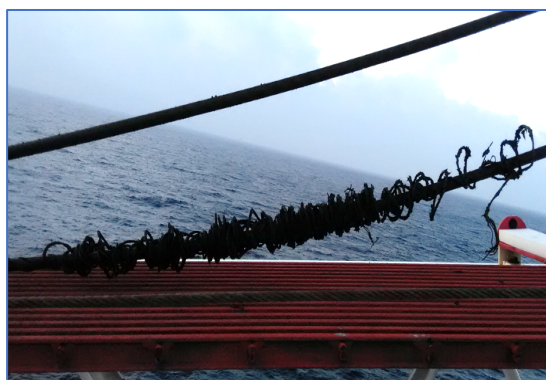
Damaged auxiliary line

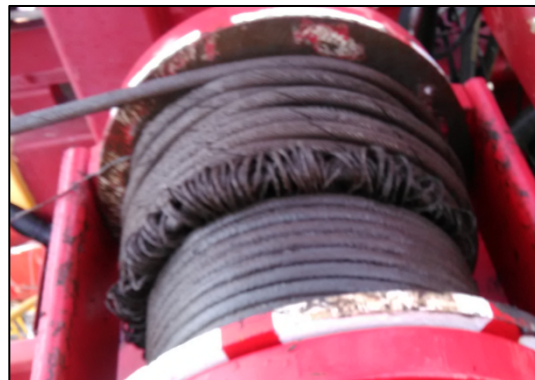
Damaged auxiliary line boom tip sheave

in bypass, hoisted the auxiliary line up without a load attached, and placed the crane boom over the heliport for another inspection by the crane mechanic. It was discovered that the A2B weight was carried into the boom tip and damaged the sheave and auxiliary cable. The crane was subsequently placed out of service.

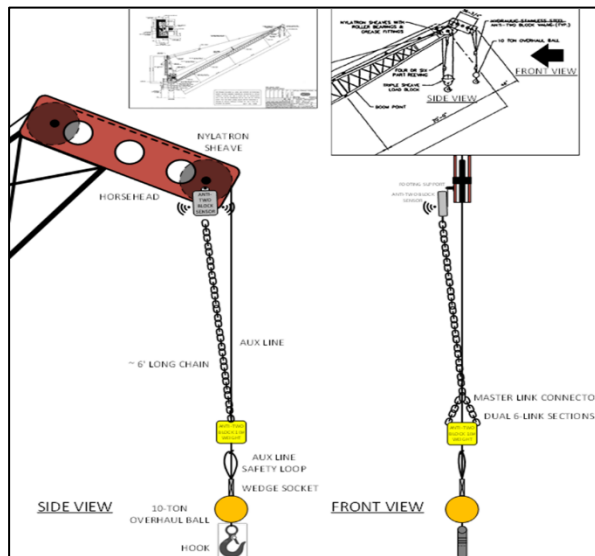
As a corrective action to this incident, the Operator removed chains and installed retention cables from the wireless A2B sensor to the weight. This change was also implemented on other platform cranes where chains were installed. The annual crane inspection conducted several months before the Dec. 31, 2021, incident revealed the A2B system worked but after the chains were removed and cables installed, the wireless A2B sensor would trip when mostly loading and unloading boats. This finding was noted as a recommendation instead of deficiency and was not corrected prior to the incident.

Illustration of chain installation

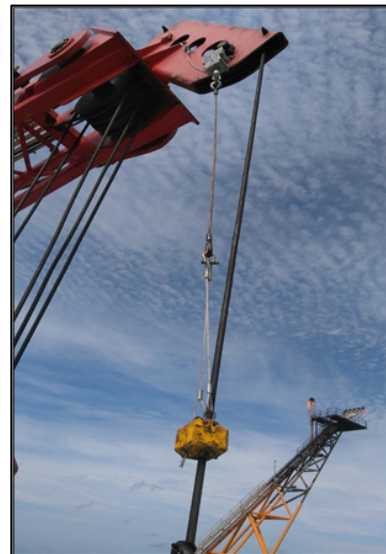
Picture of cable installation

- Promoting the topic of crane safety during Health, Safety and Environment (HSE) meetings.
- Updating the crane manuals, and procedures to reflect the use of cables instead of chains. Adjust inspection and maintenance procedures if appropriate to account for the use of cables.
