SAFETY ALERT

Safety Alert No. 362
July 29, 2019

Poor Tag Line Awareness Leads to Multiple Incidents

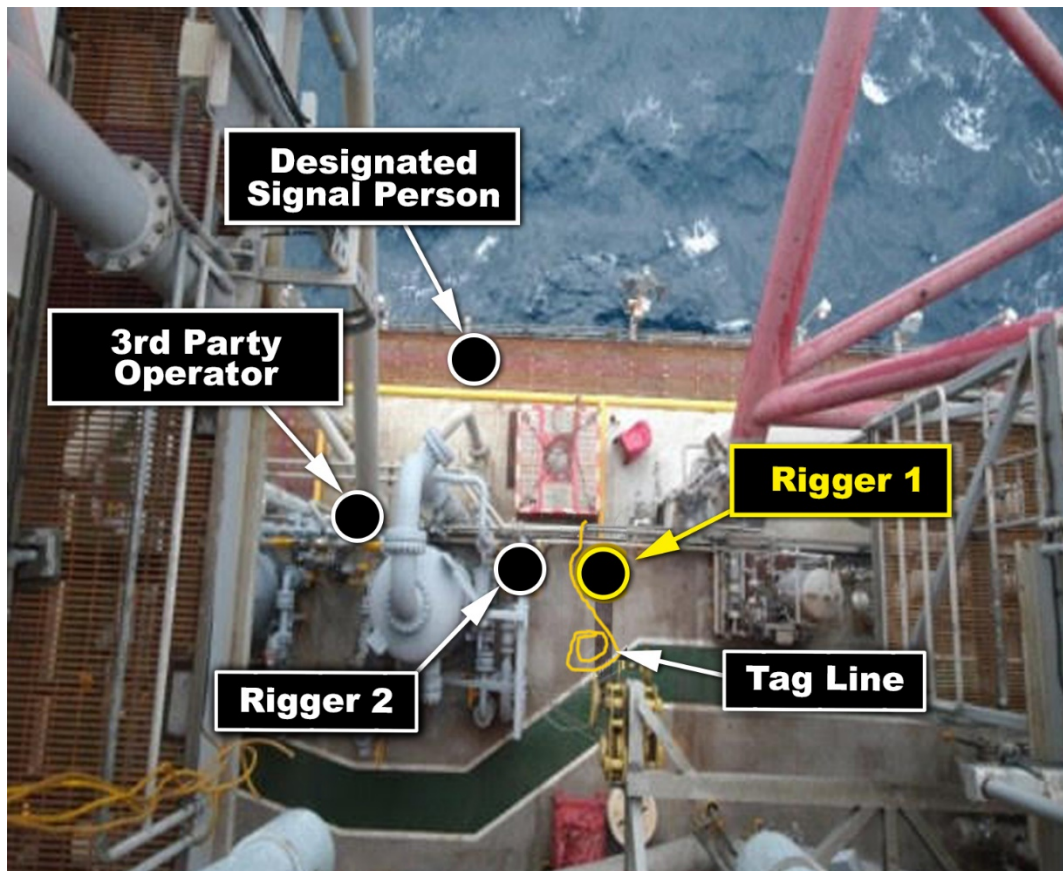
Layout of lift with the locations of relevant parties in January 2019 Incident. Rigger 1 became entangled in the excess tag line (the tag line in this photo was inserted to simulate conditions prior to the incident).

January 2019 – During a blind lift to move a tank to a new location, a rigger grasping one of the tag lines was unknowingly standing in a loop in the middle section of the tag line. As the load lifted vertically, the crew lead noticed that the tag line had wrapped around the rigger's ankle and called an "all-stop." Before the crane operator could stop all activity, the rigger was lifted approximately five feet off the deck. The crane lowered the worker to the deck without injury.

- Make sure riggers are mindful of tag line locations prior to starting a lift. Riggers should stand away from the tag line to prevent entanglement.
- Ensure that crane operators verify, via hand signals and/or radio, that all riggers and spotters are ready before beginning a lift.

- During lift planning, ensure that there will always be more than one way to communicate an “all-stop” to the crane operator.
- Have workers check for proper tag line length before each lift. Excess tag line length is always a potential hazard for entanglement. During pre-job meetings, dangers associated with tag line entanglement should be discussed.

- During pre-job planning, consideration should be given to the effects of vessel motion (heave and displacement) on tag line length, slack, and personnel situational awareness.

- Ensure that all personnel understand the risks associated with tag lines and perform the necessary risk assessments and calculations required for the job.
