# SAFETY ALERT

**Safety Alert No. 409**  
**February 8, 2021**

## Fall from Platform Results in a Fatality

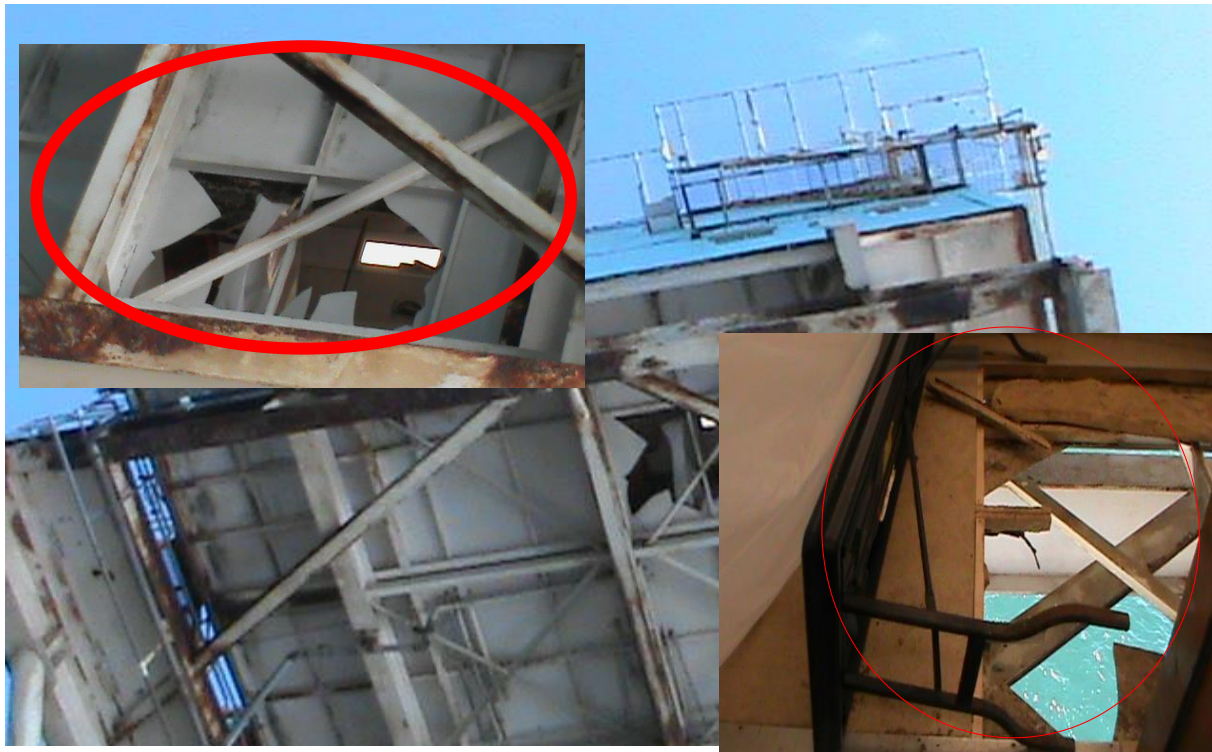
On December 2, 2020, an incident resulting in a fatality occurred while repairing the sub-flooring of a platform galley. The repair required removal of all layers of floor except the cementitious material layer used as a moisture barrier in the original design of the quarter/galley flooring. A member of the repair crew stood on this layer and when another employee, not part of the repair crew, stepped onto the layer, the material shattered, and the two employees fell approximately 80 feet into the ocean.

*Images of the shattered floor material*

- Check for a similar design on their facilities and inspect them for signs of potential danger; and,
- Always barricade and restrict access to work areas.
