SAFETY ALERT

Safety Alert No. 424
August 12, 2021

Recent Uptick in Lifting Injuries due to Unrecognized Pinch Point Hazards

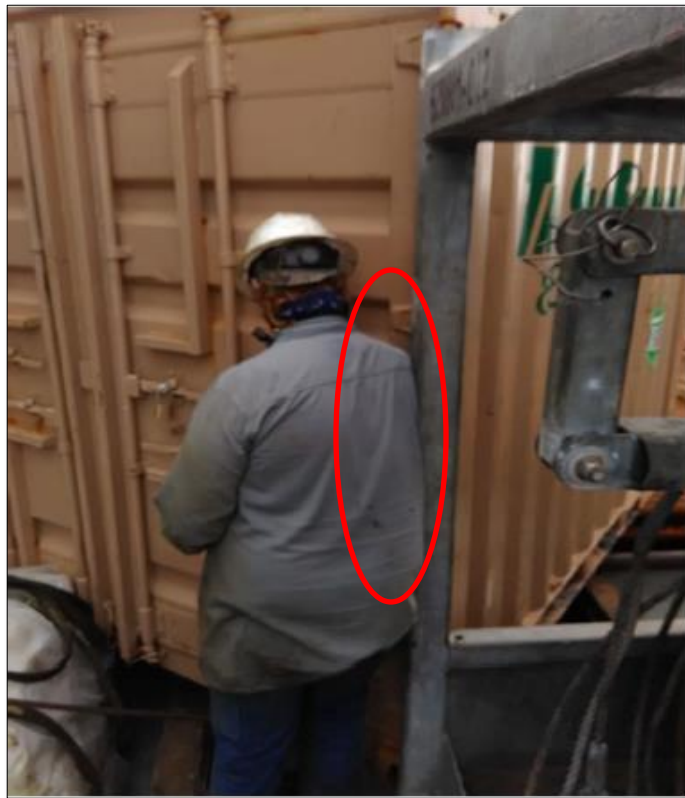
Re-enactment of Pinch Point Location as Identified in Incident #1.

Incident #1: Rig floor personnel attempted to reposition a Connex box initially set in a precarious orientation on a pipe rack. When the crane operator began to lift the load, the box inadvertently shifted, causing the box to pin the arm of the individual monitoring the load between a sling rack and the load (see photograph above). The injured person sustained bruising and abrasions on his right arm.

Therefore, BSEE recommends that operators and contractors consider the following:

- Verify all designated flaggers assigned to monitoring the load can maintain open communication and a clear line of sight throughout the lift.
- Ensure pre-job reviews contain discussion points for reducing the risk of a pinch point incident occurring, such as load dimensions, load travel path, environmental conditions (i.e., sea state and wind speed), and Stop Work Authority.
- Confirm the boom is centered over the load before the lift to minimize the potential for the load to swing.
- Validate an adequate amount of deck space is available to maneuver, control, and land the load safely.
- Emphasize to field crews Hands-Off / Hands-Free standards when a load is in suspension or transit.
- Promote the use of taglines throughout the entire lifting operation.
