SAFETY ALERT

Safety Alert No. 435

Breakdowns in Communication and Preparation Lead to Failure of Synthetic Slings

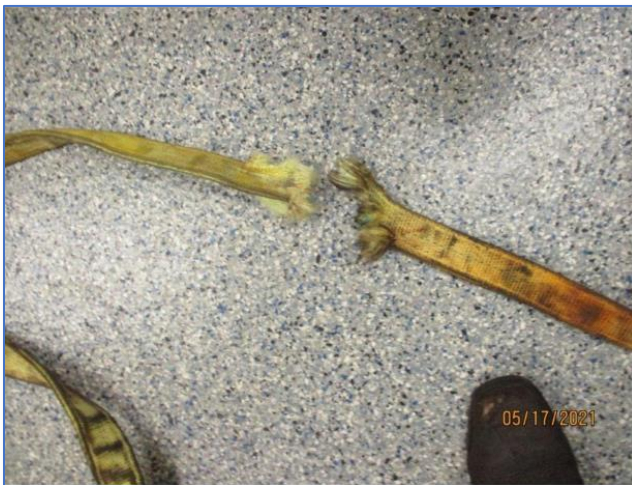
Figure 1. One of the Two Frayed / Parted Synthetic Slings from the Incident

- Despite personnel anticipating the weight of the load to be 9,000 pounds, the actual reading was more than 15,000 pounds once the load was set on the main block. The initial calculations failed to consider additional crane components, such as the winch, ladder, and ropes.

- Personnel improperly rigged the slings using a choker configuration. This sling arrangement did not have the capacity to safely lift the original 9,000-pound anticipated weight.

- Incorporating an additional verification measure for confirming the accuracy of load weight calculations prior to commencing operations. Reviewing calculations when discussing operational procedures could help to verify the information.

- Ensuring slings are rigged in the most advantageous configuration to secure the load through the entirety of the lift.
- Initiating SWA and reassessing the job scope if any activity is observed to be unsafe or unforeseen, despite positional ranking, years of experience, or seniority level.

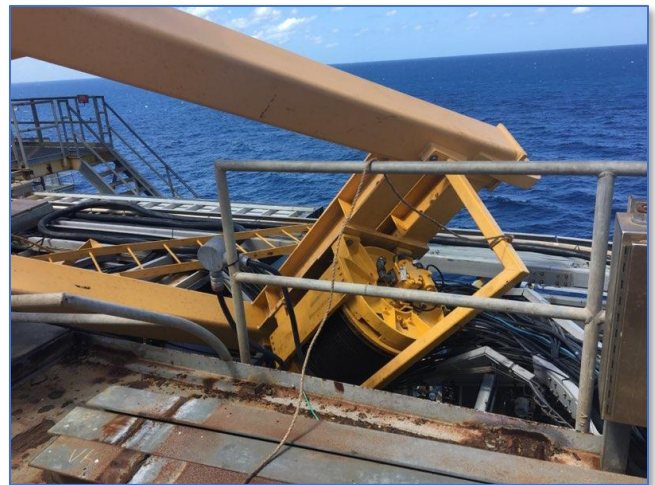
Figure 2. Gantry Contacting and Damaging the Cable Tray and Bending the Main Deck Handrail

After holding a morning safety meeting, the crew proceeded to prepare for the demobilization. To remove the gantry by use of a rental crane, the lift required the application of two synthetic (i.e., polyester) slings on the rental crane auxiliary line in combination with a two-part wire rope sling on the rental crane main line. The two polyester slings were tied to the bottom section of the gantry to assist with the orientation of the load. When attempting to lift and rotate a section of the gantry, one of the polyester slings failed, which caused the weight to shift to the remaining polyester sling. As a result of this additional weight, the secondary polyester sling subsequently failed (Figure 1). With the slings compromised, the load fell approximately six feet to the deck, striking a handrail and a portion of the facility's cable tray containing electrical wiring (Figure 2). There were no injuries associated with this event.
