Investigation of H₂S Gas Release Platform Hermosa, OCS-P 0316 Pacific OCS Region

August 3, 1999

Prepared By

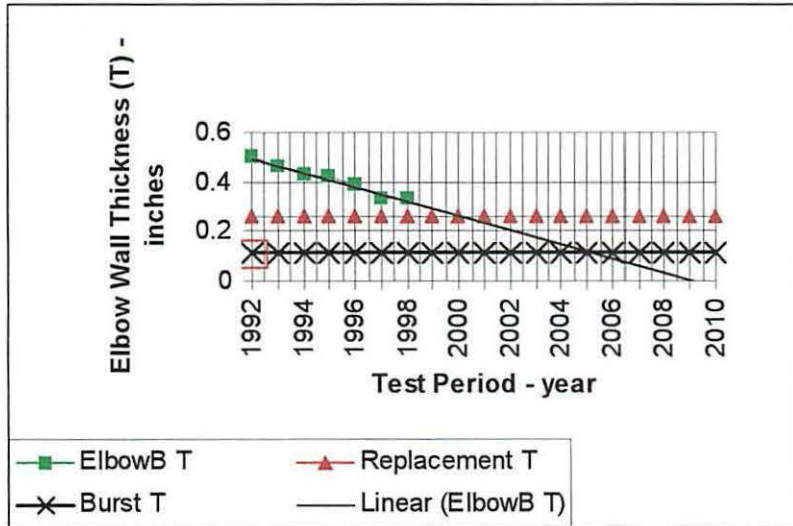
Figure 1. Elbow Thickness Upstream of Rupture.

It is common practice among all Pacific OCS Region facility operators to use the A-scan UT to spot check wall thickness at predetermined points along process piping (e.g., every second or third fitting and pipe length). Chevron followed this commonly used practice, but the elbow that failed was never tested. The wall thickness of the ruptured elbow was nearly half the thickness reading found on the elbows just upstream and downstream of the failure.

Using criteria A above and the UT data collected by Chevron from 1992 to 1998, the piping at Platform Hermosa was graphed. These graphs, shown in Figures 1 and 2 on the following page, use data collected immediately before and after the ruptured elbow. The trend lines, identified in the legend as "linear (Elbow T)," project that at the current rate of corrosion upstream of the ruptured elbow, the piping would reach its replacement thickness, 0.026 inch, in the year 2000 and would burst in the year 2005 if left unchecked (Figure 1). Figure 2 shows that the portion downstream of the ruptured elbow would reach its replacement thickness in 2005 and would not reach the burst thickness until after 2010.

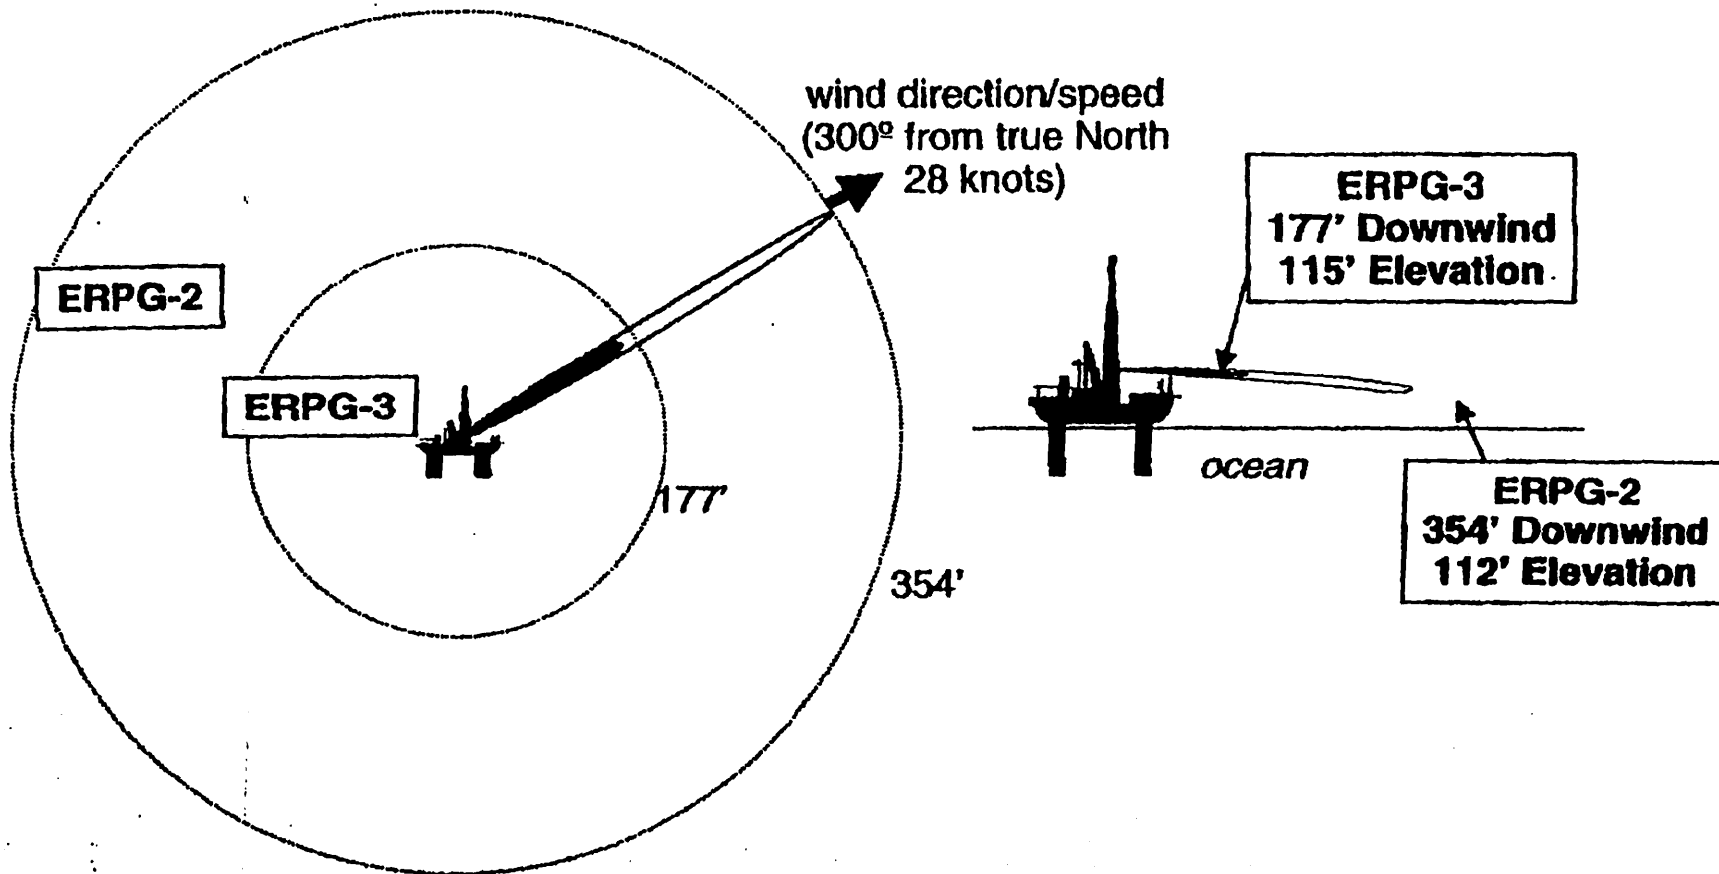
Figure 1 H₂S Toxic Hazard Footprints for Point Arguello Offshore Gas Release on August 3, 1999

Results of the consequence modeling are presented in Table 2. Figure 1 shows a plot of the H₂S toxic hazard zones. These results indicate that hydrogen sulfide concentrations exceeding the ERPG-3 level, which could be life threatening, would be limited to the vicinity around the platform with the hazard zone extending approximately 177 feet (53.9 meters) from the platform. The hazard zone would have had a maximum width of approximately 13 feet (3.9 meters). At the farthest downwind distance the plume would have been approximately 115 feet (35 meters) above the water level. Therefore, the H₂S toxic cloud would not have represented a hazard to boaters in the area.

Potential serious injuries, as represented by the ERPG-2 level, would also be limited to an area near the platform. The ERPG-2 hazard would extend approximately 354 feet (108 meters) from the platform. The hazard zone would have had a maximum width of approximately 31 feet (9.4 meters). At the farthest downwind distance the plume would have been approximately 112 feet (34 meters) above the water level. Therefore, the H₂S toxic cloud would not have represented a hazard to boaters in the area.

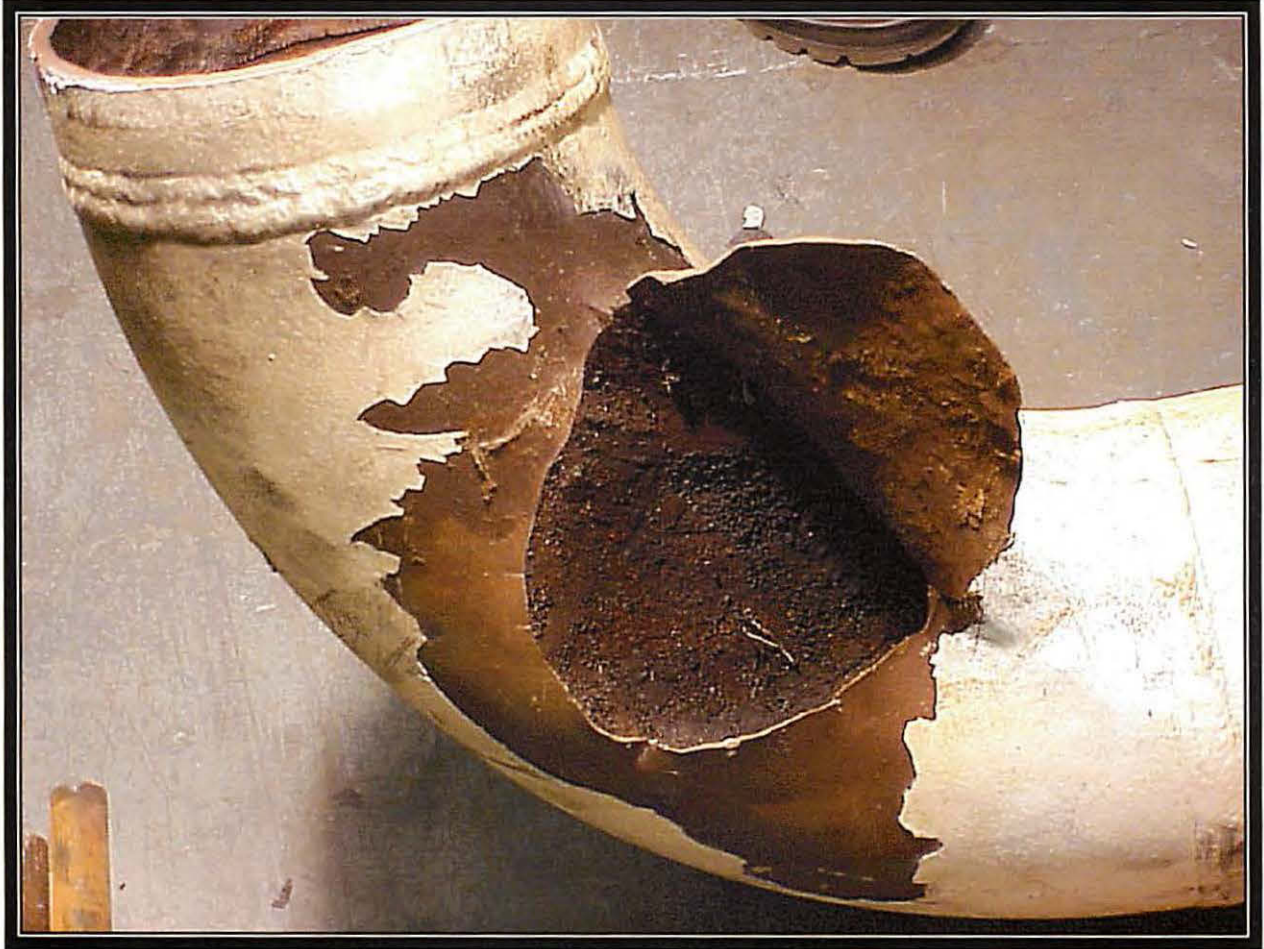
Appendix A.5-Ruptured Elbow and Surrounding Damage

The flowline failed due to internal corrosion, which reduced the wall thickness until it could no longer support the normal operating pressure. Corrosion was caused by condensed liquid water reacting with H₂S gas to form a corrosive acid gas.

The original nominal wall thickness of the flowline was 0.50 inch. The thickness at the rupture was 0.14 inch. Per ASME B31.3, the minimum allowable operating thickness for 1209 psi is 0.26 inch and the burst thickness is 0.11 inch.

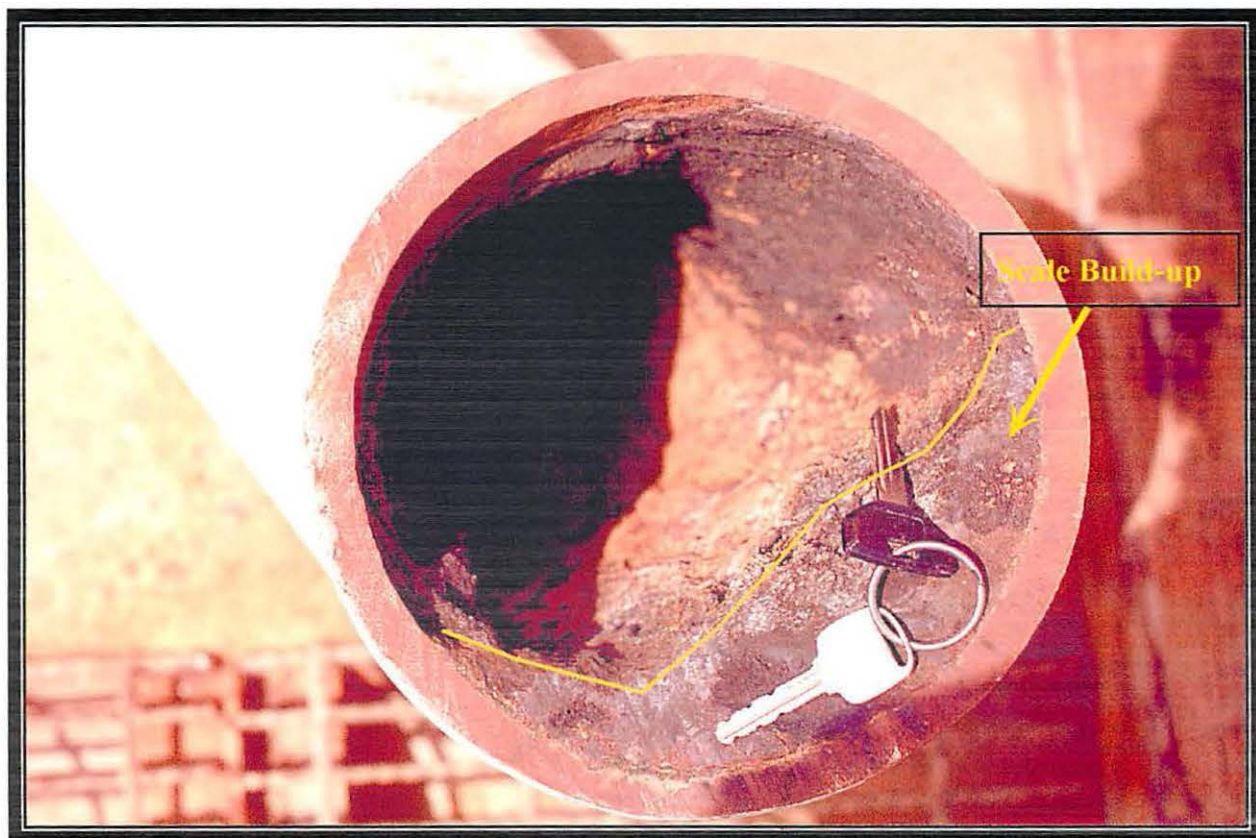
Appendix A.8-Scale Build-up in Flowline

The results of the scale analysis confirm that H₂S was responsible for the corrosion. In three of the four scale samples analyzed, the XRD showed major iron sulfide (FeS) present with minor FeS present in the fourth sample. The FeS is a by-product of corrosion occurring in the flowline ($\text{Fe} + 2\text{H}_2\text{S} \Rightarrow \text{FeS} + 2\text{H}_2$).

The heavy FeS scale deposition upstream of the failure location is a by-product of the corrosion occurring in the flowline. Chevron believes that similar scale also existed in the failed elbow, but was dislodged by the force of the rupture.
