**Investigation of Fatality  
South Marsh Island Block 130  
OCS-G 02280  
December 6, 2003**

Gulf of Mexico  
Off the Louisiana Coast

U.S. Department of the Interior  
Minerals Management Service  
Gulf of Mexico OCS Regional Office

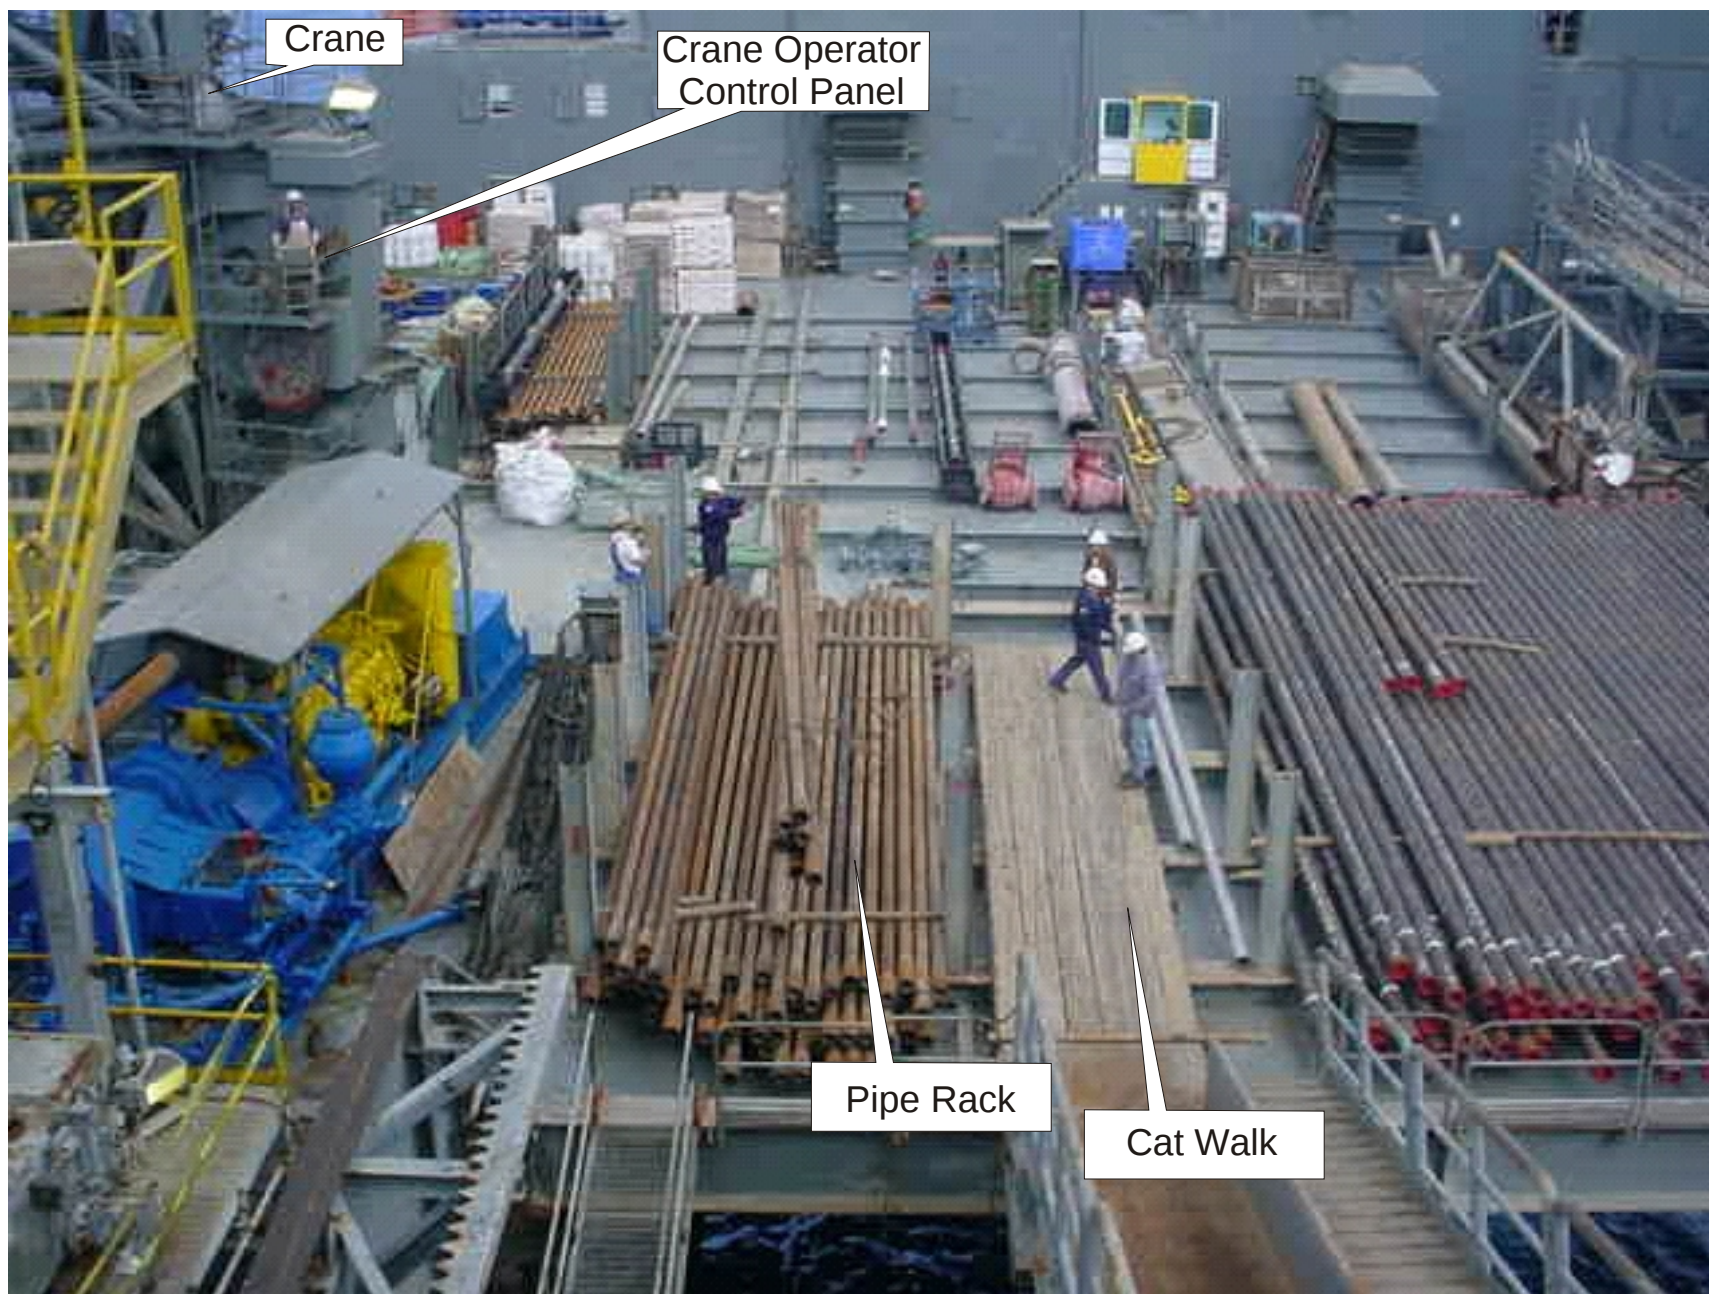
On the evening of December 6, 2003, the Rowan crane operator and three Rowan roustabouts began the task of lifting bundles of 5-inch drill pipe by crane from the pipe rack to the adjacent cat walk for eventual placement on the rig floor. *For a photograph of the pipe rack taken from the derrick, see Attachment 2. For a photograph of the pipe rack taken from the opposite direction (from the living quarters), see Attachment 3.*

Photograph of pipe rack as seen from derrick.

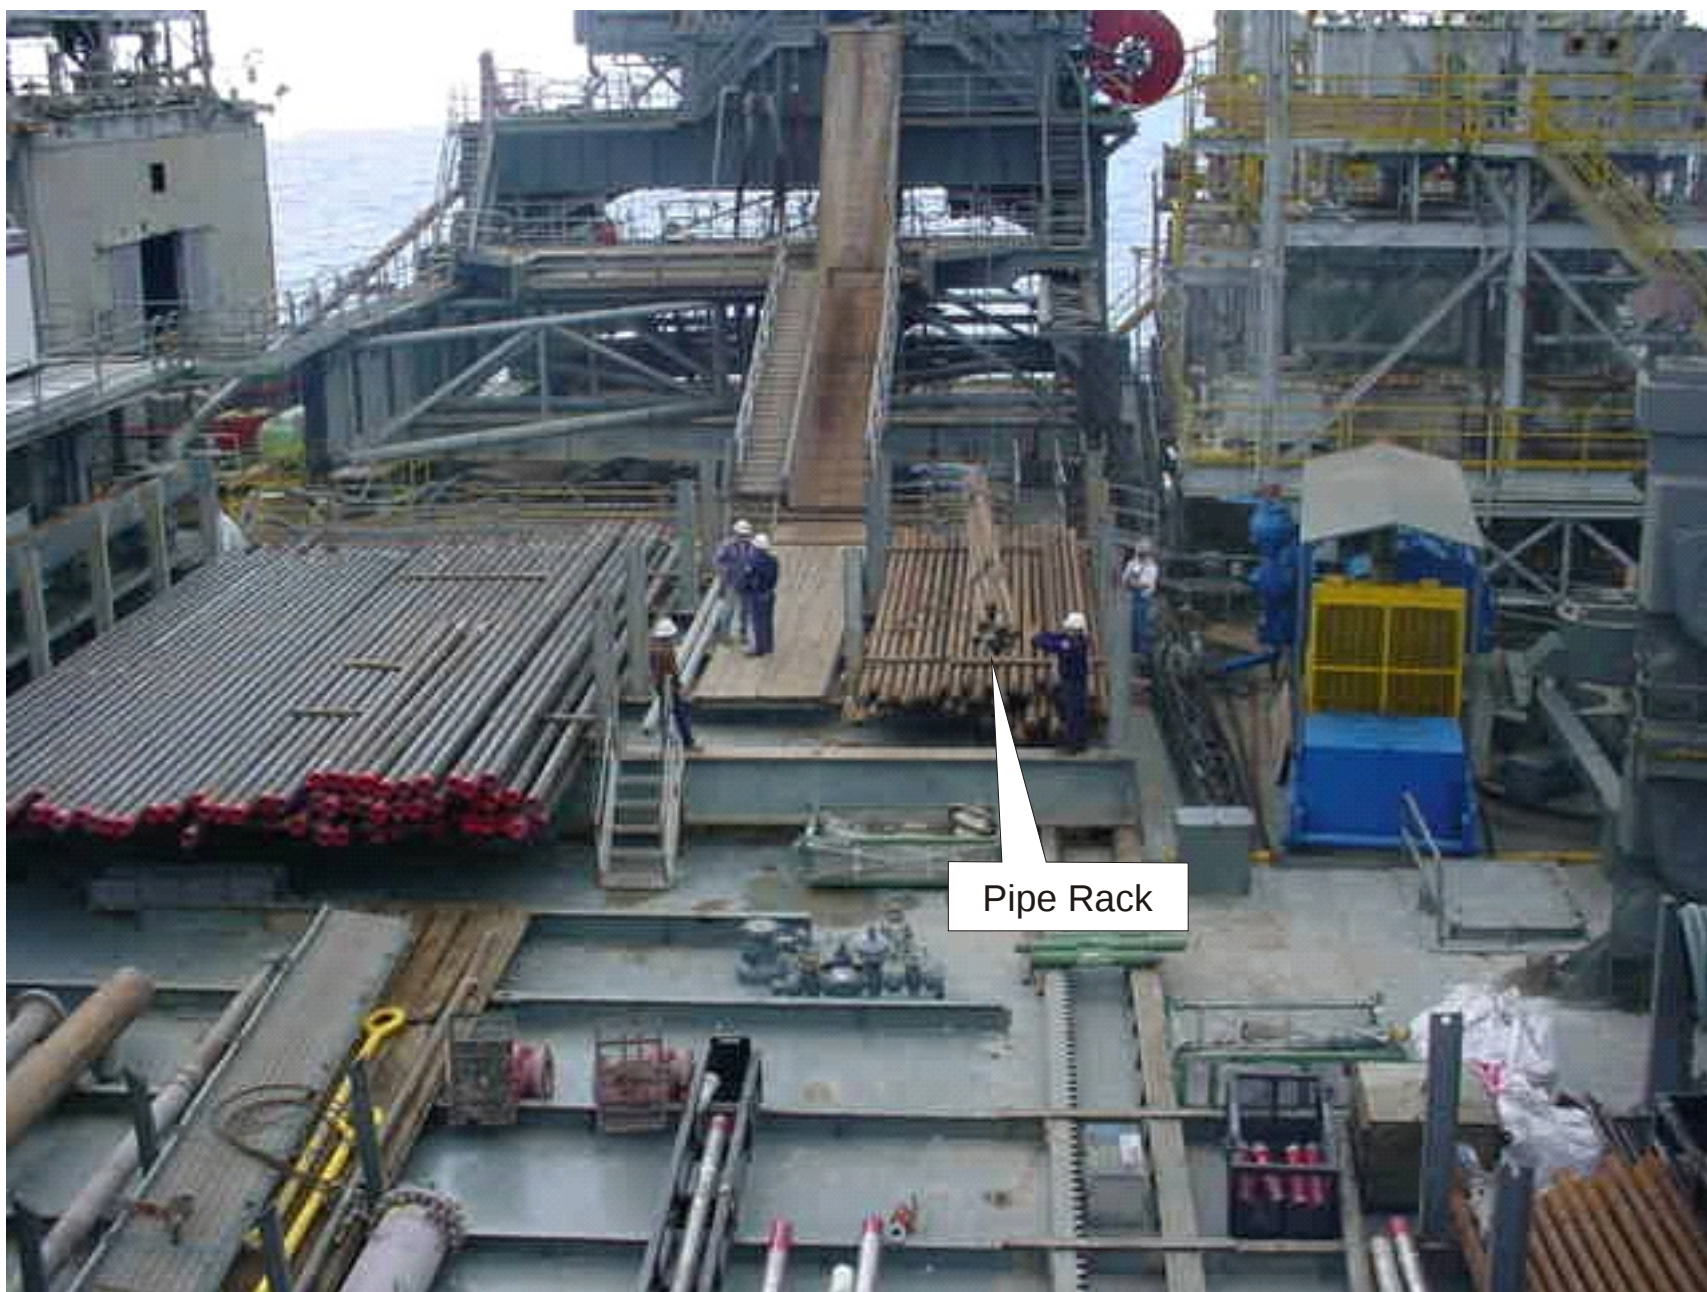
Photograph of pipe rack as seen from living quarters.

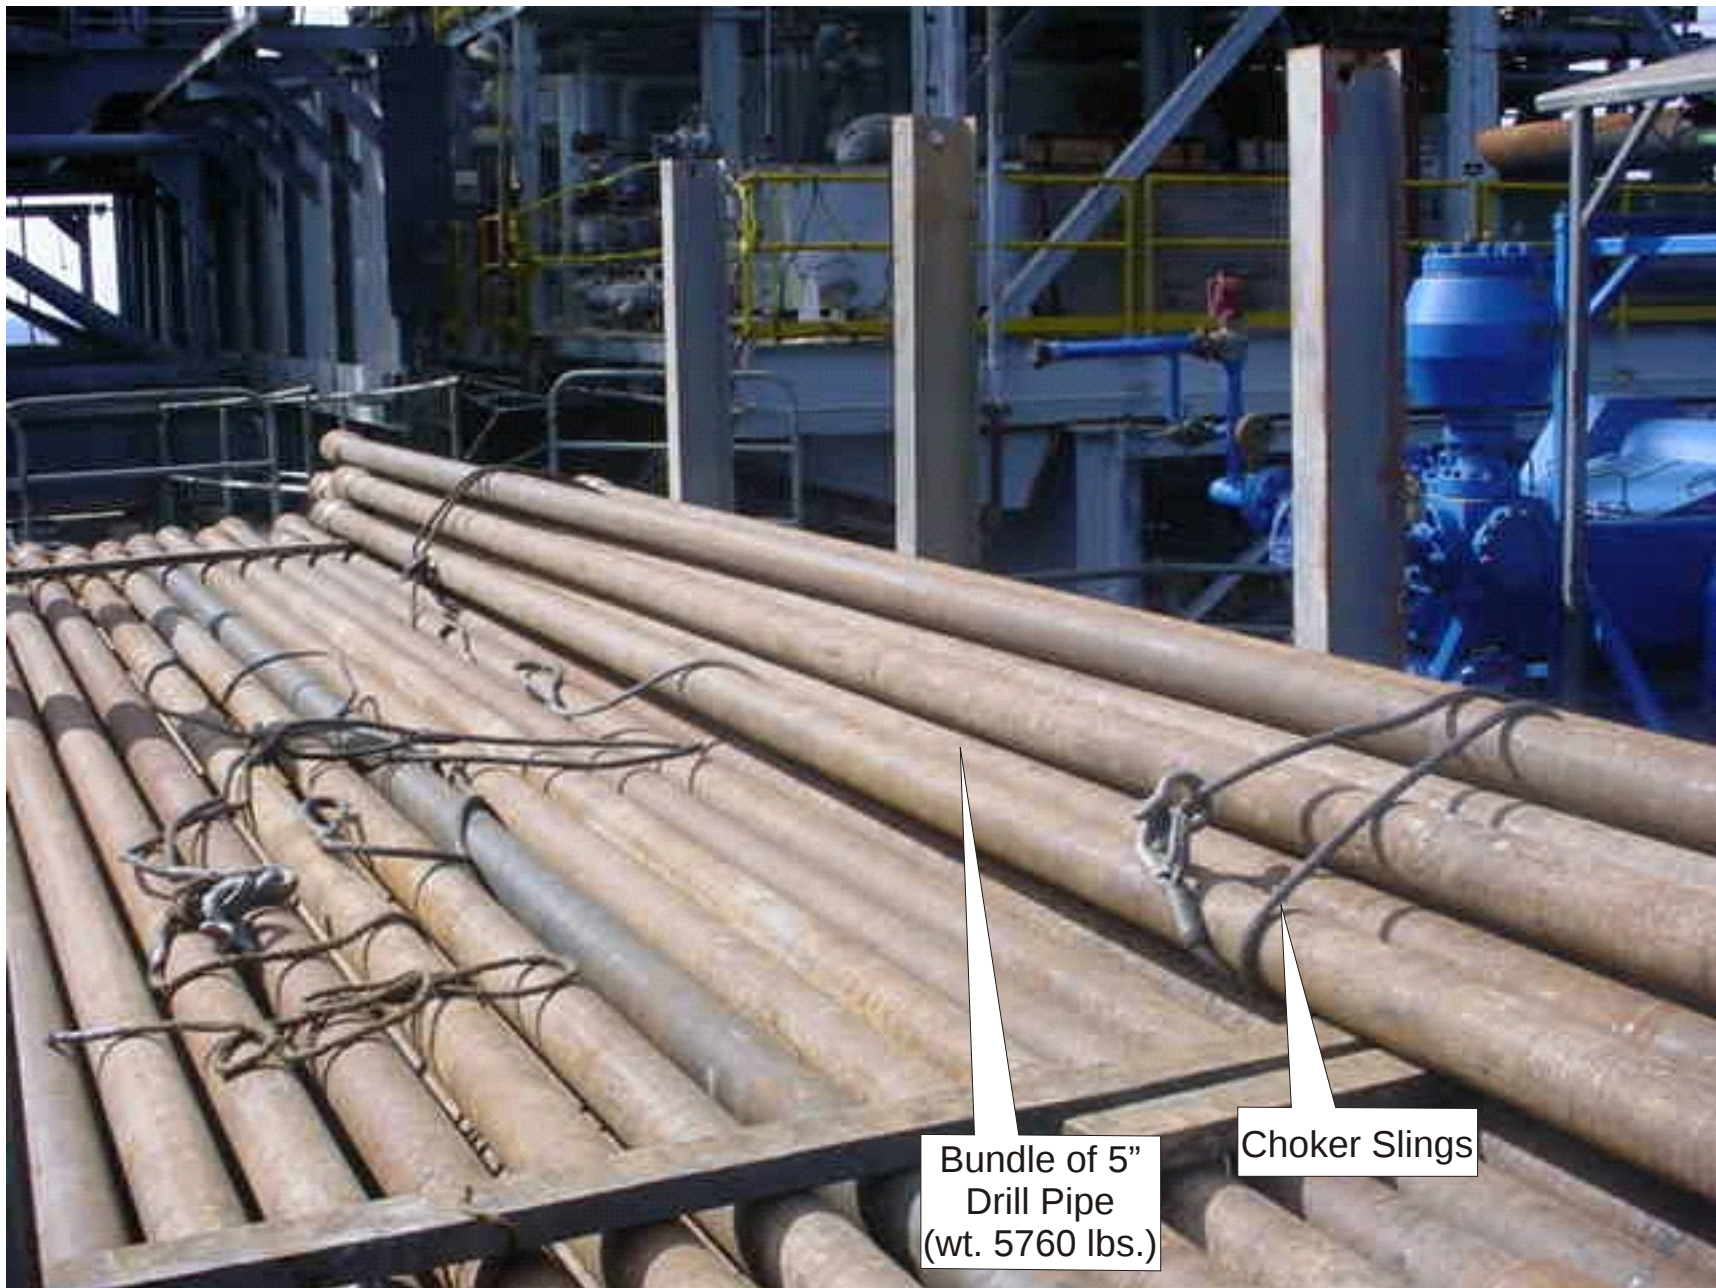
The crane sling assembly consisted of two choker slings, each of which was attached to the crane hook and to opposite ends of a pipe bundle. *For a photograph of the choker slings, see Attachment 4.*

Interview statements indicated that, at the time of the fatal lift, the bundle had been evenly secured with the crane hook located directly over the bundle.

According to rig personnel, the crane lowered the bundle of pipe immediately after the accident and was touched for the first time since the accident two days later when it lifted the bundle in the presence of MMS personnel, including a panel member. The MMS personnel witnessed that the slings were evenly spaced and that the crane performed with no irregularities.

It is concluded that neither sling placement, the crane's performance, nor the crane's operation are causes of the accident.

Bundle of 5"  
Drill Pipe  
(wt. 5760 lbs.)

Choker Slings

Photograph of choker slings.

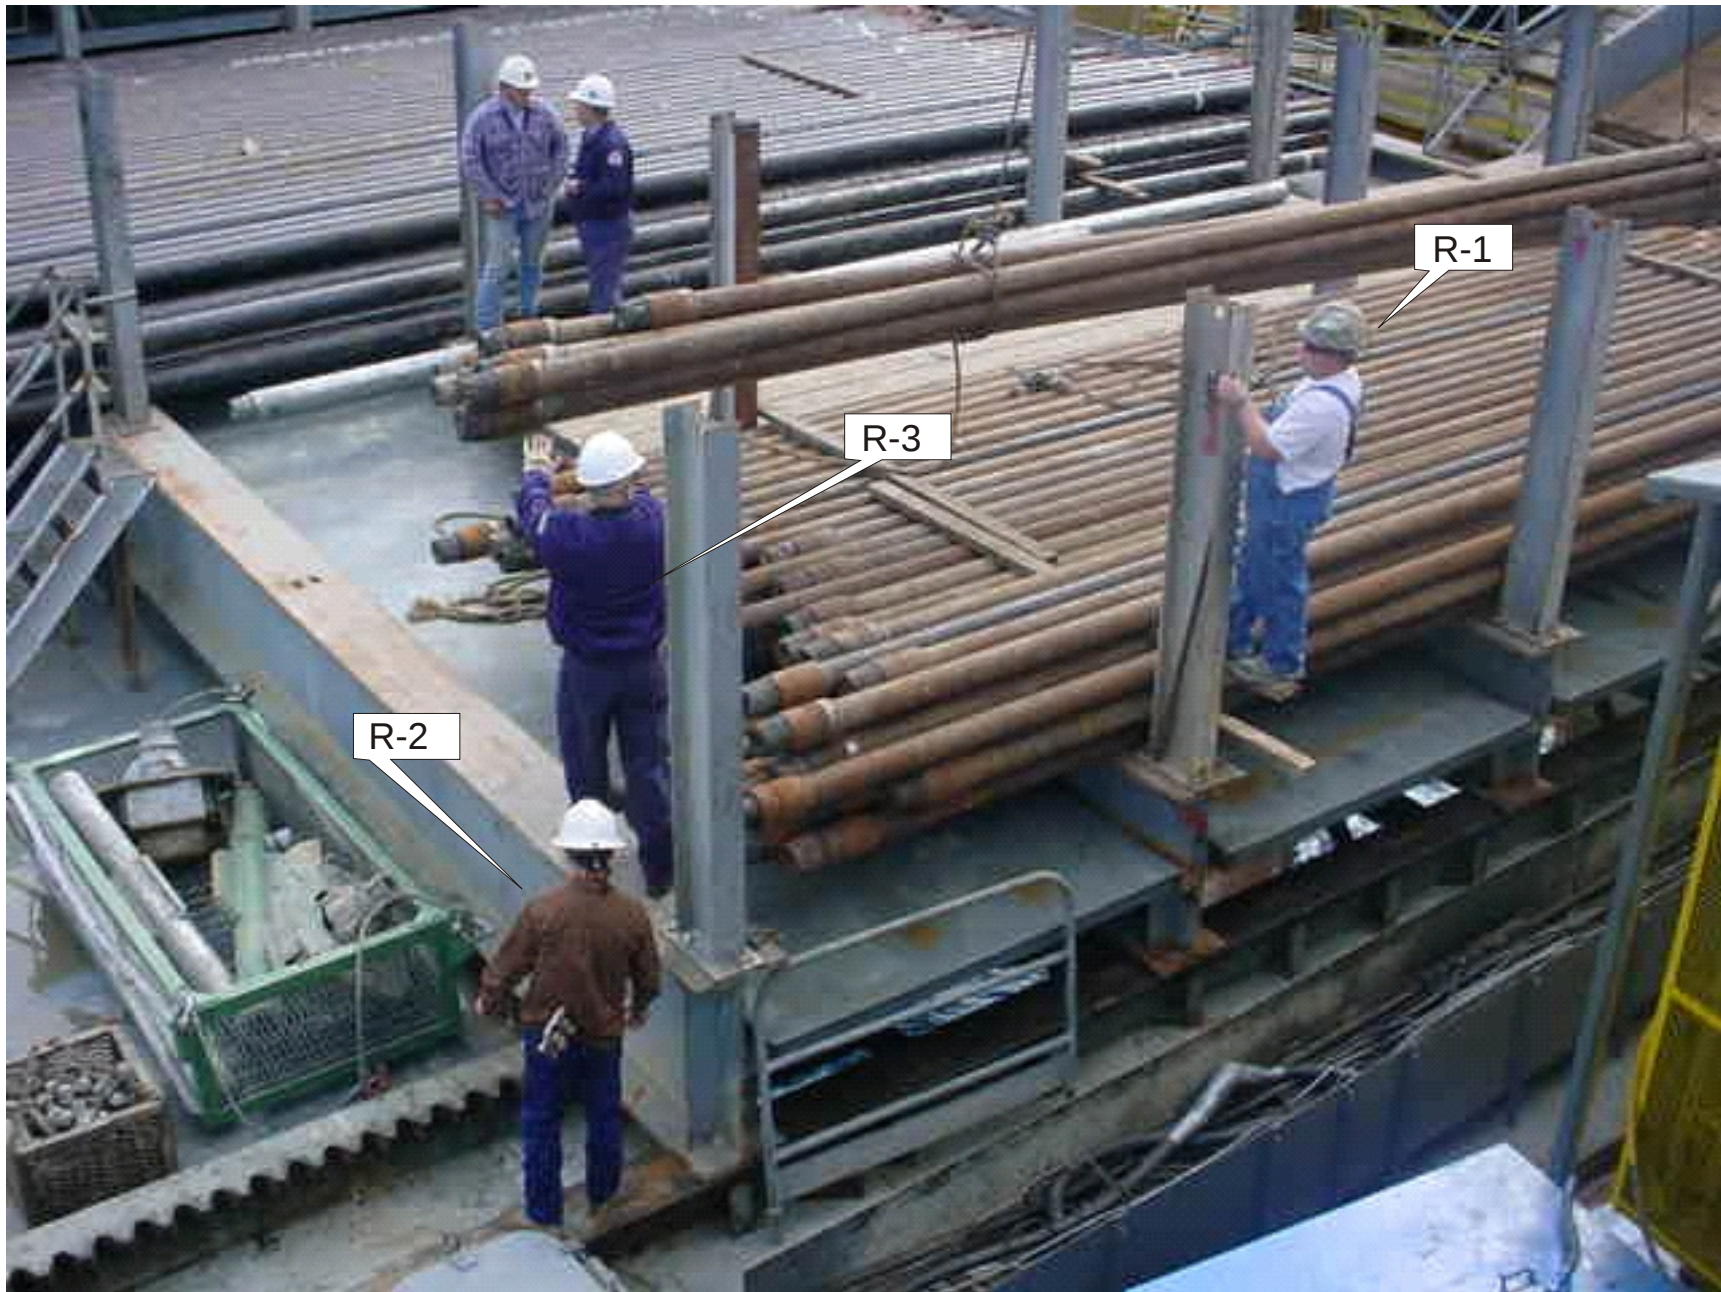
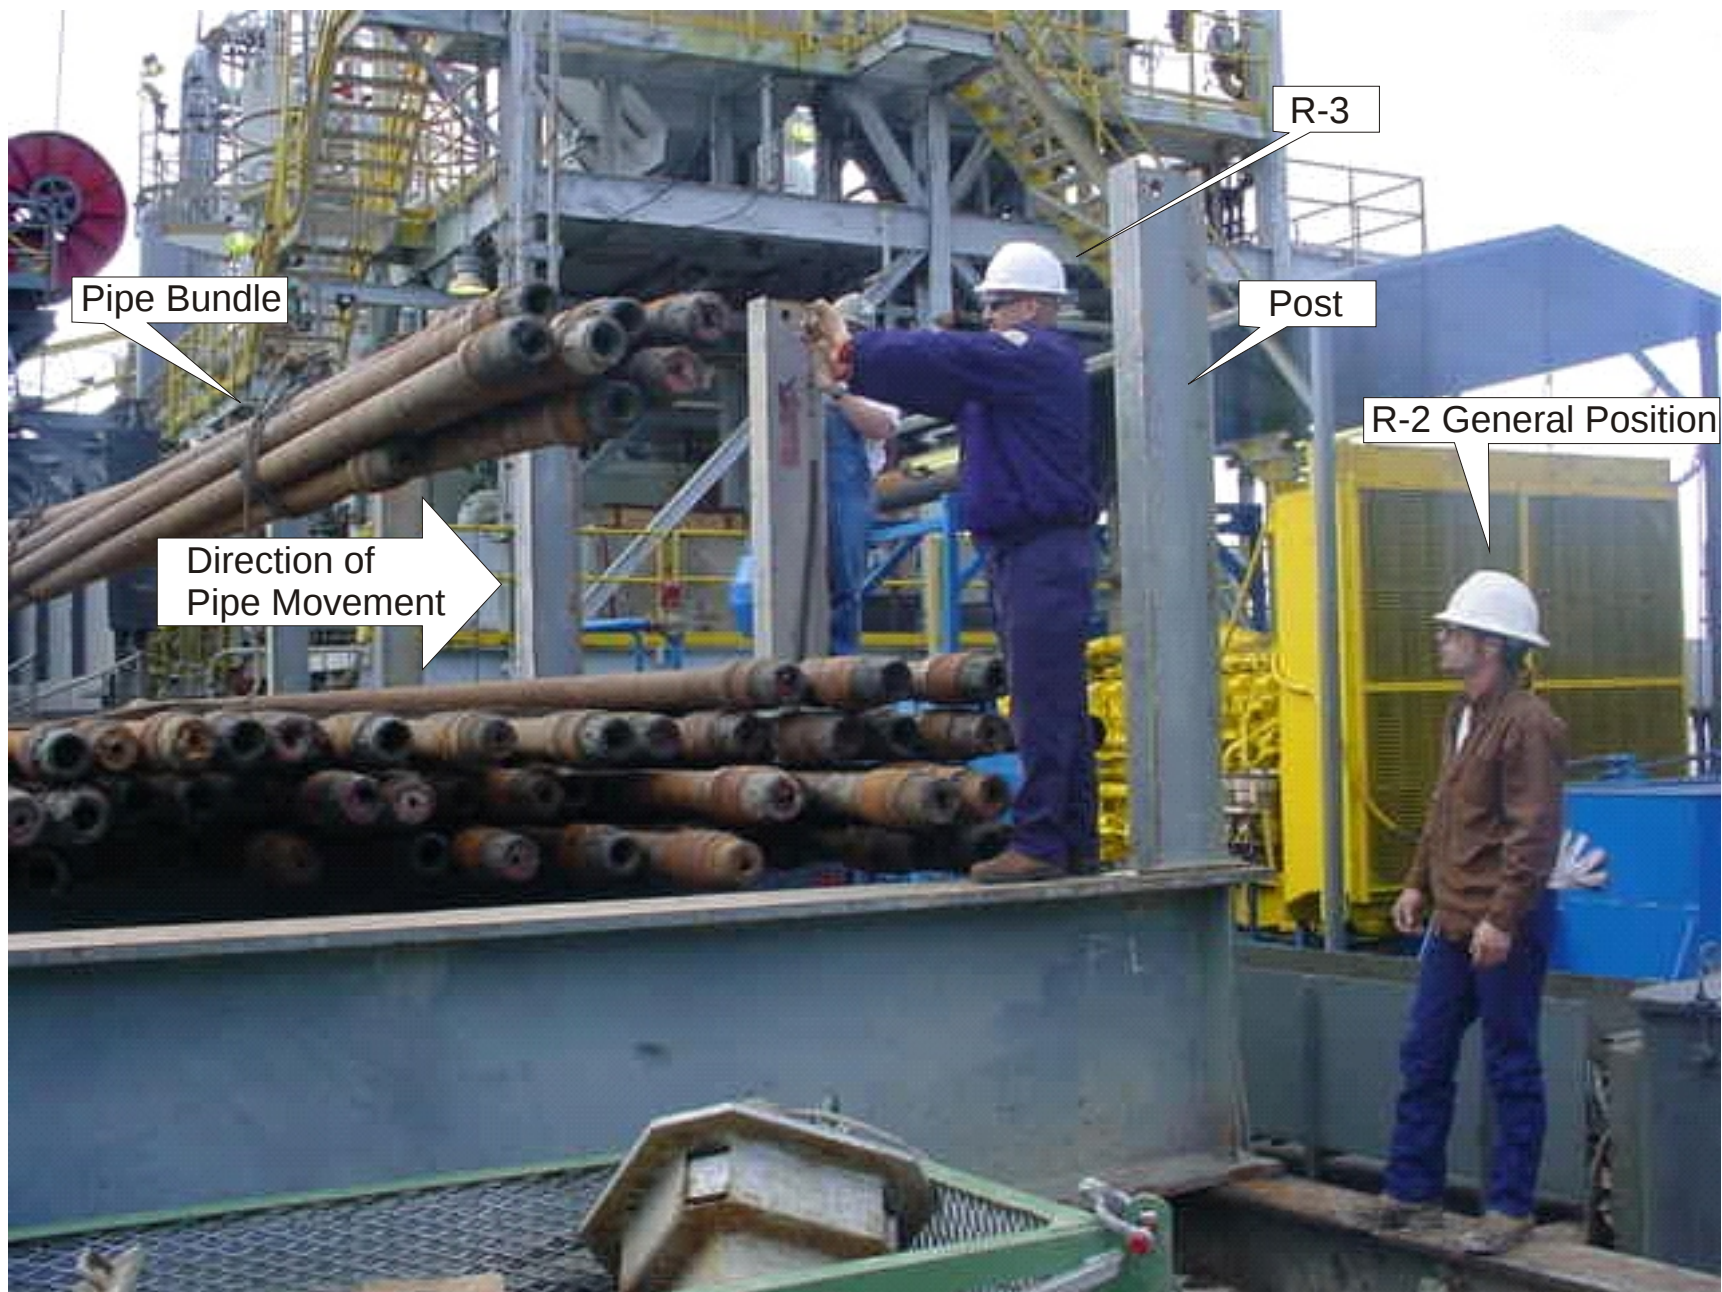
As the lift was being made, after R-1 signaled for the lift to commence, both R-1 and the CO stated that they next saw R-3 on the crane side of the pipe rack attempting with extended hands to stop the bundle from swinging. They next saw the bundle strike R-3 in the chest as his back was pressed against the pipe rack post. No one saw R-3 walk from the catwalk side to the crane side of the pipe rack. They then saw R-3 fall approximately four feet from the I-beam of the pipe rack to the skid deck. This occurred at approximately 2115 hours. *For a photograph taken from the crane operator's console panel of the pipe rack and the position simulation of the roustabouts at the time of the accident, see Attachment 5. For a photograph taken from the deck of the pipe rack and the position simulation of the roustabouts at the time of the accident, see Attachment 6.*

R-3 abandoned the tag line and walked unobserved to the crane (port) side of the pipe rack. Whether he went to the crane side of the rack to intervene manually in an effort to stop the swinging of the suspended load or walked to that side of the rack to move away from the intended placement area (cat walk) of the load is not known. However, once on the crane side of the rack, he attempted stop the load from swinging and was fatally pinned between the load and the pipe rack post. The reason the bundle swung is not known.

The employee's decision to intervene manually in attempting to stop the load from swinging is a cause of the accident. Whether the intervention was more reflexive or more thoughtful is not known. In either case, the intervention was fatal.

Photograph of position simulation of roustabouts at time of accident.
