**Investigation of Equipment Failure  
Green Canyon Block 242, Well No. 1  
OCS-G 21788  
September 5, 2004**

**Gulf of Mexico  
Off the Louisiana Coast**

**U.S. Department of the Interior  
Minerals Management Service  
Gulf of Mexico OCS Regional Office**

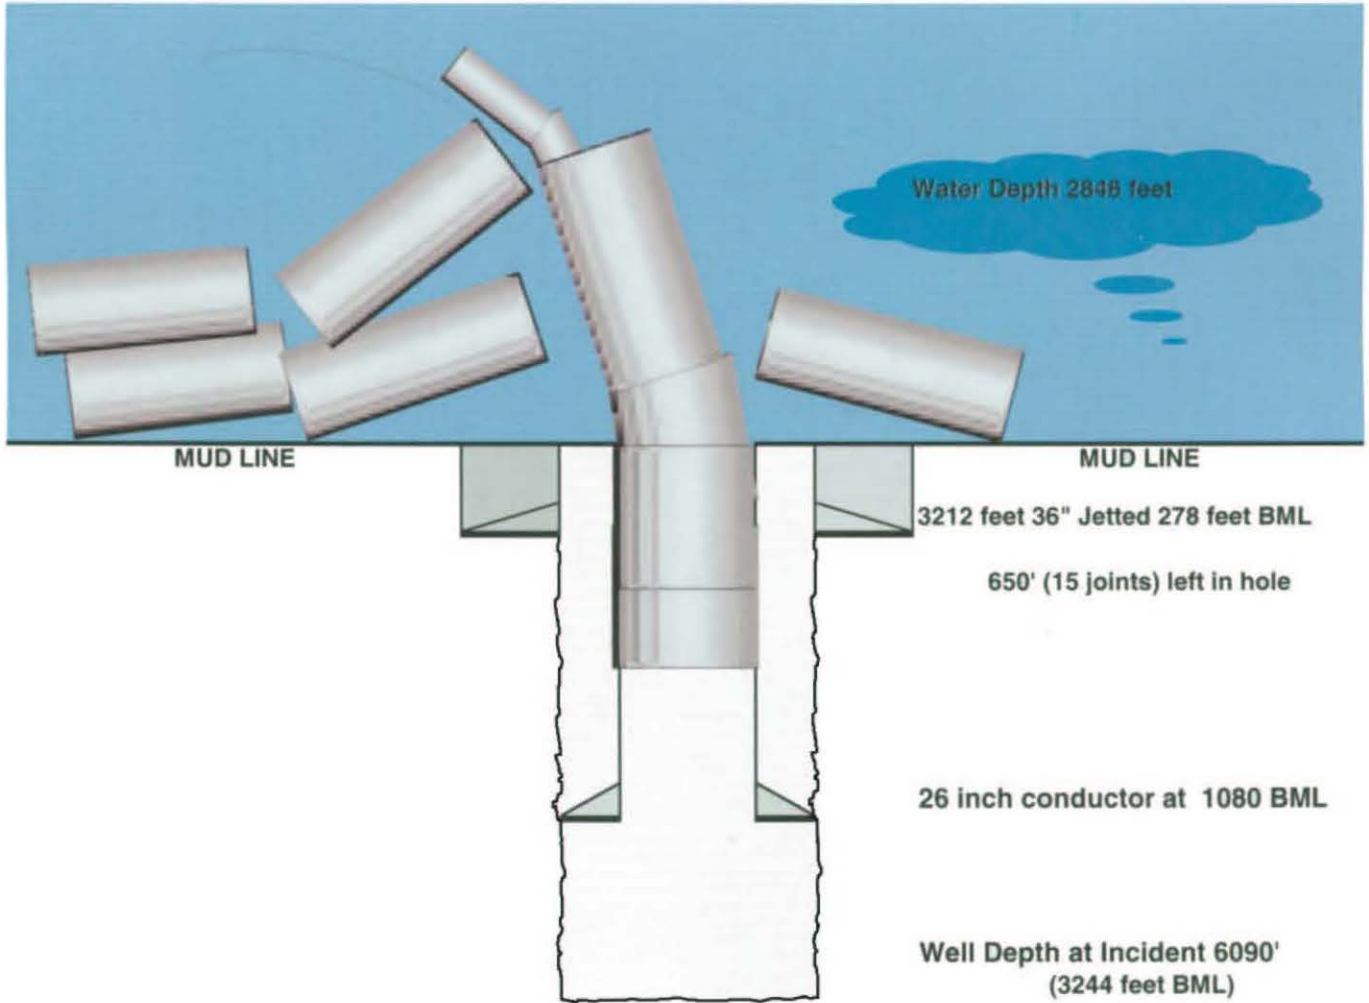
Well configuration, Post-Incident

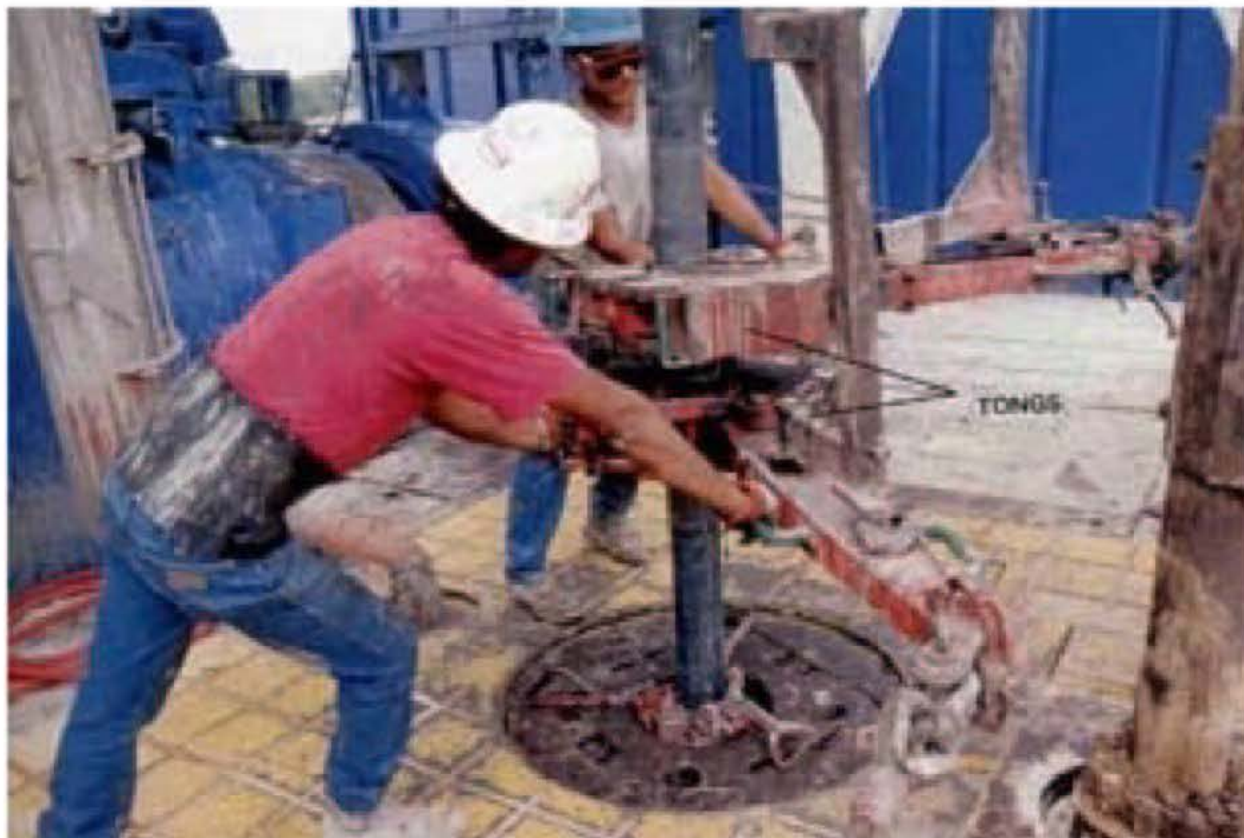
View of drill pipe in rotary slips.

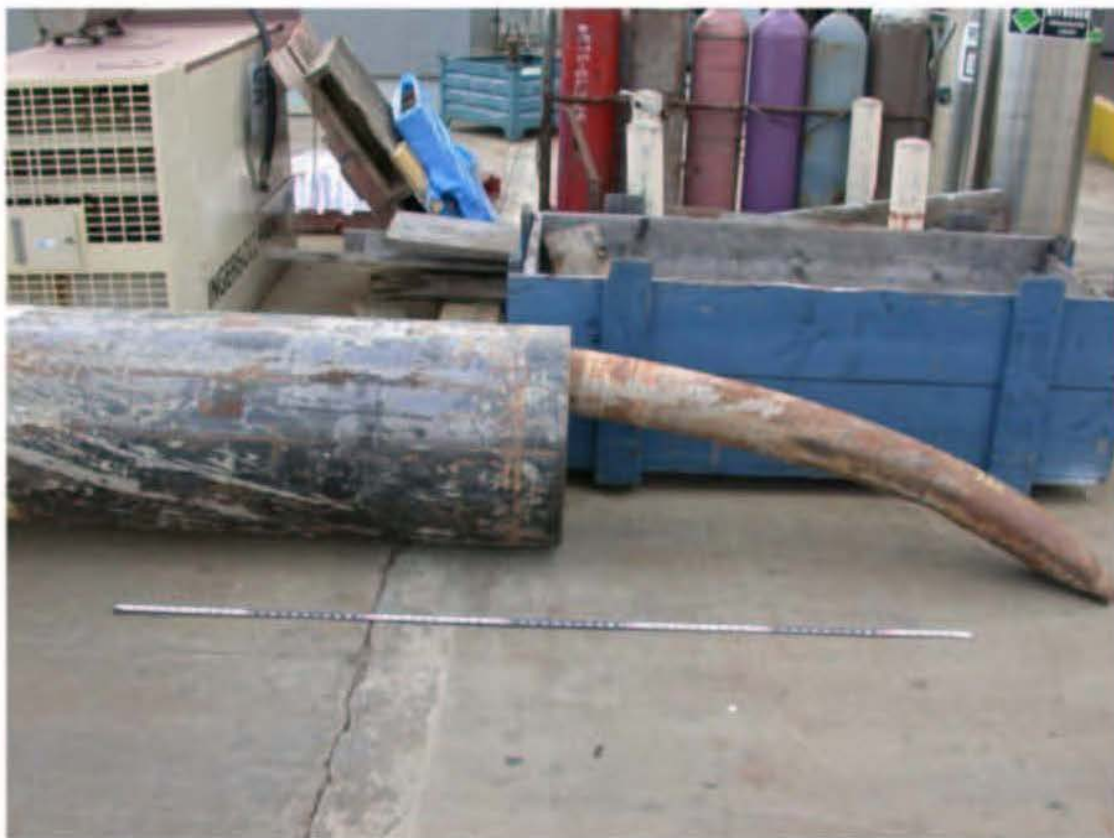
## DAMAGED CASING AND DRILL PIPE

- Visual inspection of the top joint of drill pipe from the first stand (*Attachment 4*) contained an area of “*severe crushing damage, obviously caused by the action of the slips on the pipe.*” The crushing damage, with deep, slip teeth marks, was approximately 16 inches long and extended outward from 41-1/2 inches to 57-1/2 inches from the outer end of the box. Another area of deformation (about 9-1/2 inches in length) extended from 32 inches to 41-1/2 inches from the end of the box, apparently caused by the slips sliding along the pipe. A second set of slip teeth marks on the crushed pipe was found at a location approximately 10.9 feet below the heavily damaged area of pipe. SES personnel concluded that the pipe had been plastically deformed at the level of the second set of slip marks.

Upper damaged end of the 22-inch casing, showing the upper end of the drill pipe as delivered to lab.

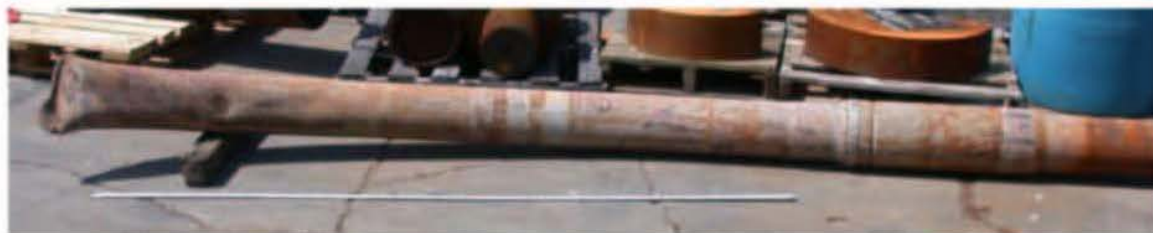
Upper end of the section of the drill pipe, after removal from the 22-inch casing.

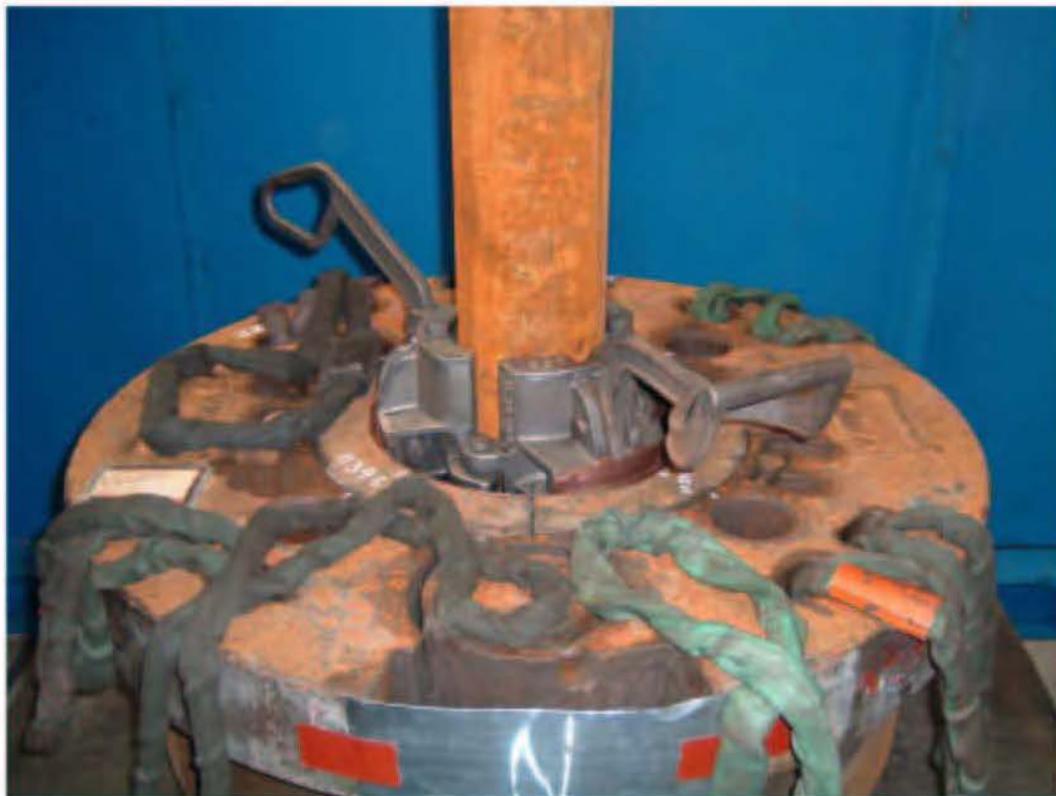
**SLIPS AND PIPE BEFORE AND AFTER LAB TEST**

View of the slips and pipe before test at lab.

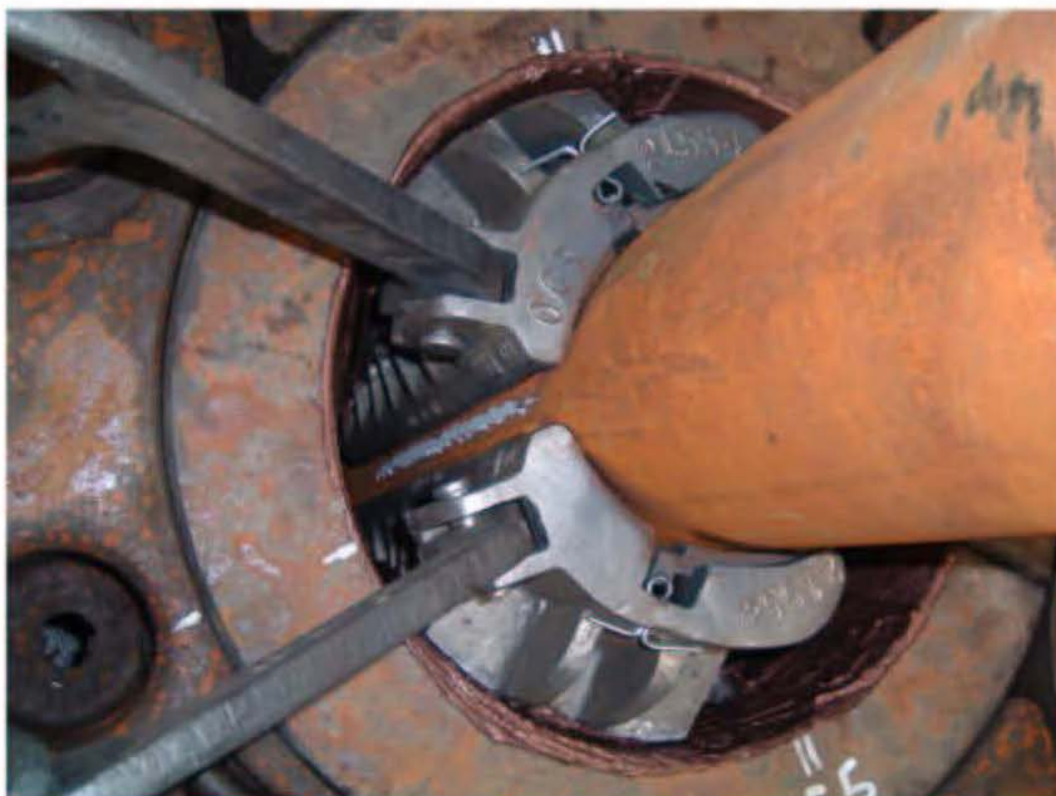
- A visual inspection of the slip bowl and master rotary bushing indicated that the master bushing was in good shape, with dimensions that were within allowable tolerances. However, the angle of the taper area of the slip bowls had been worn, suggesting that some loss of support for the slips in the contact area could have been realized. A “crush test” performed on a section from the same joint of drill pipe (*Attachments 5 & 6*) that had been damaged in the incident (using the master bushing and slip bowl from the rig) suggested that 870,000 pounds of load would initiate plastic deformation. The final failure of the drill pipe was noted to have occurred at 884,000 pounds.

Pipe in slips after test at lab.

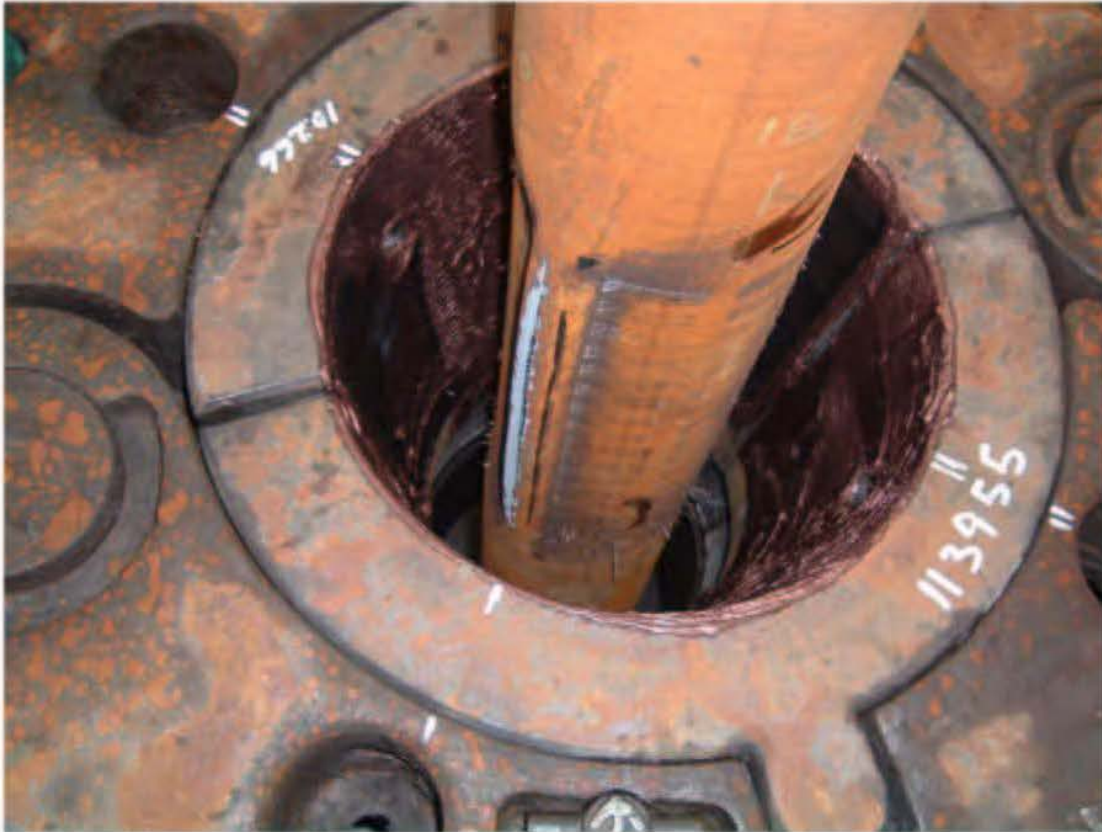
**COMPARISON OF CRUSHED TEST PIPE  
TO DAMAGED DRILL PIPE FROM FIELD**

View of the crushed test pipe, following removal of the slips at lab.

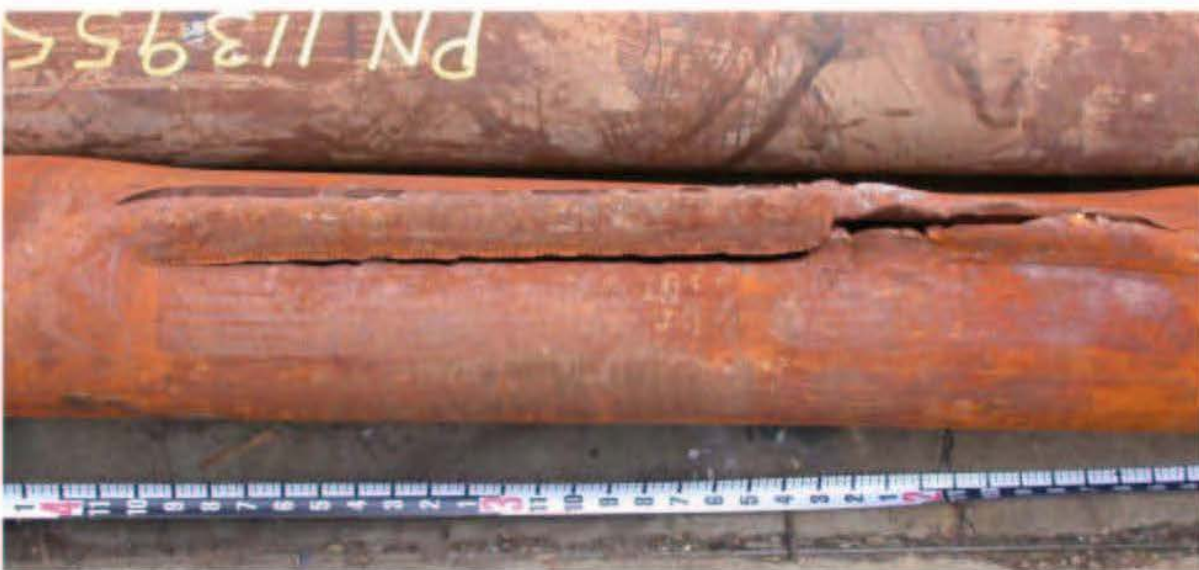
Damage in the drill pipe as received from the field.

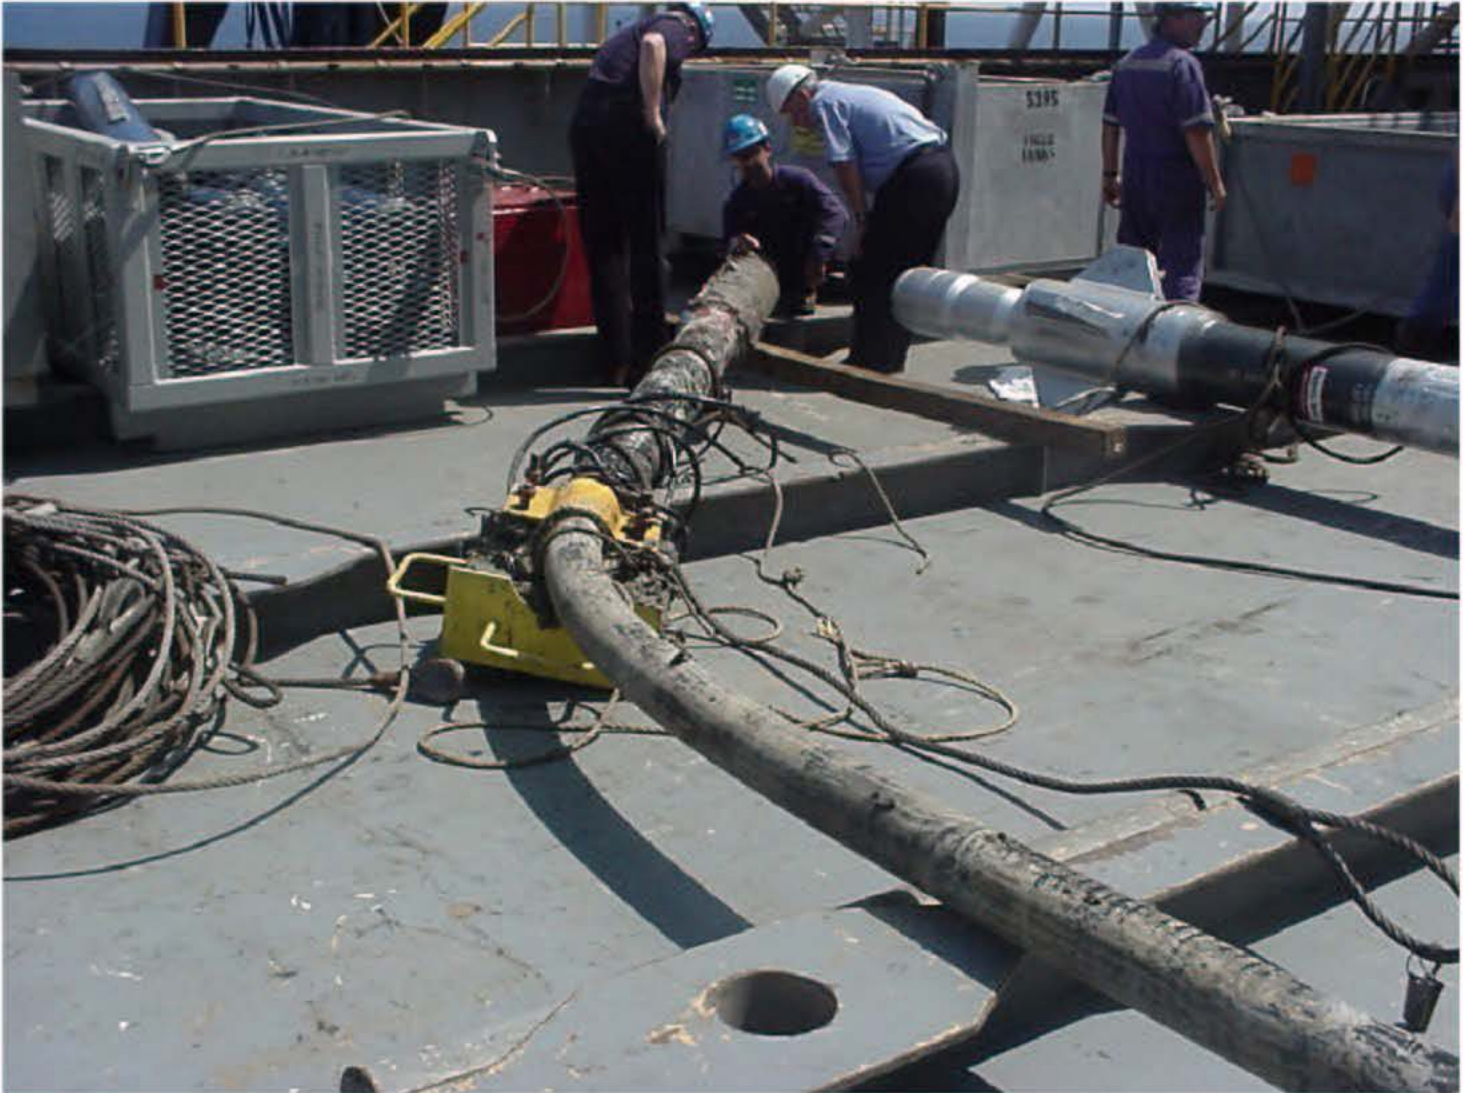
- Observations of field samples appeared to show that the casing and drill pipe failures likely took place primarily by bending as the casing assembly was falling downward (*Attachment 7*) after being released by the slips. Visual evidence showed that a joint of 22-inch by 0.75-inch casing had suffered significant deformation by bending (*Attachment 8*). Three joints of drill pipe that were found inside one field sample had clearly failed by bending at both their upper and lower ends. Further, the box connection at the upper end of the field sample was found to contain the pin end of the next higher casing joint. With the estimated total buoyed weight only 53 percent of the measured axial yield load of the drill pipe body, and only 17 percent of the yield load of the XLF connection in the 1-inch thick casing, and only 34 percent of the

Drill pipe bending below running tool.

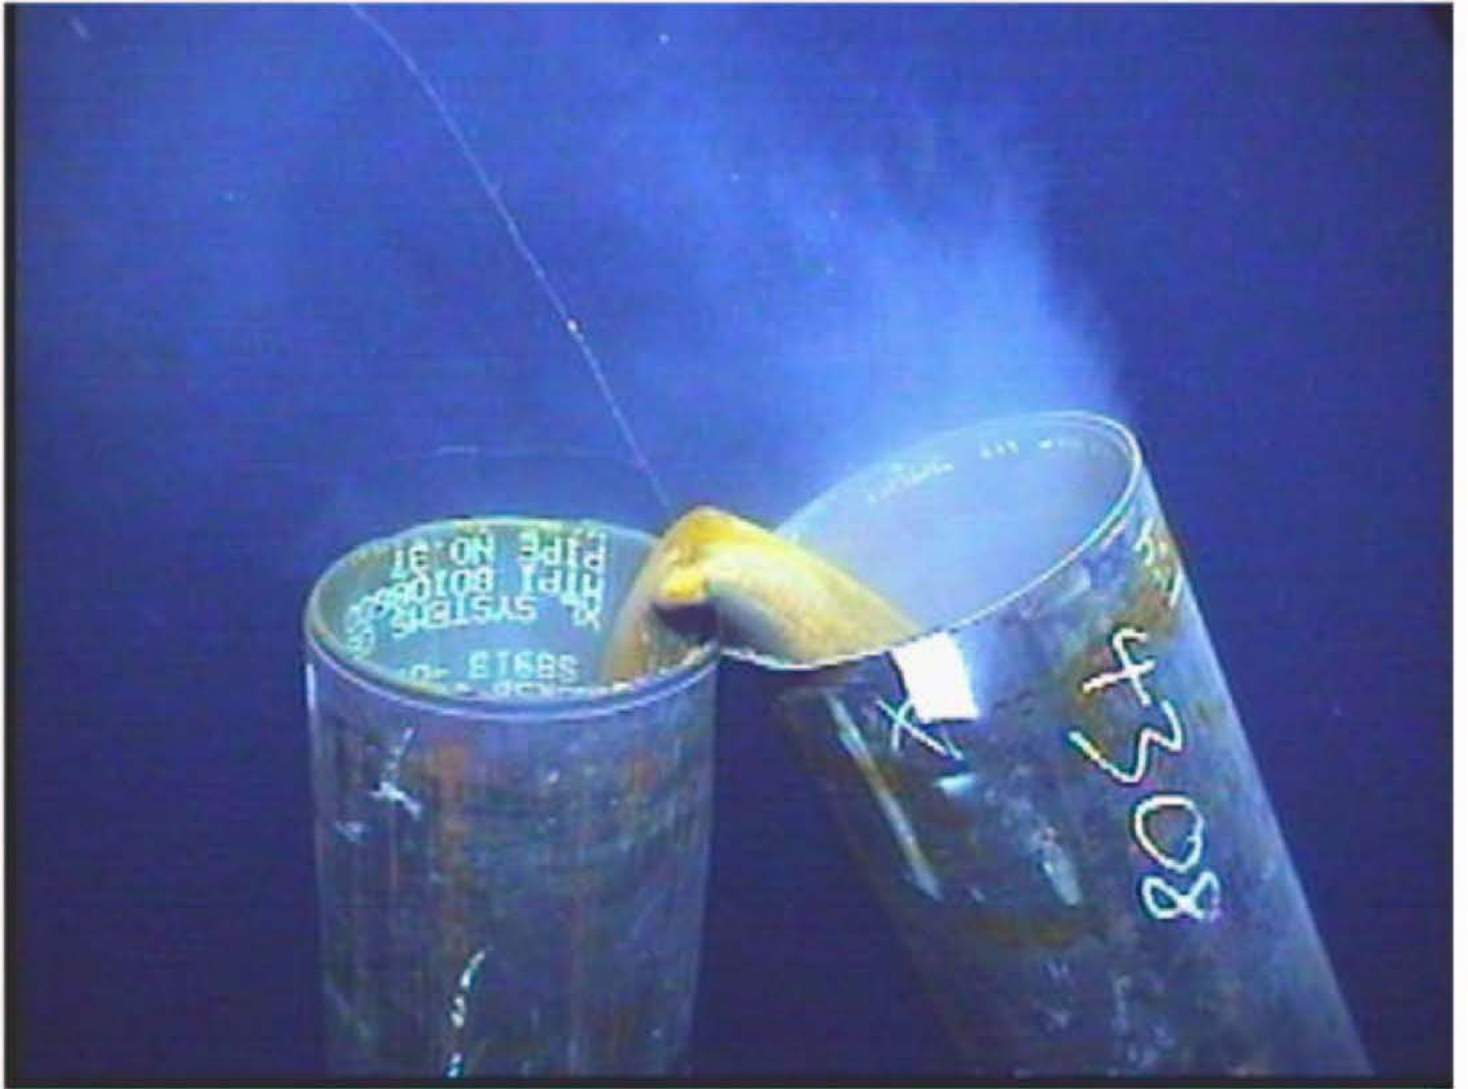
Pipe failure by bending.

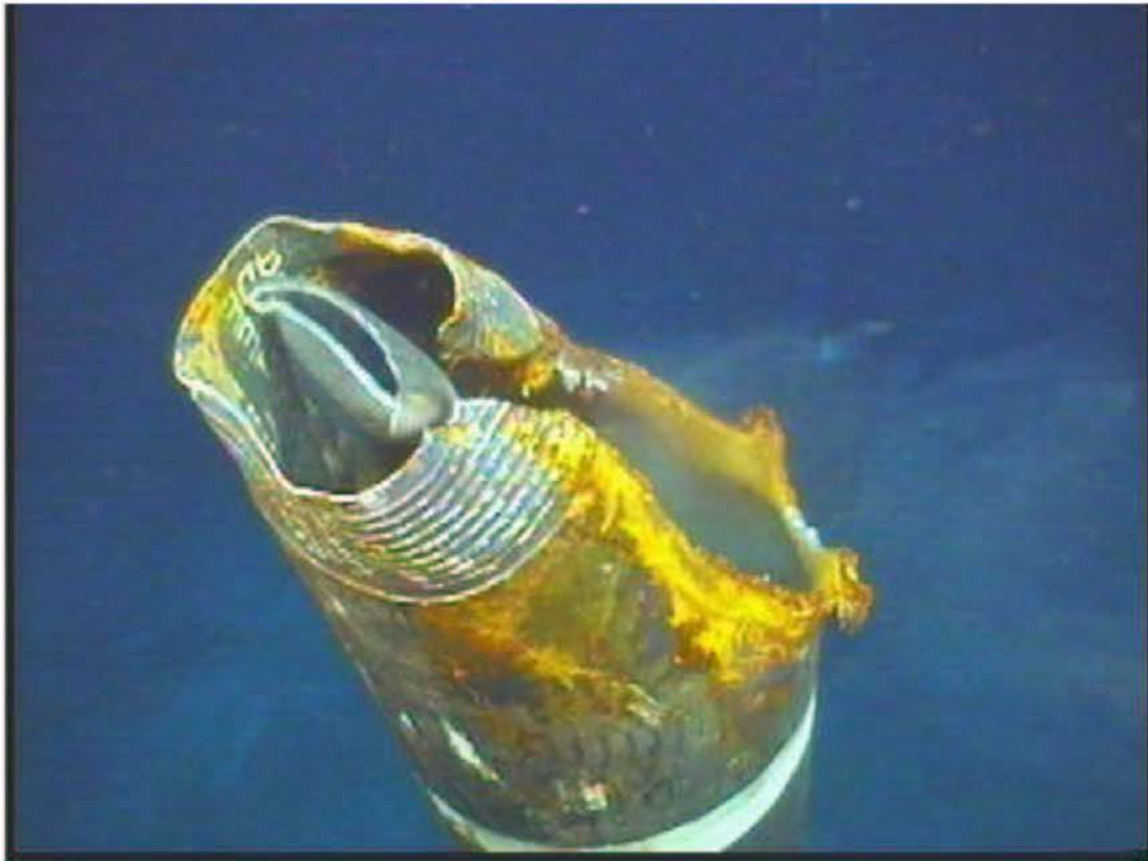
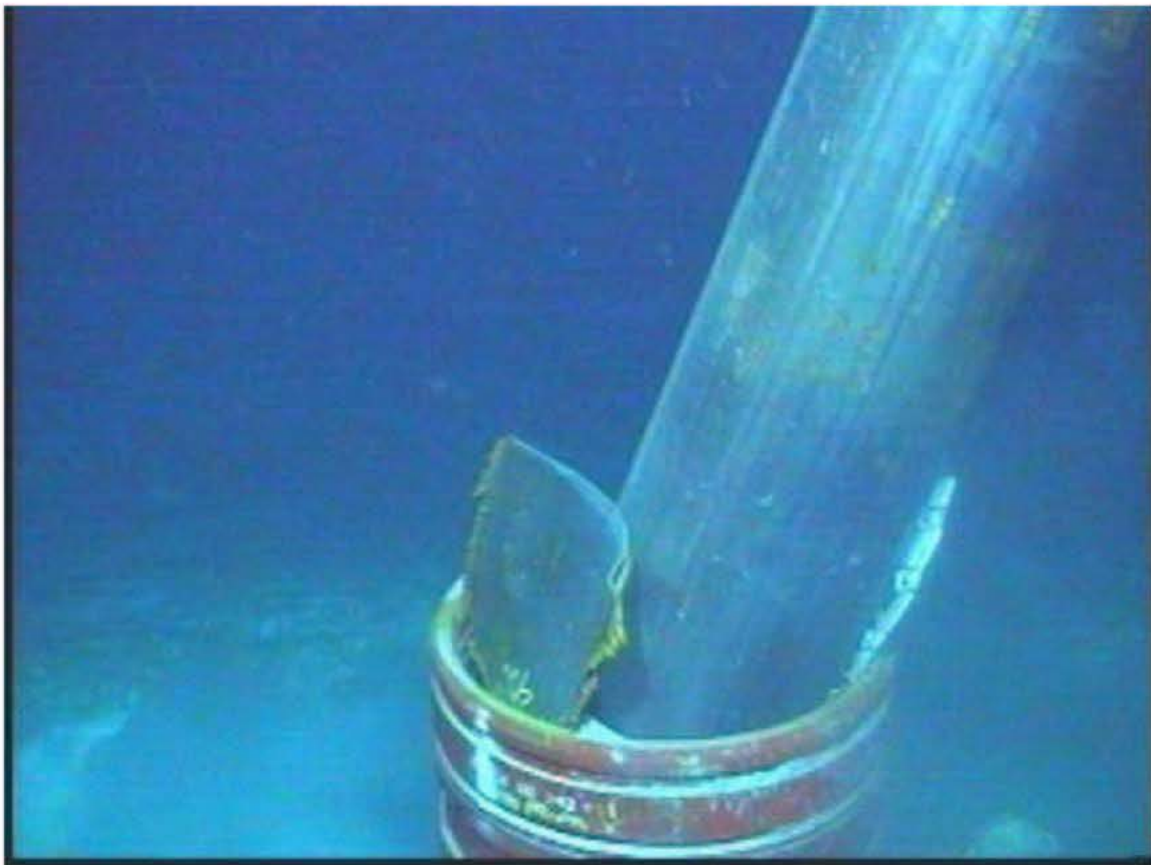
Parted and pinned casing on seafloor.
