**Investigation of Pollution Incident
Area 6B, Block 5165, Platform A
Lease OCS-P 0241
7 December 2008**

**Pacific OCS Region
Off the California Coast**

**U.S. Department of the Interior
Minerals Management Service
Pacific OCS Regional Office**

**Camarillo
April 2009**

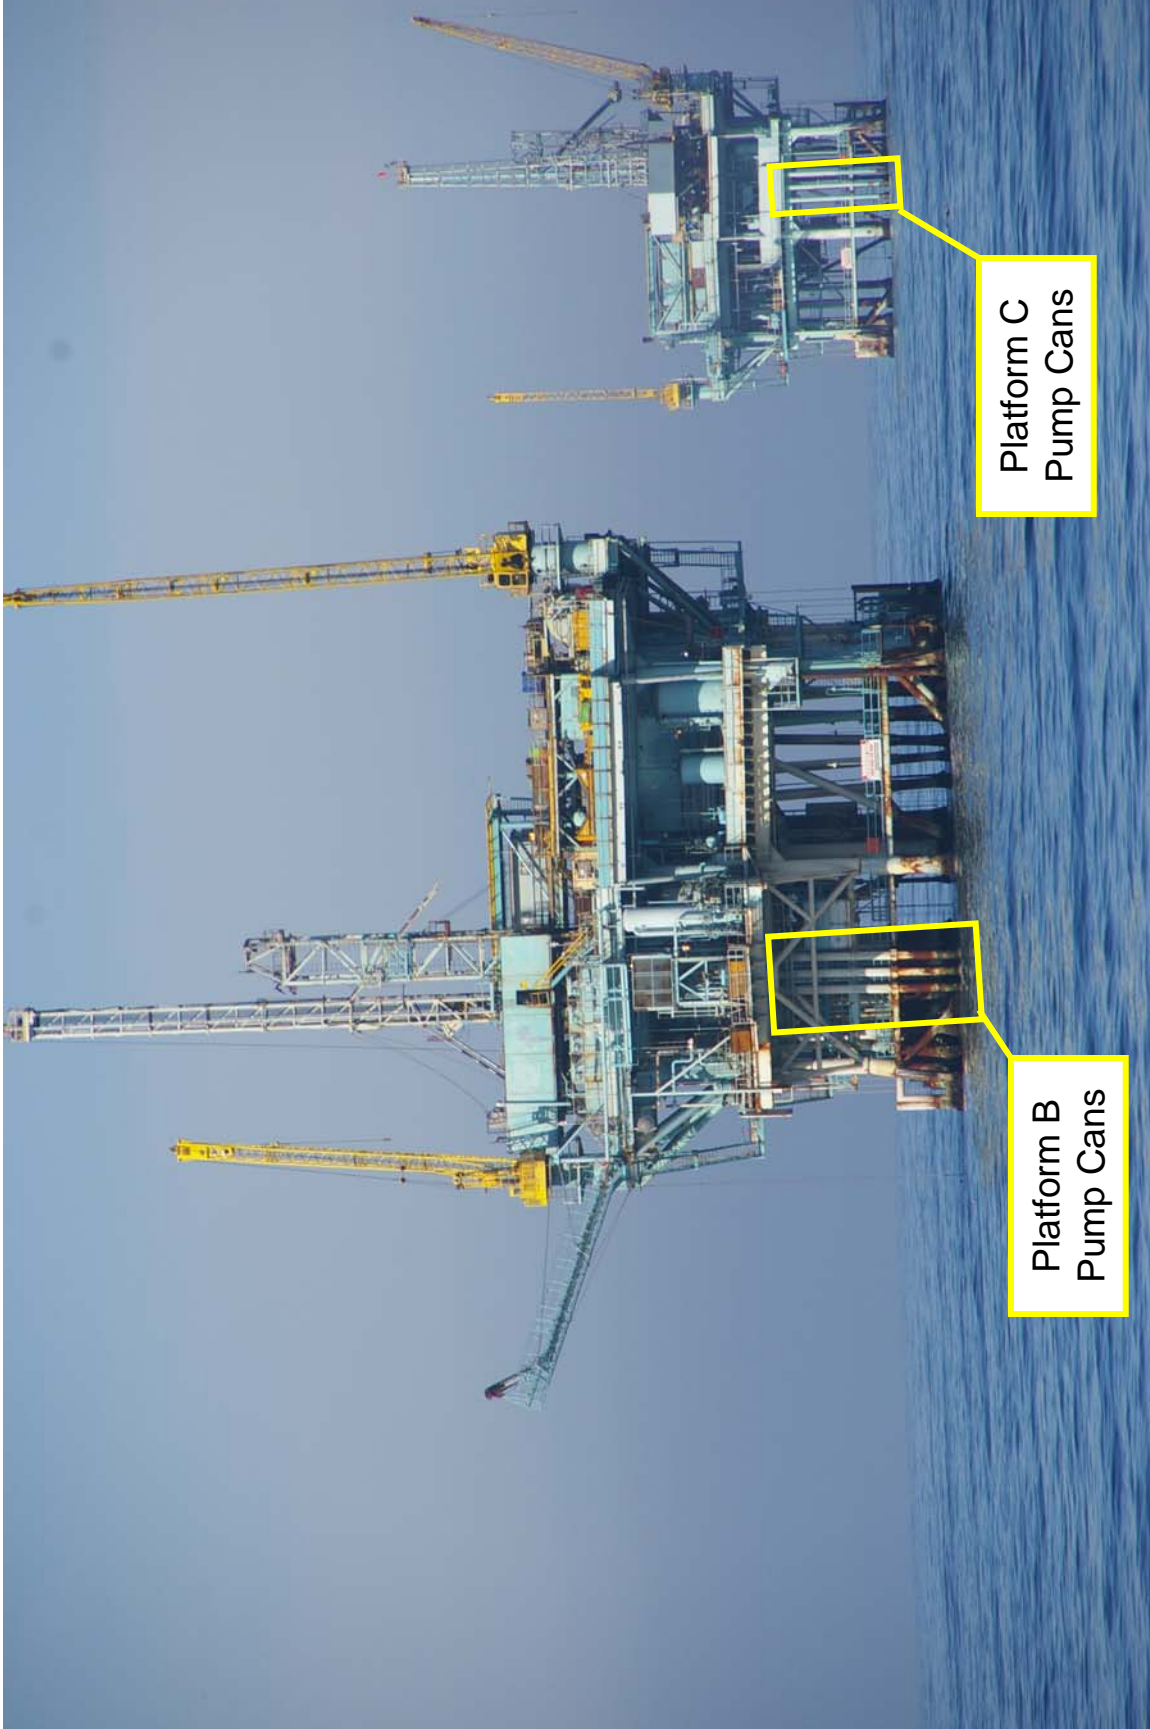
Pump Cans on Platform B and Platform C

Platform Name	Number of Pump cans	In-Service Pump cans
Platform A	3	1
Platform B	3	2
Platform C	3	2
Gilda	3	3
Irene	3	3
Hidalgo	3	2
Hermosa	3	2
TOTAL	21	15
