U.S. Department of the Interior
Minerals Management Service
Gulf of Mexico OCS Region

Safety Alert No. 235
December 15, 2005

Multiple Cable Transit Failures

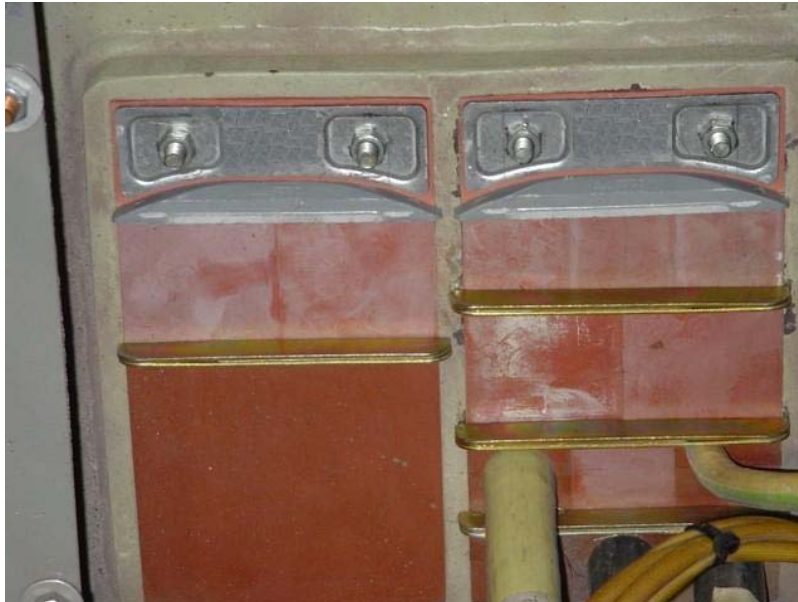
Preliminary findings from the investigation indicate that water movement among the access spaces occurred through failed multiple cable transits (MCT's). MCT's are the points in the watertight bulkheads where cables that carry electrical power and instrument signals pass through the watertight bulkheads. Essentially, MCT's are molded blocks of plastic that seal around each cable. Failure occurred in the spaces filled with blank blocks. Specifically, the findings indicate that either the MCT's may not have been installed properly, may have been installed using the wrong procedures, or may not have been properly pressure rated for the configurations being used.

Until the investigation is completed and the findings verified, the MMS recommends that all operators and contractors should

- Review their facilities to determine if they have these types of MCT's.
- Determine if the MCT's were properly installed and properly pressure rated for the configurations being used.
