Safety Alert 295
6 April 2011Contact: Glynn T. Breaux
(504) 736-2560

Compressor Fire Resulting from Separated Fuel Line Coupling

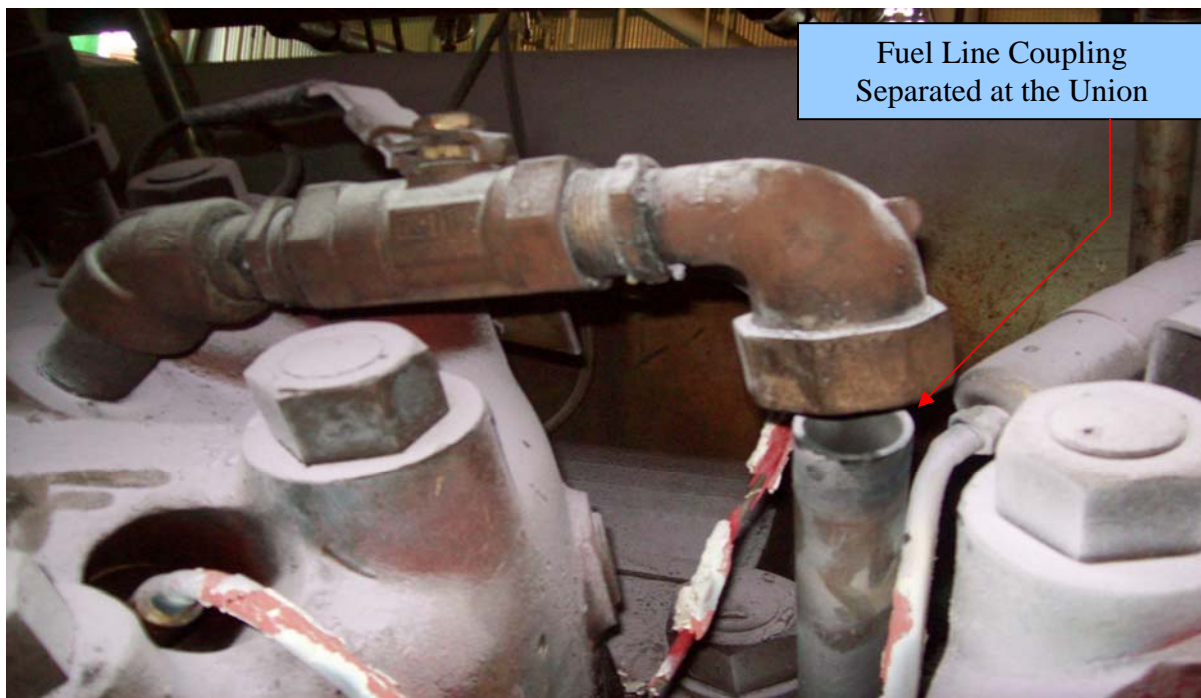
Recently a compressor fire occurred on a Clark VRA20 compressor, when the fuel gas line feeding the #5 L/B cylinder came apart, allowing the gas to ignite. The operators immediately activated the platform's ESD system and shut-in the platform. A 30-pound handheld fire extinguisher was used to extinguish the fire. Damage consisted of burned compressor spark plug wires and four feet of burned compressor building wall insulation.

- The intake fuel valve may have stuck in the open position allowing hot exhaust gas to mix with the fresh fuel.
- The fuel line coupling separated at the union due to excessive heat and vibration, resulting in ignition of the fuel line contents.
- The fuel line consisted of hard piping in lieu of a flexible steel hose.
- The intake fuel line was not equipped with a high temperature shut-down for each cylinder.

- Consider designing piping such that induced heat and vibrations are damped out at the source and not transmitted through the piping system.
- Perform periodic maintenance inspections of piping systems for identifying and possibly eliminating piping vibrations that could result in piping and coupling separation.
- Consider replacing hard piping with a flexible hose to account for vibrations as appropriate.
- Consider installing a fuel valve temperature monitoring system that will shut down the compressor if the fuel valve's temperature reaches a designated temperature.
- Review Safety Alert No. 003 (vibration induced thread cracks of glycol return line) that also discusses the need to account for vibrations in piping design, performing periodic maintenance inspections of piping systems and eliminating piping vibrations when possible.
