Investigation of Riser Leak  
Platform Elly, OCS-P 0300  
Pacific OCS Region  
September 13, 2002

**Investigation of Riser Leak  
Platform Elly, OCS-P 0300  
Pacific OCS Region  
September 13, 2002**

Catherine Hoffman  
Ralph Vasquez

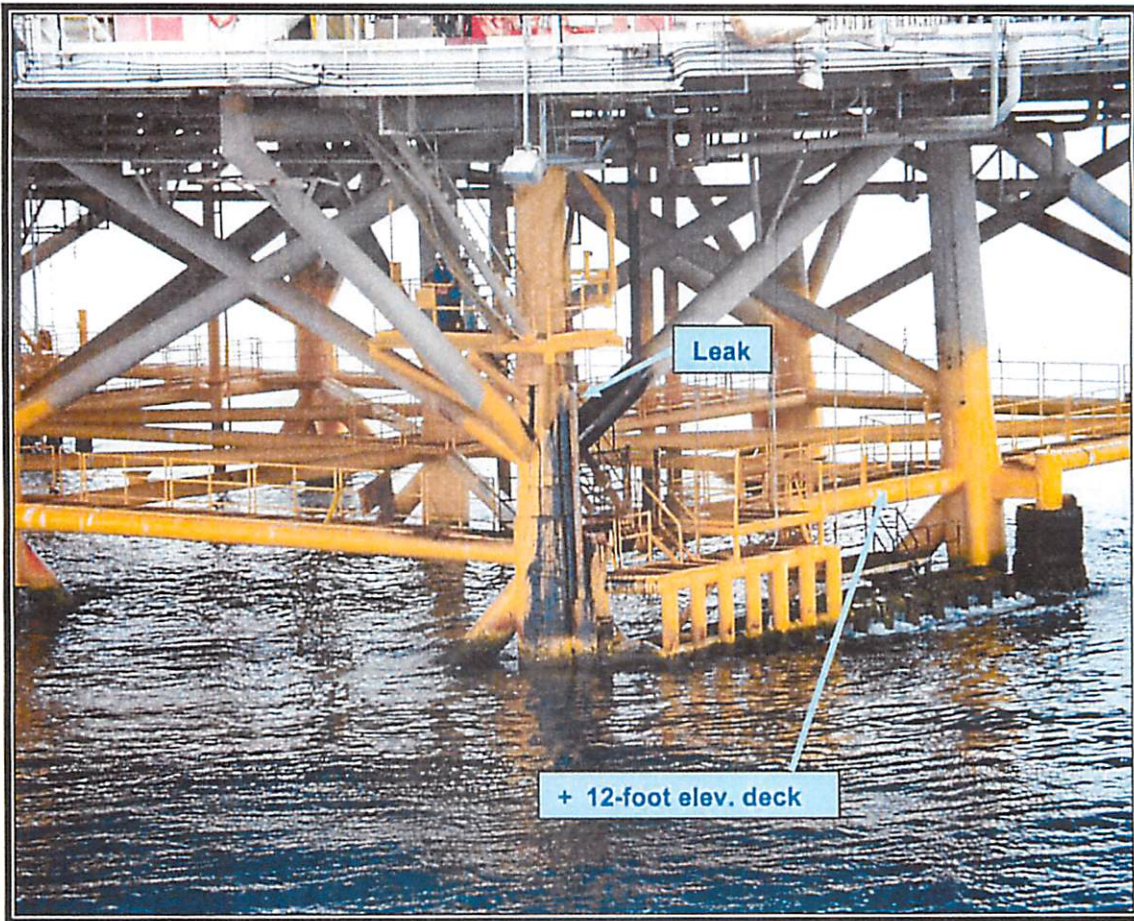
## Attachment 1 – Platform Elly

On July 7, 2002, at about 11:35 p.m., a 6-inch diameter oil pipeline failed at the riser-to-flange weldment, resulting in a 9-barrel oil spill. The break occurred approximately 10 feet above Elly's (+) 12-foot elevation lower deck (Attachment 1—Platform Elly). The pipeline is used to transport oil from Platform Edith, operated by Nuevo Energy Company, to Platform Elly, operated by Aera Energy LLC. The pipeline is approximately one mile.

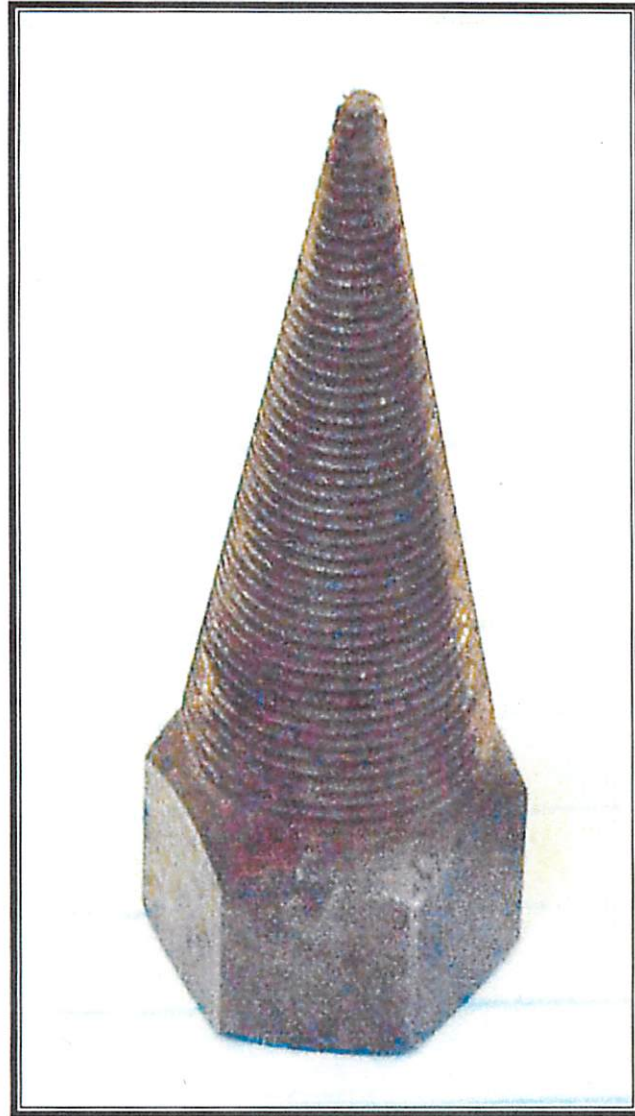
**Attachment 2 -- Adam's Plug (Device Used to Seal ¼-inch Hole in Pipeline Riser)**

After the pipeline was shut down, the flow from the riser decreased dramatically; however, some oil continued to escape. Elly personnel screwed an Adam's plug into the quarter-inch hole to completely abate the oil spill (Attachment 2—Adam's Plug).

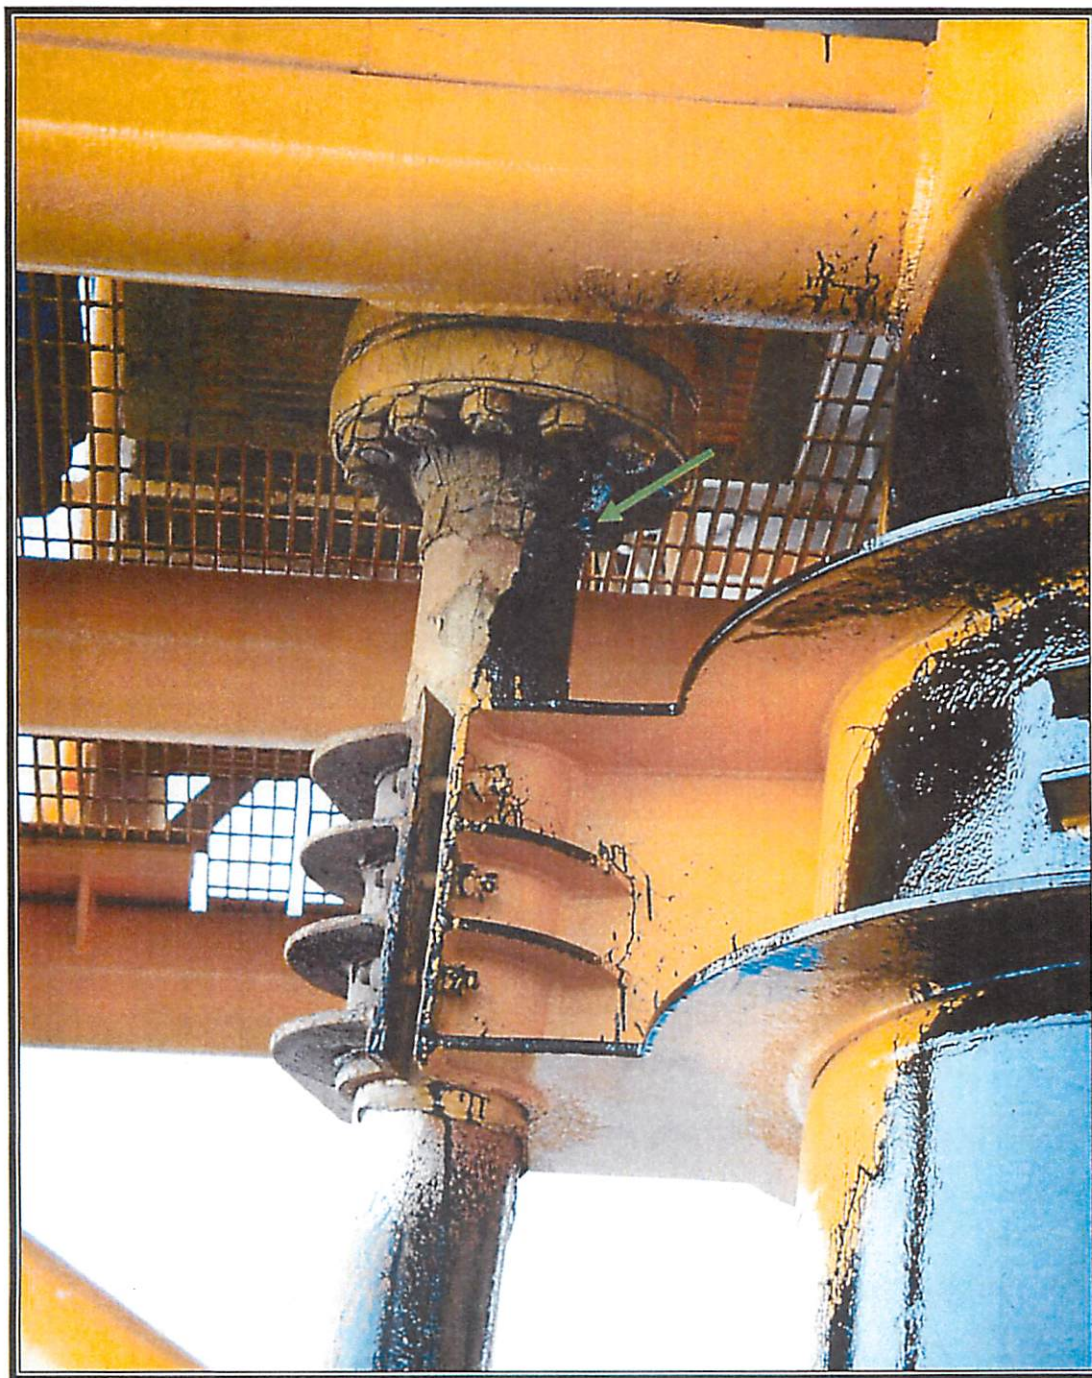
Attachment 3 -- Failed Riser

The MMS investigators first went to Platform Elly, operated by Aera, to examine the quarter-inch hole in the riser (Attachment 3—Failed Riser) and to interview Allen Knowles, the Aera operator who discovered the leak. The area around the riser was badly oiled. Oil was found to have sprayed as far as approximately 30 feet from the riser.

After review of the circumstances surrounding the incident we conclude that the probable cause of the riser leak was external corrosion. The riser had corroded to the point that it was insufficient to hold the maximum allowable operating pressure and ruptured.

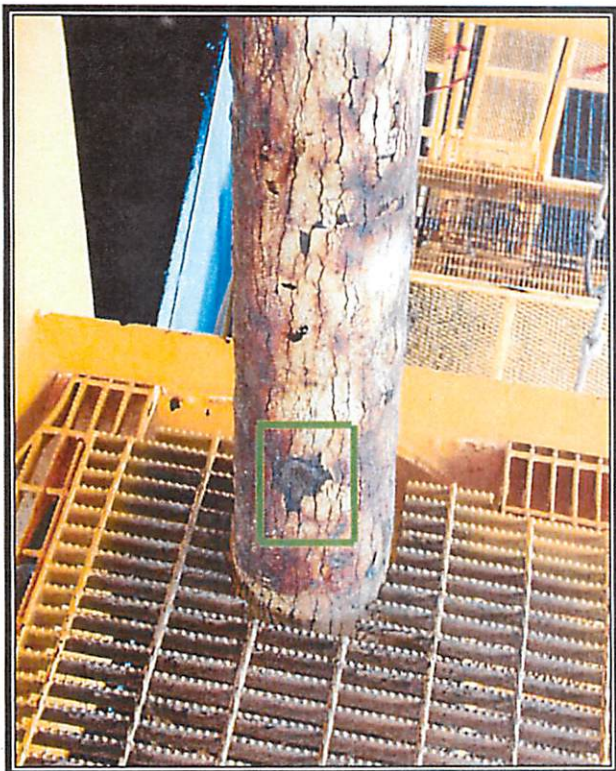
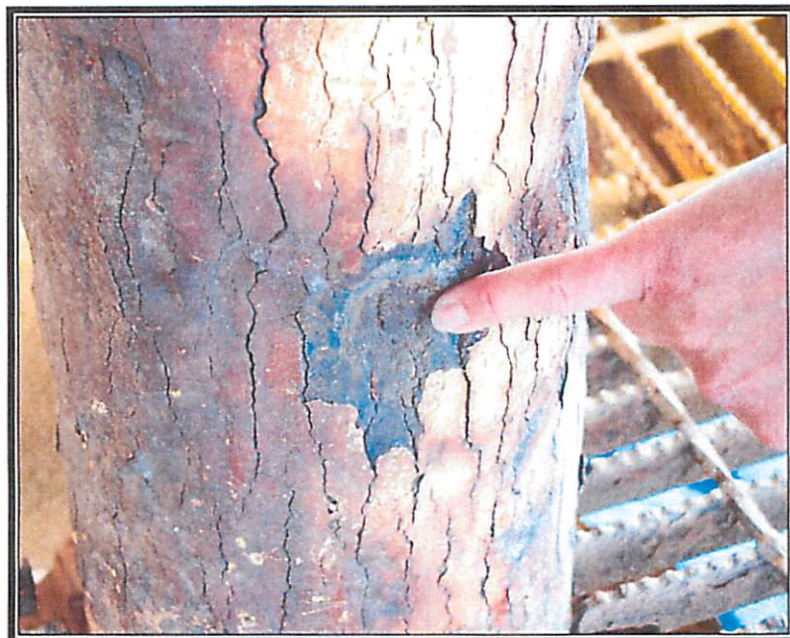
## Attachment 5 -- External Corrosion on Riser

Some obvious external corrosion could be seen on the riser (Attachment 5—External Corrosion on Riser). Aera had just completed painting the Platform Elly structure; however, the riser was not repainted because it was operated by Nuevo. Mr. Knowles said that he was not aware of Aera notifying Nuevo of the riser's condition nor were there any procedures in place for Aera to regularly communicate any concerns related to Nuevo's pipeline on Platform Elly.

G-100: "Pipeline riser at Elly was found to be badly rusted and corroded, posing a danger to the environment and to personnel and equipment at Platform Elly."

On July 11, 2002, ultrasonic tests conducted on the riser indicated that there were two areas of "major concern." In the first area, the test found severe external corrosion on the section of pipeline beginning at a weld just above the surf sleeve and extending down to just below the water line. There was no apparent internal metal loss. The second area is located on the pipeline support at the center leg of the platform. The survey showed severe external corrosion/pitting. Damage in these areas was visually verified.

Nuevo should ensure that personnel performing visual inspections of piping and risers are adequately trained to identify corrosion or anomalies and can accurately assess their severity. Documenting the condition of the risers, including videotaping or photographing the risers, regardless of their condition, should be incorporated into the visual inspection program.

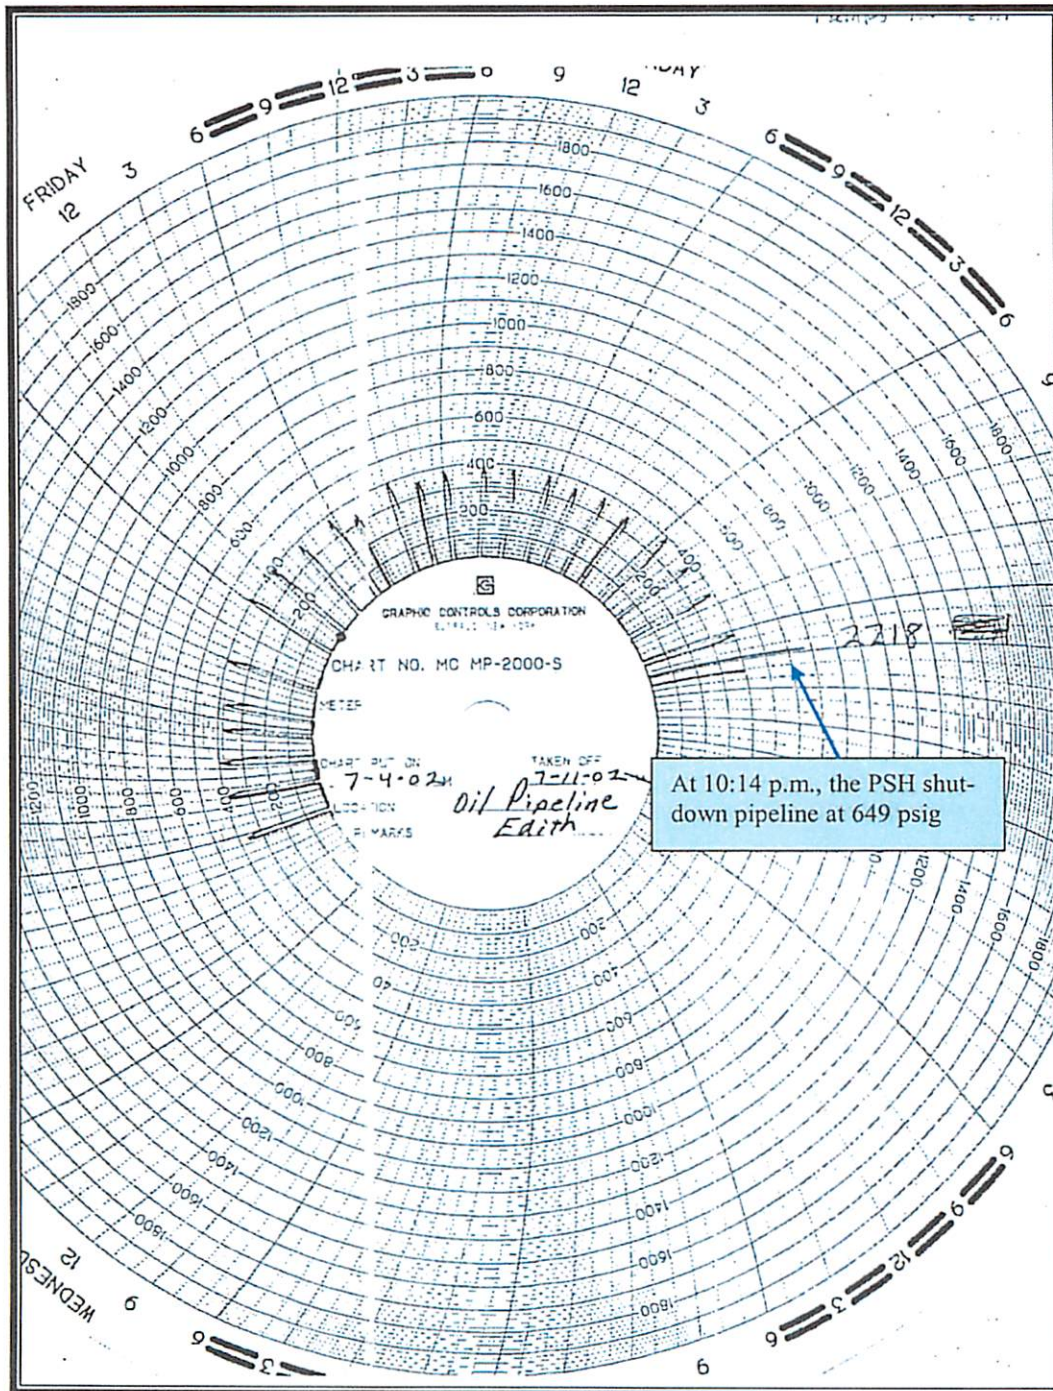
Attachment 6 -- Pipeline Pressure Gauge Chart from July 11, 2002

The July 4-11, 2002, chart from the pipeline pressure gauge on Platform Edith (Attachment 6—Pipeline Pressure Gauge Chart from July 11, 2002) shows that the normal operating pressure was 400 psig and that the pipeline shut in at 649 psig; substantially higher than 15% above the normal operating pressure. Upon further investigation, the MMS determined that the Pressure Safety High (PSH) sensors on pumps P-4 and P-5 were set too high, at 649 psig, and should have been set no higher than 460 psig, per MMS regulations at 30 CFR 250.1004(3).

The oil pipeline's high-pressure sensor located on Platform Edith was set higher than the 15% above the normal operating pressure range specified in our regulations, allowing the riser to experience higher pressures. As the normal operating pressure was approximately 400 psig, the high-pressure sensor should have been set at 460 psig instead of at 649 psig. Had the high-pressure sensor been set correctly, the pipeline pumps would have shut down at a lower pressure, a pressure that the riser's wall thickness may have been sufficient to hold.

**Pressure Charts:** Under PINC L-106<sup>5</sup>, carefully review the proof pressure charts to ensure that the normal operating pressure range has been correctly identified, that the PSH is set accordingly, and that the pipeline is operating at the normal operating pressure range.

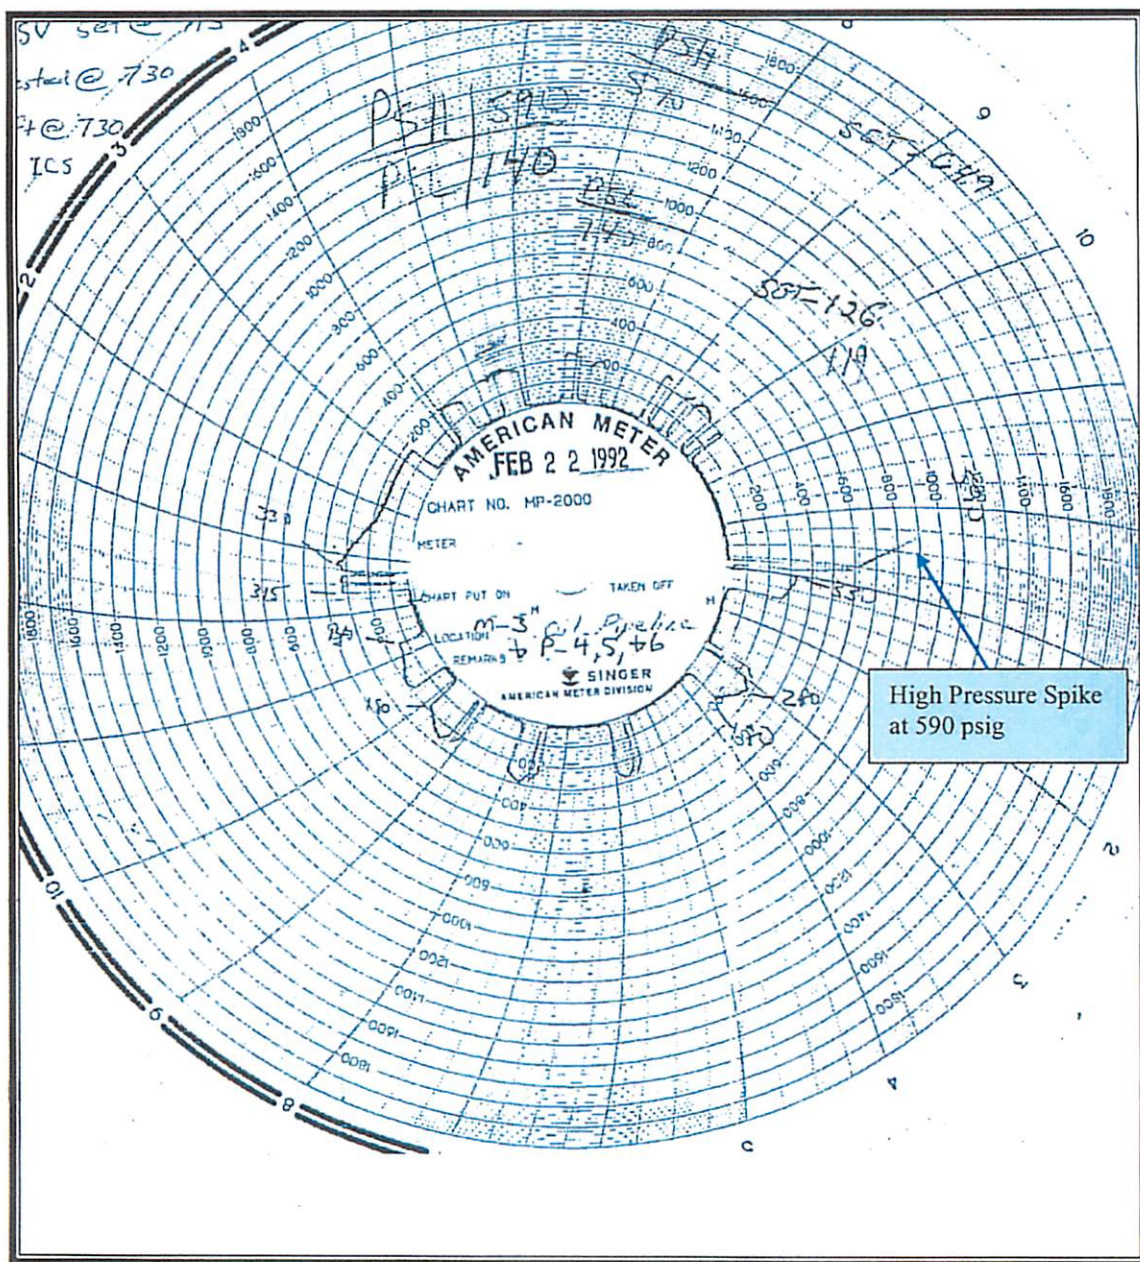
# Attachment 7 -- Proof Chart for Platform Edith 6" Oil Pipeline

The PSH settings were based on a 7-day proof chart conducted in 1992 (Attachment 7—Proof Chart for Platform Edith Oil Pipeline). The proof chart showed that an abnormal high pressure spike of 590 psig lasting approximately 5 minutes occurred once during the seven days of monitoring. Nuevo incorrectly interpreted this spike to be the high normal operating pressure and set the PSH accordingly at 649 psig. If that proof chart is actually representative of a typical week's pressure range and fluctuation, then ignoring the spike in determining the correct PSH setting would result in a weekly, unnecessary shutdown. However, the spike cannot be considered "normal"; the operator would have to establish, with additional pressure charts and/or explanation as to the cause of the spike, that

the higher pressure should be considered part of the normal operating pressure range. No further substantiation or investigation of the spike pressure was made by the operator.
