U.S. Department of the Interior
Bureau of Ocean Energy Management,
Regulation and Enforcement
Gulf of Mexico OCS Region

Safety Alert No. 296
12 May 2011

Catastrophic Failures in Mooring Systems Possibly Put Floating Structures at Risk

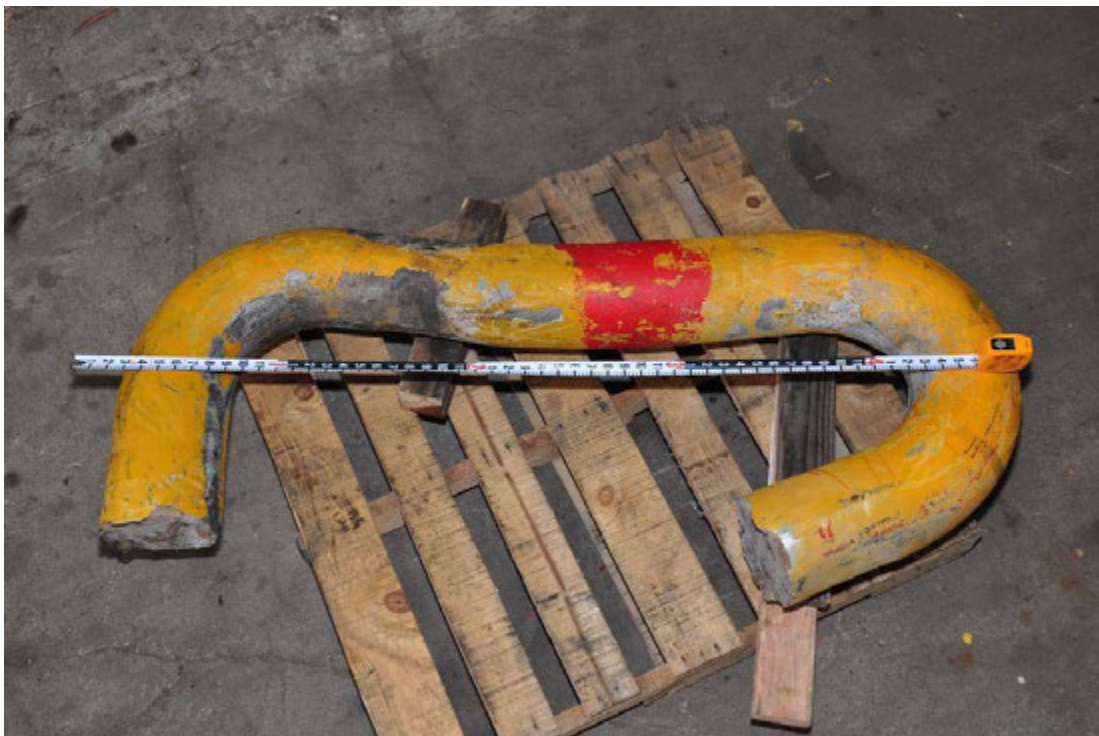
Failed Chain Link

The investigation determined that a 6 3/4-inch diameter, 862-pound chain link in the tether chain had fractured and separated near its butt weld. Analysis of the fracture indicated that the chain link had a weld repair and the fracture initiated in the middle of the weld. Three links of the 24-link tether chain were found to have weld repairs. After the chain had been heat treated, the non-US based manufacturer had made weld repairs to the chain by grinding defects and filling the void with weld material. The chain was being built in accordance with Det Norske Veritas (DNV) Offshore Mooring Chain standard. Post heat treat weld repairs are disallowed per DNV's Offshore Mooring Chain standard. The post heat treat weld repairs made the chain susceptible to hydrogen induced stress cracking due to the extreme hardness

of the weld material and the residual stress within the weld.

- **Operators** should monitor and inspect critical mooring components 100% of the time during the manufacturing process.
- **Operators** should ensure that the personnel and companies contracted to perform inspections and quality assurance of critical mooring components are qualified to do so.
- **Operators** should treat the area above a buoyancy air can for a free-standing hybrid riser as potentially hazardous. No floating production facility or support vessel should be allowed to pass over a free-standing hybrid riser.

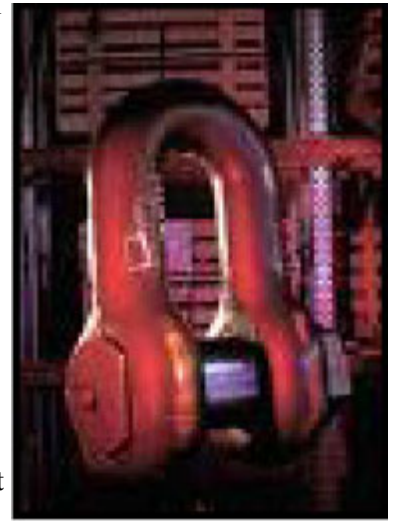
Example: Mooring Shackle

Incident No. 1: A one-ton, 8+ inch-diameter shackle connecting a mooring system to anchoring pilings failed on an overseas floating production facility. Subsequently, an identical shackle scheduled to be used in a deepwater GOM production facility also failed catastrophically under test loads below specifications. Operator reviews of the manufacturing and testing procedure and additional material testing indicated that all of the shackles were possibly defective.

Because anchor pilings with shackles attached had already been driven, the GOM test failure required new shackles to be manufactured, new pilings installed and the replacement of portions of the mooring systems that could not be recovered. Production start-up of the facility has been delayed by at least one year.

- **Operators** should review their specifications requirements to insure testing and manufacturing produces a product that will meet the usage demands.
- **Operators** should include sufficient *Charpy testing requirements* in the specifications to insure the materials and manufacturing process will produce a product of sufficient toughness.
- **Operators** should review their requirements for both destructive and non-destructive testing of critical elements. Operators should insure their test coupons are properly representative.
- **Operators** should review their requirements for equipment inspection and handling to insure no damaging techniques are employed in transportation or installation.

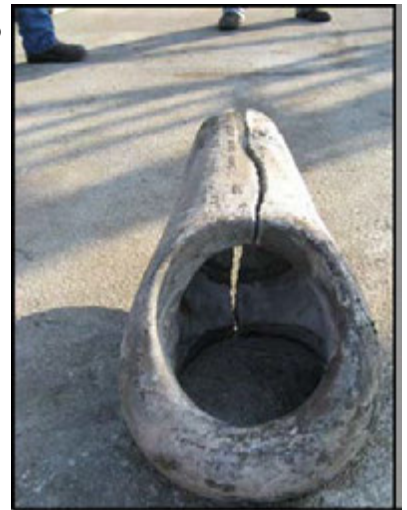
Failed Mooring Socket

Incident No. 2: Two sockets in a mooring system for a MODU failed under moderate loading. Testing of the remaining sockets found that others were also defective and a number of them failed catastrophically at less than specification loading.

- In both cases the manufacturing procedures are thought to have been defective. Heat treating after casting apparently resulted in a metal unable to meet “Charpy” standards for material “toughness.”
- In both cases, the Operator’s and/or manufacturer’s specifications for the items were either out of date or inadequate.
- In both cases the Operator’s material testing requirements were either not followed, or were not adequate to insure specifications were met.
- Material handling during installation may have exposed the equipment to potential critical damage.
