**Investigation of Fall with Fatality
High Island Block A-368
OCS-G 02433
June 5, 2003**

**Gulf of Mexico
Off the Texas Coast**

**U.S. Department of the Interior
Minerals Management Service
Gulf of Mexico OCS Regional Office**

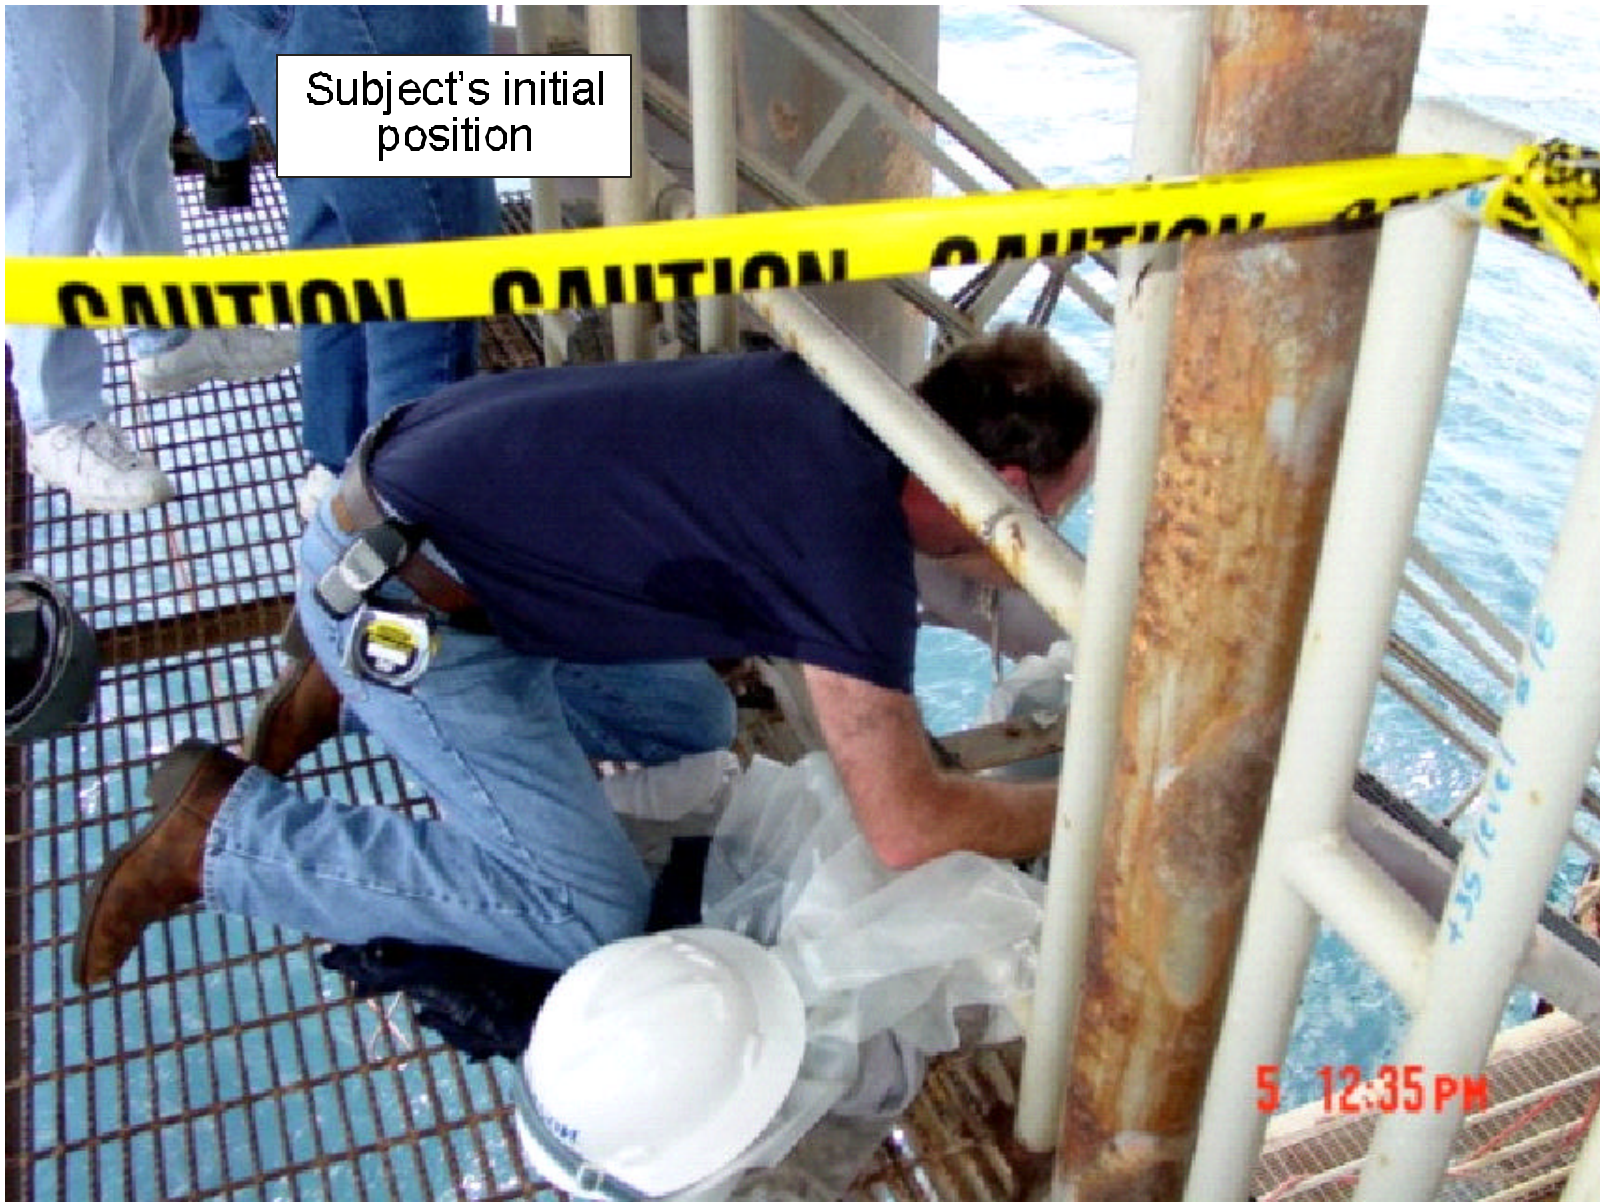
Photograph of employee position simulation

According to the statement given by the MSP supervisor, as he was making his rounds after the safety meeting checking on sand blasters, he saw the MSP employee stretching out through the guardrail and attempting to wrap the light fixture. He called to the employee for the purpose of informing him to put on his PPE, “full body harness and work vest.” He states that the employee looked up at him and pushed out farther to wrap the light. He states that at that moment the light fixture broke and that the employee fell through the guardrail. He states that the employee held on for “a few seconds” before falling, hitting the plus ten deck, and falling into the water. Records indicate that these events occurred at approximately 0630. *For a photograph depicting a simulation of the employee’s position at the time of the accident, see Attachment 4. For a photograph showing the various pertinent levels of the platform, see Attachment 5.*

It is concluded that, when the contractor employee leaned out through the walkway handrails in an attempt to wrap the light fixture with plastic, his center of gravity extended beyond the walkway, with most of his weight being supported by the light fixture. Consequently, when the light fixture gave way, the employee fell through the guardrails for a distance of approximately 23 feet before striking his head on a plus 12 level beam and subsequently falling into the water. It is further concluded that the employee was instructed by his supervisor to use the spider and PPE in performing his task.
