# SAFETY ALERT

**Safety Alert No. 356**  
**13 June 2019**

## **Pipeline Pigs Inadvertently Ejected in Vicinity of Personnel**

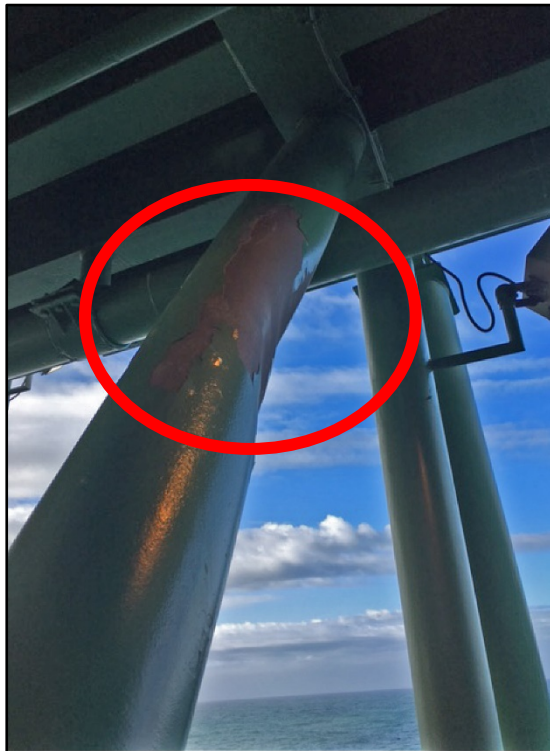
*(left) Damaged/Bent Platform Structural Member*

After apparently bleeding down the launcher to zero pressure, the launcher door was opened in order to begin loading pigs. One employee looked inside the launcher to confirm that there was at least one spherical pig in the launcher. (Note: records indicate that there were two pigs in the launcher prior to opening the launcher door, and a third was subsequently loaded.) As one employee was preparing to place another pig onto the pig raising mechanism, and the other employee was nearby, three pigs were ejected from the launcher. The force was strong enough that a platform structural support member was damaged (see photograph above). The employees pulled the facility Emergency

In addition to the damaged structural support member of the platform, the pigs also damaged an atmospheric storage tank and hand railings. The pigs were lost into the GOM as unrecoverable marine debris. The incident was originally reported as marine debris. The most likely causal factor was determined to be pressure inside the 36-inch launcher isolation valve body that was released into the pig launcher. Another possible cause was that a pig expanded to seal off the launcher from exiting pressure in and upstream of the isolation valve.

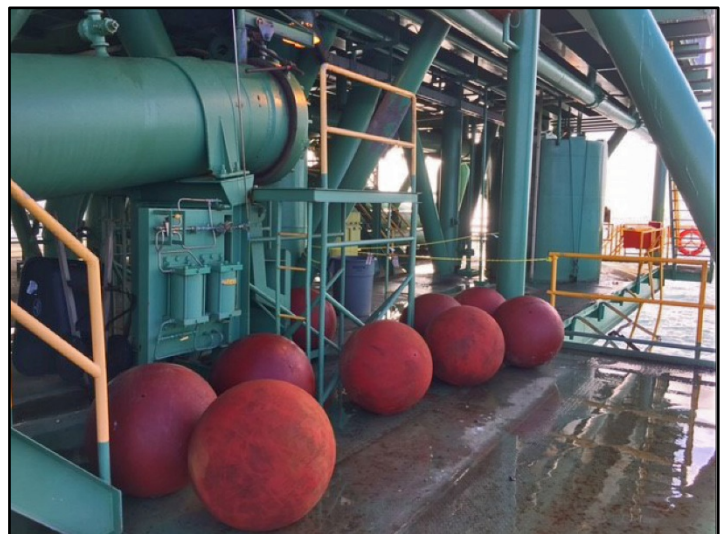
*(above) Pigs located in Pig Loading Area*
