Fall/Fatality during P&A/Platform Abandonment: Supervision, Operational, Equipment, and Organization Errors

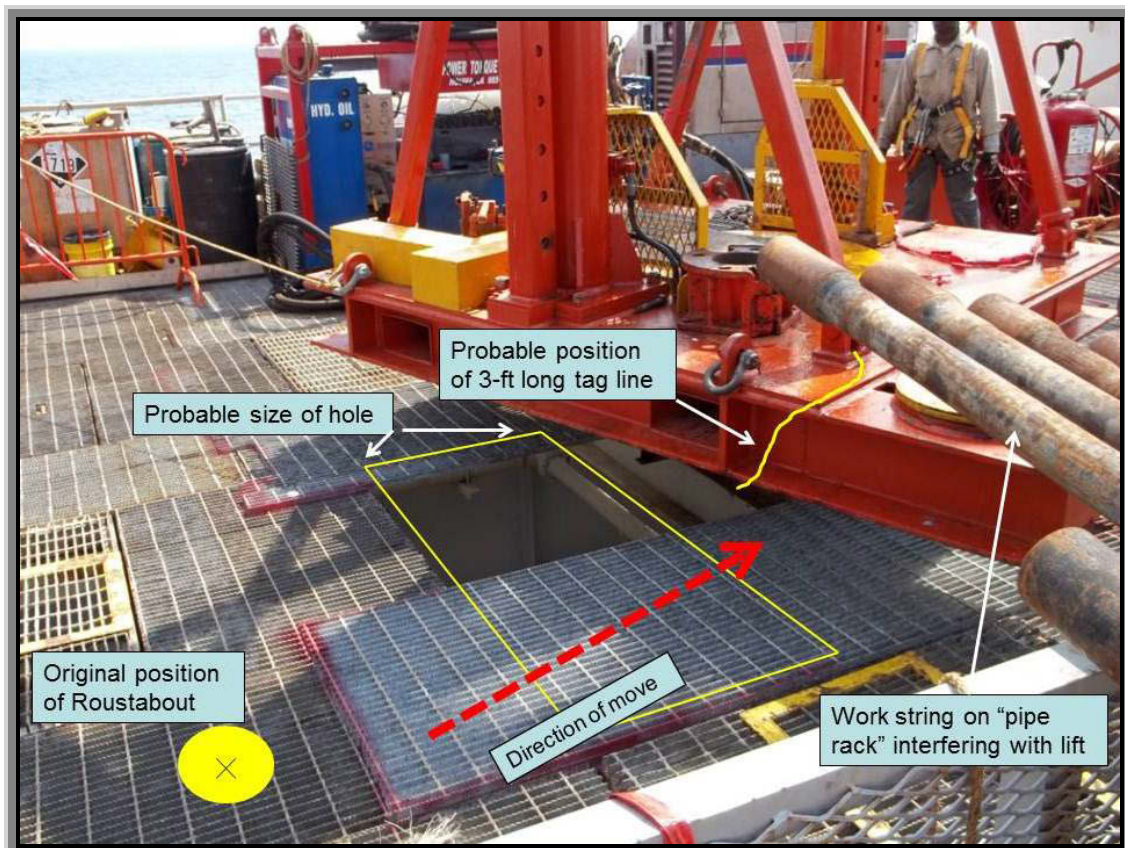
The accident occurred at night while the power swivel was being moved from atop the well with the roustabout acting as a rigger helping control the load. When the power swivel was lifted, the roustabout stepped, or was dragged by the load into the well-access opening in the deck that was exposed by the movement of the power swivel, and fell to his death. Night medevac callout was delayed due to confusion in emergency planning.

- The supervisor and company man on site did not have an emergency plan with medevac procedure and contact information readily available.
- The pre-shift JSA meeting did not address the hole in the main deck beneath the power swivel. The JSA meeting was not attended by all parties including the roustabout, and no signed, unique JSA form was created.

- The pre-lift “tool-box” meeting did not discuss the existence of the hole beneath the power swivel, and no fall protection was provided as required by company policies, BSEE, and USGC.

- The power swivel skid was equipped with two “tag lines” that were only three-feet long thus requiring the riggers to be in close proximity to the load. The tag lines were attached to the power swivel in such a way that they would drag across the open hole as the skid was moved;

- Other P&A equipment on the platform was positioned poorly and interfered with the crane operation.
 - A rudimentary, inherently dangerous, “pipe rack area” allowed the box ends of 15 joints of work string to protrude over the skid, requiring riggers to manually maneuver the load to keep from hitting the pipe.

- The temporarily stored casing jack interfered in the crane operator’s vision of the lift.
 - The lighting may have been inadequate for a night operation.

- Management and on-site supervision failed to address safety hazards and equipment deficiencies in planning, and made operational errors that contributed to the cause of the accident.

- There was no clearly designated, direct supervision of the lift because of multiple responsibilities assigned to the only supervisor on duty.

- Medical evacuation procedures and contact should be prominently displayed and all crew members acquainted with that information and the procedures.
- P&A/platform decommissioning operations should have a comprehensive safety evaluation for the organization of multiple simultaneous tasks.
- A fully attended and comprehensive JSA that covers all the risks should be a requirement.
- Fall protection should be available and used in the presence of open holes, or if holes may be exposed in the course of an operation.

- A lift should be evaluated for all risks, and the appropriate tag lines, and use of tag lines, should be reviewed.
- Management and supervisors should insure the work space organization, availability of necessary equipment, proper positioning of equipment, and the conduct of operations, be fully and constantly reviewed for safety hazards before and during operations.
- Management should assign enough supervisors to P&A/platform decommissioning operations to allow direct, oversight of operations.
