Boom Hoist Wire Rope Failure Results in Fatality

A **Safety Alert** is a tool used by BSEE to inform the offshore oil and gas industry of the circumstances surrounding an accident or a near miss. It also contains recommendations that should help prevent the recurrence of such an incident on the Outer Continental Shelf.

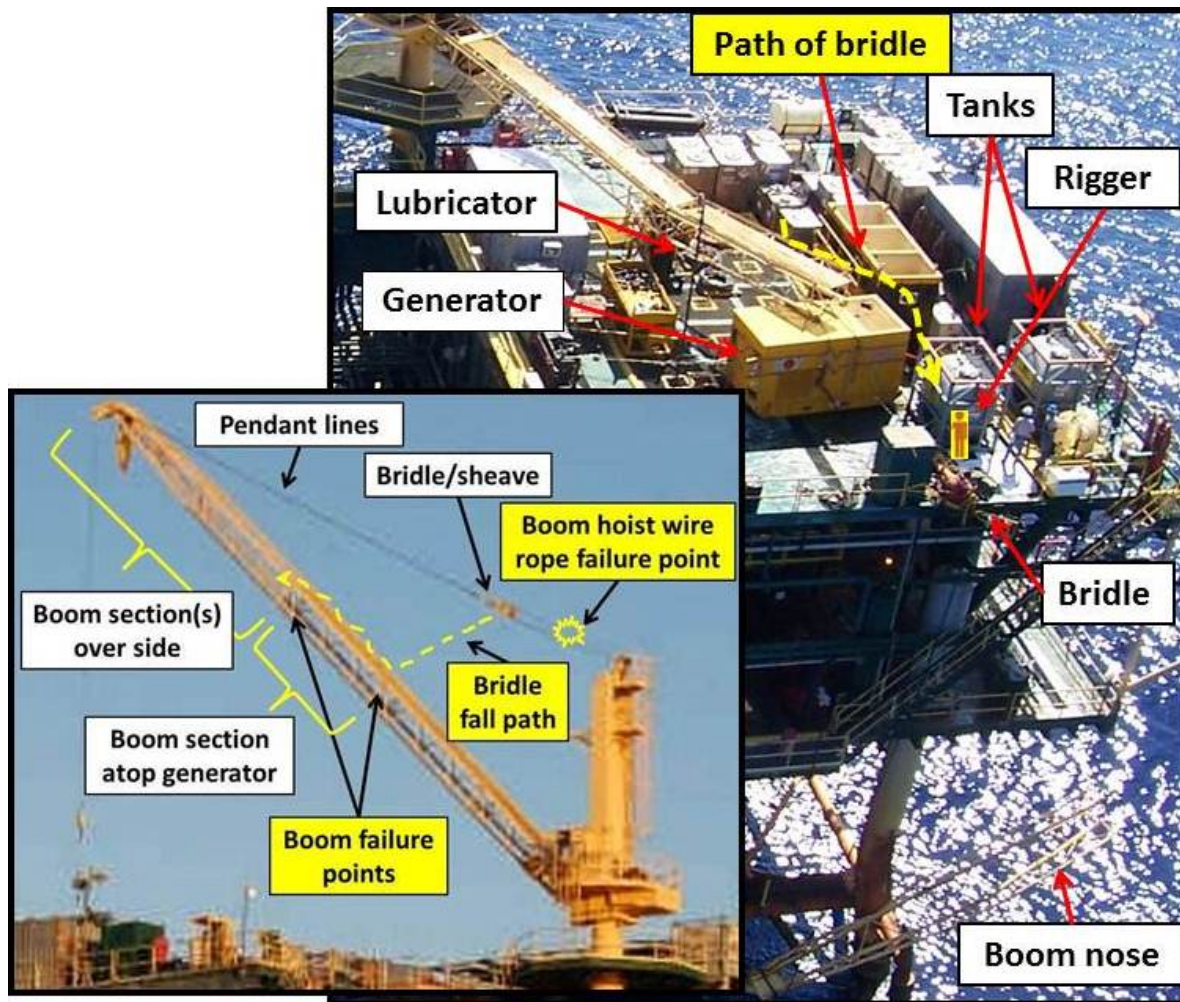
When the load was lifted, the crane's boom hoist wire rope parted. The boom fell, struck the generator, and broke into three sections with the nose section falling overboard. The falling nose section dragged the attached bridle behind it until its fall was arrested by the main hoist line and bridle pendant lines.

- (1) The Crane's boom hoist wire rope parted due to being weakened by advanced corrosion.
- (2) The vicinity of the lift was constrained by other equipment which caused the riggers to use tag lines to control the load, and to be positioned in the path of the falling boom. The positioning of riggers in the case of a boom hoist wire rope failure was not considered during the JSA.

- (3) The crane's corroded boom hoist wire rope lacked internal lubrication; probably because of improper lubrication method, frequency, and an improper lubricant type.

- Operators should review their methods of inspection of crane wire ropes to insure full and comprehensive examination as per API RP-2D.
 - Third party crane inspections should be checked and verified by Operator personnel.

- Coats of heavy grease on the crane lines should be removed during inspections so that the external and internal integrity of the lines can be examined.

- Special attention should be given to indications of changing wire rope diameters (both increasing and decreasing).
 - Wire ropes should be regularly lubricated with the proper lubricants, using recommended methodology to ensure full penetration by the lubricant.
