Safety Alert

Safety Alert No. 307 19 March 2014 Contact: Rob Carroll (504) 736-2671

Lower Stairwell Step Collapses Causing Injury

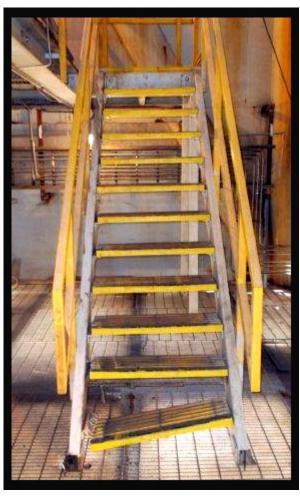
An injury occurred when a contract employee was descending the mezzanine well deck area heading to the lower second deck. When the Injured Person (IP) reached the last step, the fiberglass bracing of the metal step collapsed causing the worker to fall to the deck and injure his knee.

- The bracing supporting the step may have exceeded the manufacturer's 20-year life expectancy.
- The bracing may have deteriorated due to periodic exposure to chemicals or prolonged exposure to weather or excessive vibration.
- Unless inspected closely, the bracing appeared to be in good condition.

- Replaced the fiberglass bracing with more durable aluminum supports.
- Added diagonal and cross bracing for additional strength and support.
- Installed J-bolts to secure stairway to lower grating deck.
- Inspected similar construction on all associated facilities to verify the safety of the step bracing of all stairwells.

- Inspect all stairwells to determine the type of bracing that supports the steps.
- Install and maintain all fiberglass bracing as per the manufacturer's installation and maintenance recommendations.
- Schedule periodic maintenance to ensure adherence to manufacturer's recommendations with regard to fiberglass bracing.
- Take specific precautions to aging fiberglass bracing construction nearing the manufacturer's replacement recommendations.
