Safety Alert

Safety Alert No. 308 19 March 2014 Contact: Matt Nagy (504) 736-2828

Overloading Leads to Catastrophic Failure of Crane Boom

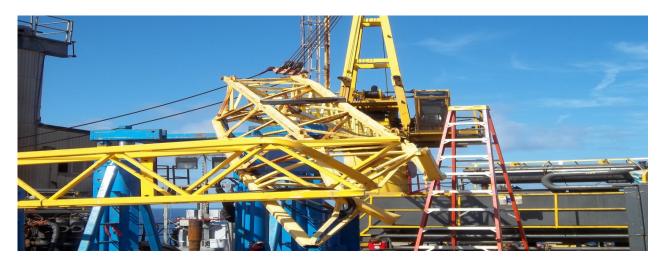
A lease operator was performing a well permanent abandonment (PA) on an Outer Continental Shelf (OCS) platform. Operations were being conducted to pull the 3.5" workstring and casing knives from the well after using a power swivel to cut the $9^{5/8}$ and $10^{3/4}$ casings. The cutter assembly had become stuck while mechanically cutting the casings, and the hydraulic cylinders on the swivel stand were used to free the stuck knives. The cutter came free from the casing and the assembly was ready to be pulled from the well using the crane. The workstring and knives weigh approx. 6,600 pounds. The load line on the platform crane was attached to the workstring using pipe elevators. The load chart in the crane indicated that the crane could perform a static lift of 21,448 pounds and dynamic lift of 16,780 pounds at a boom angle of 63 degrees. The boom was raised to a 63 degree angle and the crane operator then proceeded to pull on the workstring until 21,000 pounds was displayed on the weight indicator with no success. The crane operator stated "looked like workstring was stuck." After slacking off on the load, a second attempt was made to pull the workstring and knives from the well. The crane operator stated that "the weight indicator in the crane cab was displaying 21,000 pounds during the second attempt." The operator then stated that "all of the weight fell off of the indicator at which time the crane boom began to fall to the deck of the platform." The crane boom, as well as a power pack, came to rest on the power swivel stand that had been used for the cutting operation. The tip section of

the boom came to rest at approximately 90 degrees to the right side of the main stem of the crane boom. No personnel were injured, and all were accounted for immediately following the incident.

- Incorrect load chart was used at the time of the incident.
- The crane operator used static load limits when pulling cutter assembly from the well instead of using the dynamic load limits as required by the contractor's SOP.
- The bore holes of the pin connections in the boom showed excess wear thus causing slack in the connections and improper load distribution in the boom.
- The diagonal lacing, boom cords, and pin connections of the middle boom sections were found to be corroded.

- Conduct proper crane pre-use inspections as per API RP 2D, C.4.1.2a which should include proper load chart verification.
- Conduct proper crane maintenance inspections as per API RP 2D, C.4.1.2 which should include thorough inspection of boom connections and proper load chart verification.
- Adherence to the SOPs and procedures put forth by both the operator and contractor while conducting lifting operations.
- Use the load chart for the dynamic load limits when pulling tubulars from wells instead of using the static load limits.
- The Crane Operator shall verify that the hook load is within the crane's applicable static or dynamic rated load at the radius for which the load is to be lifted.
- Crane boom pull shall never exceed the calculated weight of the hook load, block, and rigging.
