# Safety Alert

Safety Alert No. 21  
January 13, 2014

## **Pollution from Production Operations Due to Improper Diversion of Production Flow and Rupture Disc Failure**

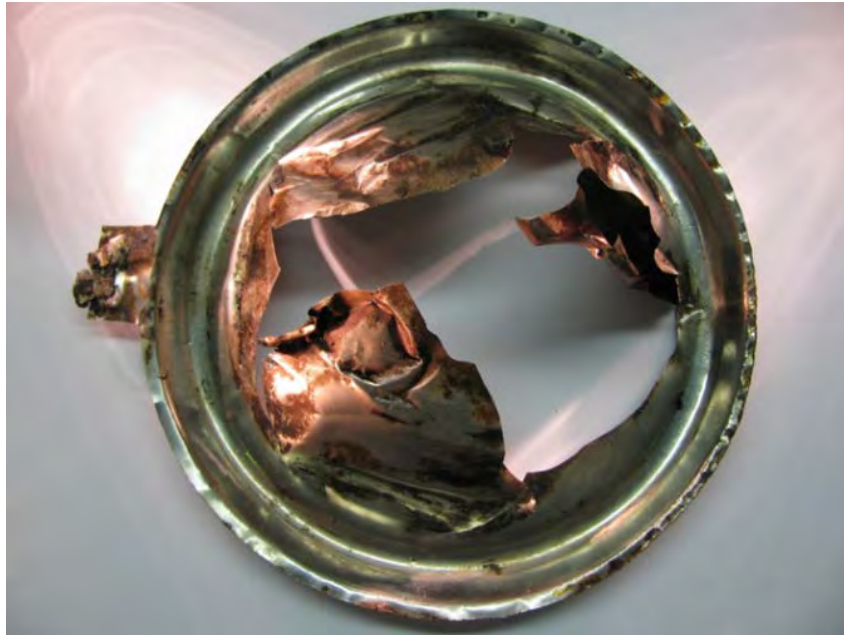
- The rupture of the PSE in the piping from the surge tank allowed the release of liquid hydrocarbons into the flare header. Based on the production volumes and normal operating pressure, it is believed that the PSE failed at a pressure well below its rated pressure. A laboratory analysis of the ruptured PSE (pictured below) indicated corrosion pitting, fatigue, and brittle cracking. There was no documentation indicating when the

PSE was installed or when, if ever, it had been replaced. It is possible that the PSE had been in service for more than 20 years.

**Rupture Disc Recovered from Platform's Surge Tank (BSEE Photo)**

- Maintenance, testing, and documentation procedures of PSEs and other safety devices are adequate to ensure those devices will perform as intended. Operators should check the status and condition of any PSEs or similar devices in use in their production systems. Operators should be especially aware of the age of such discs as well as the working conditions that the discs are subjected to, which may result in fatiguing or failure. The rupture disc marking identification tags should be attached and legible. Operators should inspect rupture discs for damage or pre-existing flaws before installing replacements.
