Safety Bulletin No. 006  
28 July 2017

## Dropped Moon Pool Flap Poses Threat

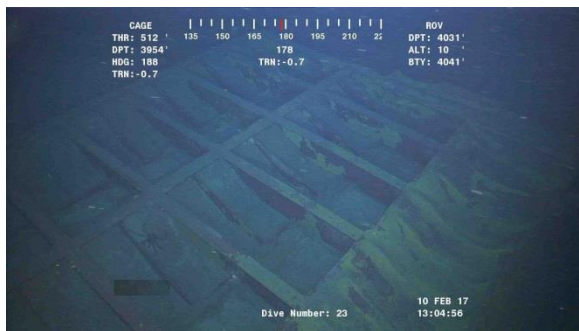
Left: moon pool flap on seafloor; Right: damage to riser buoyancy module

The moon pool flap was originally damaged during efforts to raise it in rough seas several months prior to the incident. After multiple efforts to force the flap into the stowed position in rough conditions, the pad on the underside of the flap warped. Because the flap was deformed, it could not lie level, which prevented the locking wedges from fully engaging while deployed. During transit from Trinidad to the GOM, it is likely the hinge pin structures further weakened.

While on location in the GOM, the rig crew raised the moon pool flap to the upright position in preparation for drilling operations. Because the hinge pins were impaired and could not be fully engaged, the only structural support was a chain. Over time, vessel vibrations and weather events created additional stress on the hinge pin brackets, which eventually failed due to fatigue. All brackets sheared, and the forward moon pool flap separated from the hull structure, sinking to the seafloor. The Operator was required to recover the flap from the seafloor.

- Evaluate the current condition of moon pool flaps and structural supports and implement any necessary repairs.
- Consider implementing a moon pool flap inspection program on all drillships that use this structural feature.

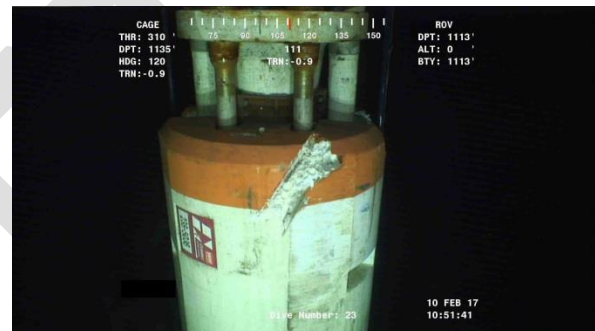
In February 2017, the forward moon pool flap of a deep-water drillship operating in the Gulf of Mexico (GOM) separated from the hull structure and sank to the seafloor. During its descent, the moon pool flap contacted the marine riser and gouged a buoyancy module before coming to rest less than 400 feet from well center. Fortunately, no injuries or spills occurred.
