Safety Bulletin No. 007
2 August 2017

\$2.7 Million in Damages from Faulty Sight Glass Valves

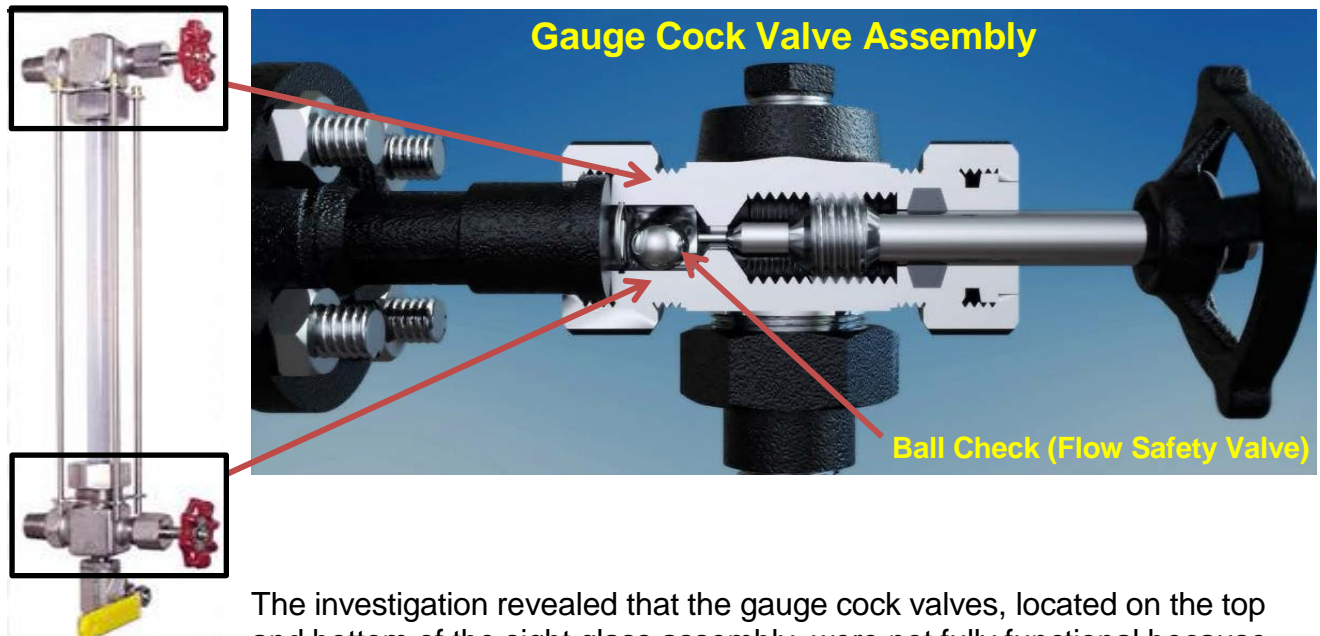
On January 5, 2017, a failed vessel apparatus (broken sight glass) located outside of the Heater Treater discharged oil because the ball checks were not present in the gauge cock valves. As oil discharged from the sight glass, it saturated the protective insulation on the Heater Treater and blew into the Pipeline Pump #1 exhaust system, causing an ignition. As a result of the fire, damages to the Heater Treater and associated equipment were estimated at \$2.7 million dollars. Fortunately, there were no injuries to personnel.

The investigation revealed that the gauge cock valves, located on the top and bottom of the sight glass assembly, were not fully functional because there were no ball checks present in either valve. If the ball checks were in place, they could have prevented the flow and/or mitigated the amount of oil discharged out of the system due to sight glass breakage. Since the ball checks were not in place, a constant discharge of oil from the system occurred until the level of oil dropped below the bottom gauge cock valve.

- Gauge cock valves should be equipped with an automatic ball check shutoff, in accordance with API 14J 3.3.2, to help prevent/mitigate rapid loss of fluid due to accidental glass breakage.
- Ensure that personnel are familiar with the manufacturer's installation, operation and maintenance requirements related to gauge cock valve assemblies.

- Ensure that personnel are familiar with and trained on the status/position of gauge cock valve assemblies.
- Ensure that personnel are familiar with and trained on operating procedures and maintenance related to sight glass assemblies.
- Periodically inspect the gauge cock valves to make sure that the balls are still in place and that they are functioning properly.
