Safety Bulletin No. 008
11 September 2017

Structural Failure of Crane Swing Gear Drive Housing Injures Three

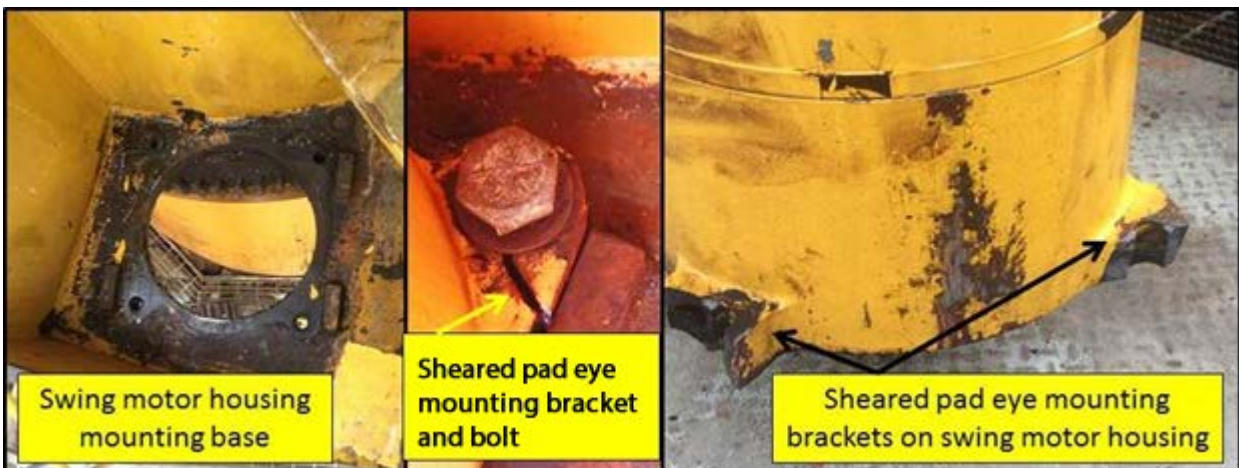
The operator, crane contractor, and BSEE’s investigation determined that the crane’s hydraulic swing gear motor (slew drive system) had failed, which made it impossible to control the lateral movement of the boom. The mounting pad eye brackets that secured the swing gear drive housing to the crane cab base had sheared, allowing the housing to deflect under loading and the swing gears to disengage from each other. The disengaged swing gears prevented any control of swing motion and effectively disabled the crane during the personnel lift.

- The mounting bolts either backed out during operations due to vibration or other operational causes, or the bolts were never fully tightened to torque specification when the crane was installed.
- The loose bolts allowed the swing gear motor mount to deflect under loading, which put unplanned stresses on the pad eye mounting brackets until the brackets sheared.
- Inspection of these bolts for any loosening and to insure the proper torque setting is not a normal part of daily pre-use, quarterly, or annual inspection(s) of the crane.
- Abnormal movement of the swing gear motor under loading, resulting from failure of the securing bolts or mounting brackets, may only be detectable by personnel looking for that specific failure.

- Evaluate the condition of the mounting brackets and the torque values of the bolts securing the swing drive gear housing of cranes;
- Consider incorporating specific periodic examination (quarterly and/or annual inspections) of the crane swing drives, including pad eye connections and bolts.
- Review this incident with all personnel and organizations that work with crane operations. Review participants include crane personnel, crane contractors, crane manufacturers, riggers, and inspectors.
