Safety Bulletin No. 015
13 February 2019
Reference [Safety Alert #326](#)

Fatality Related to Restricted Access Zones, Moving Equipment and Fatigue

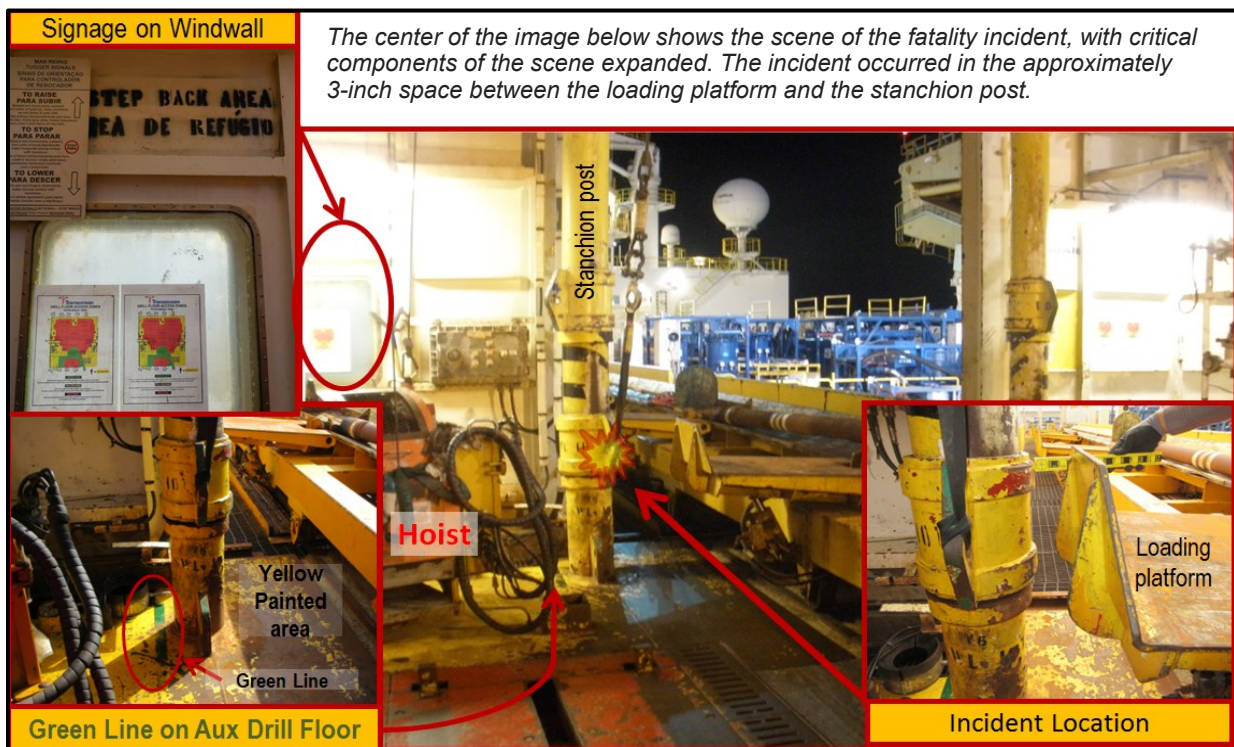
During 2017, a fatal incident occurred on a drillship in the U.S. Gulf of Mexico during pipe handling operations. At the time of the incident, the floorhand (casualty) stood in an unmarked pinch point area on the drill floor and faced away from the equipment being used. He was subsequently pinned between the moving equipment and a stanchion post on the drill floor. The incident occurred near the end of a 12-hour shift on the first day back to the drillship after the crew had been off for 21 days.

A BSEE [panel investigation](#) identified a number of direct and contributing causal factors for the incident. Primary among those, the panel concluded that access zones on the drill floor were not adequately depicted, understood, enforced and/or regarded. The risks associated with additional steps to the pipe handling procedures were not sufficiently mitigated. In addition, the floorhand (casualty) and other crewmembers failed to keep themselves and others out of the path of moving equipment and did not stop the job when unsafe coworker positioning was observed. Further, the pinch point hazard was not officially identified and properly mitigated. Fatigue and complacency could have also contributed to the incident.

- Ensure all restricted access and safe zones are sufficiently identified and communicated to personnel, and enforced by crewmembers and supervisors.
- Ensure operational procedures are updated and followed to account for, and mitigate, all known risks.
- Evaluate and address potential pinch point areas. Operators should consider reviewing the design and location of moving equipment and/or stationary structures. Operators should also consider hazard mitigations including audible proximity alarms.
- Review every employees' fitness for service on the first day of work on each hitch (including requirements to travel) and consider opportunities to maximize rest and limit fatigue.
- Consider incorporating a safety shelter area on rig floor during routine operations.
