Safety Bulletin No. 017
1 April 2019

Tool Lanyards Improperly Used as Hard Hat Lanyard

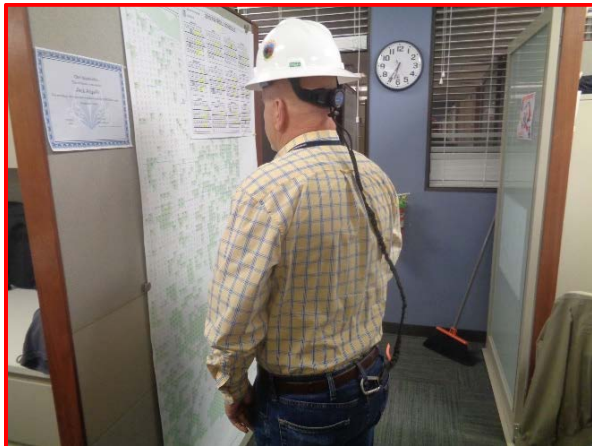
Figure 1: Tool lanyard improperly used as a hard hat lanyard

On a recent trip offshore, a BSEE inspector noticed several personnel using tool lanyards as hard hat safety lanyards (See Fig. 1). The tool lanyard's purpose is to prevent tools from falling when working at heights by securing the tools to fixed points with a carabiner. Personnel should not attach tool lanyards to their bodies, clothing or any items attached to their person. Personnel should use a proper hard hat lanyard (See Fig.2).

A tool lanyard attached to a worker with a carabiner latch can pose serious risk of injury when used near rotating or moving equipment. OEMs state that tool lanyard use around rotating or moving equipment requires extra precaution due to the possibility of entrapment in the equipment. The risk of serious injury increases if the lanyard is connected to personnel. OEMs specifically outline the limited circumstances when tool lanyards can be attached to personnel.

- Personnel with Ultimate Work Authority should stop the utilization of tool lanyards as hard hat lanyards and ensure use of the proper hard hat lanyard product.
- Operators and managers should share this Safety Bulletin with offshore personnel and encourage them to report any other misuse of equipment.

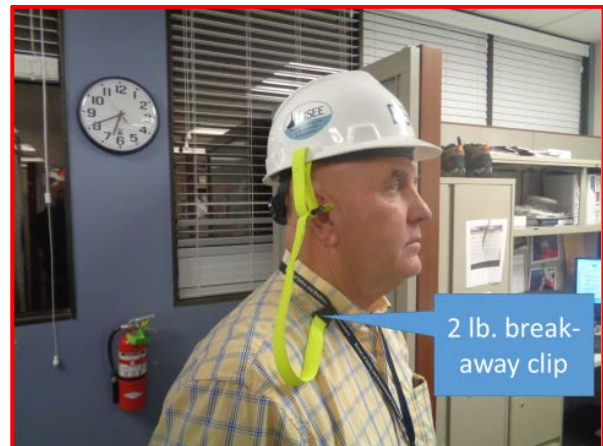
Figure 2 : Proper hard hat lanyard installed

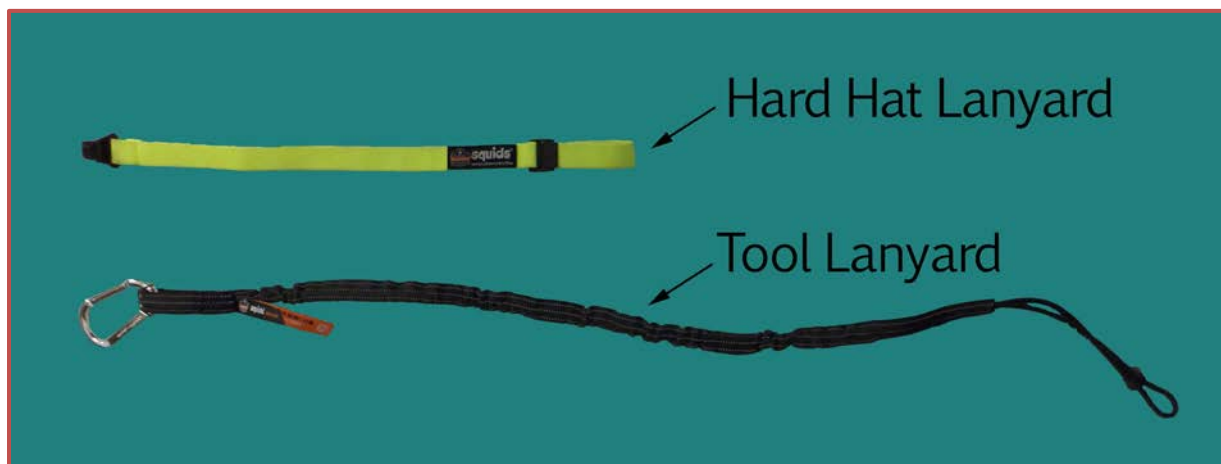
The intent of the original equipment manufacturer (OEM) design of tool lanyards is to arrest the fall of various tools when working at heights and allow for recovery of the tool without descending. They are usually longer than hard hat lanyards (See Fig. 3).

Figure 3: Typical hard hat lanyard (top) and typical tool lanyard (bottom)
